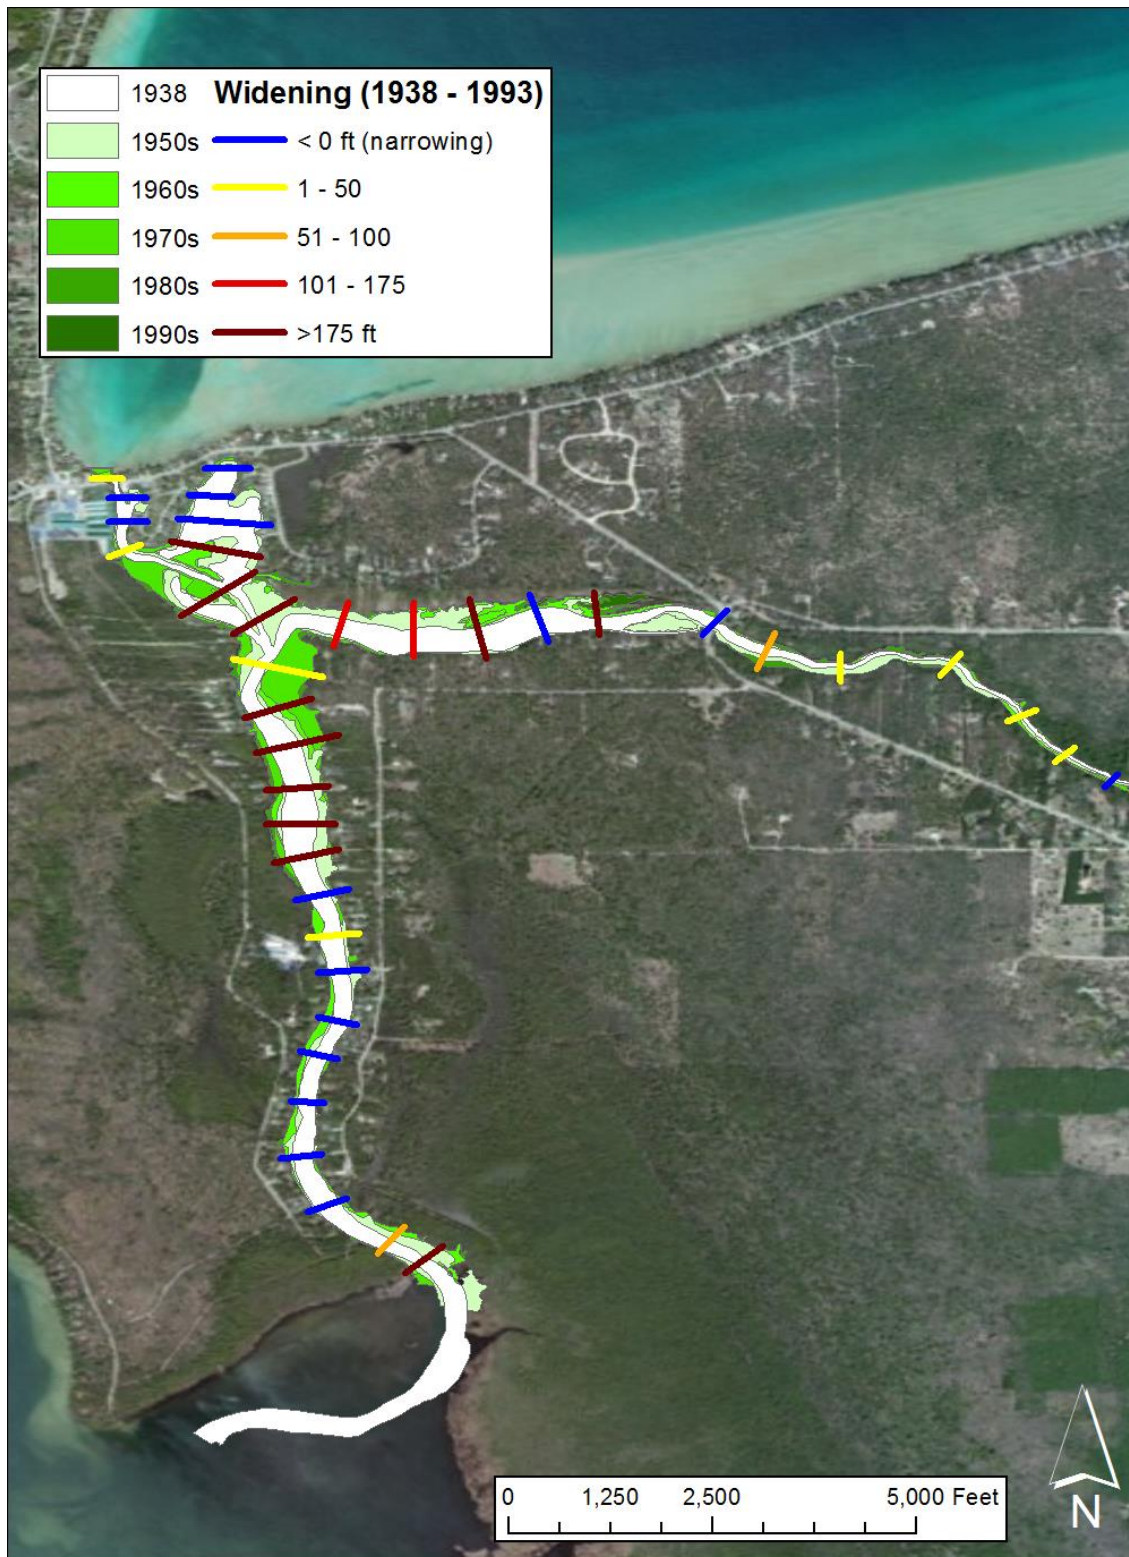
Figure 32. Map of channel cross section width changes between 1938 and 1993, overlain on historical channel geometry maps.

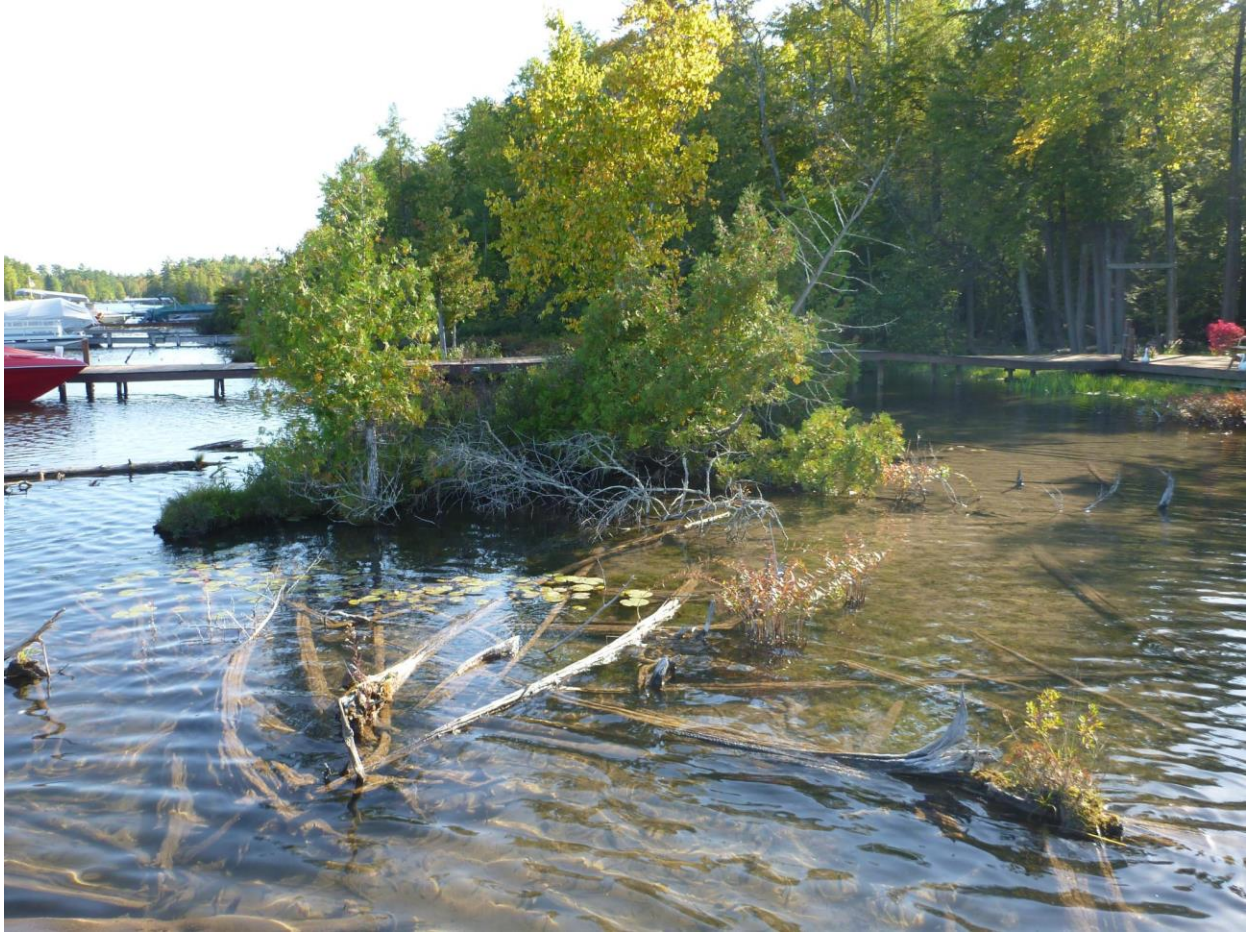
Figure 33. Image showing significant recent bank erosion just downstream of the Rapid River confluence with Torch River.

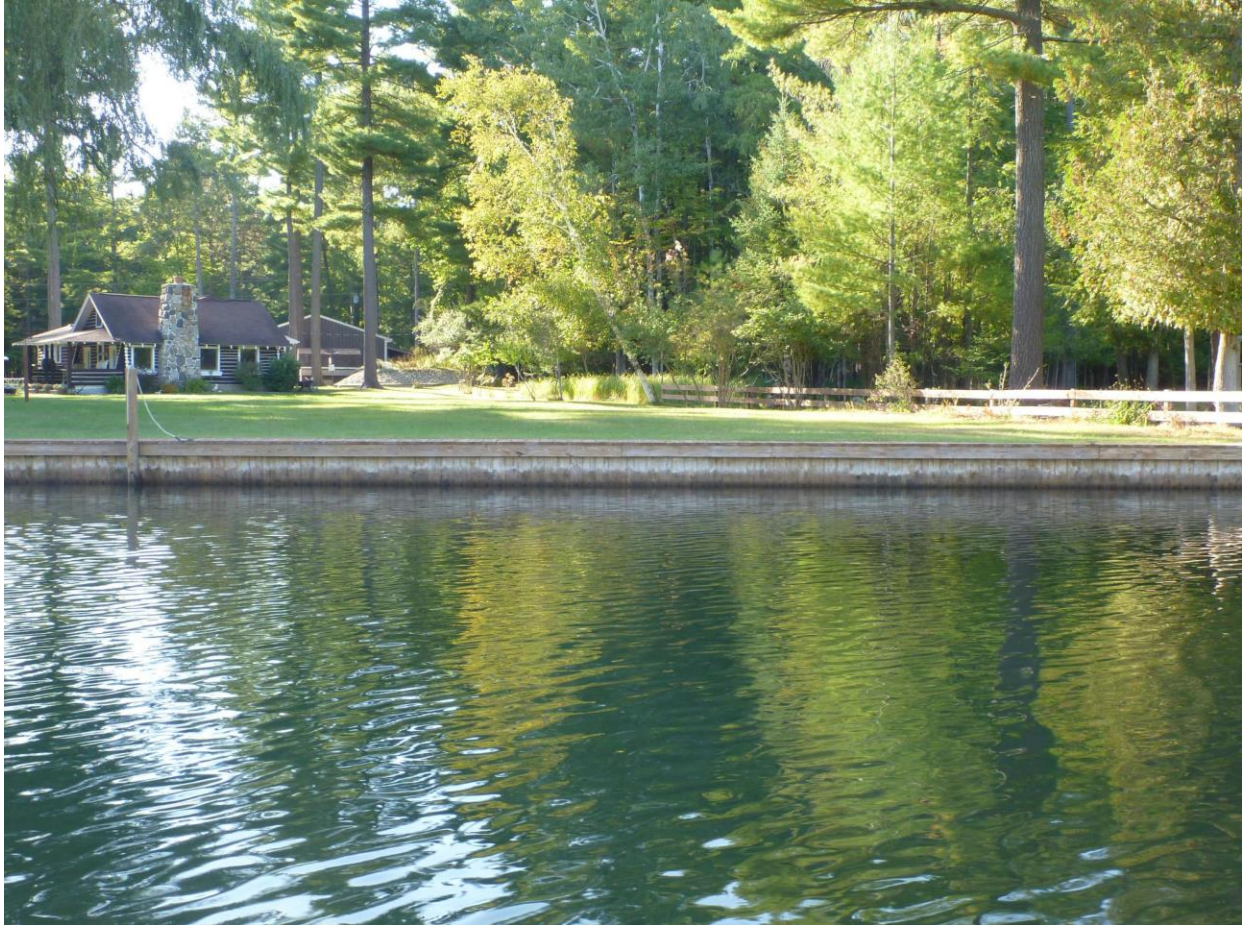
Figure 34. Image further downstream from Figure 33, in the middle Torch River. Visible is the completely armored bank of a wooden seawall.

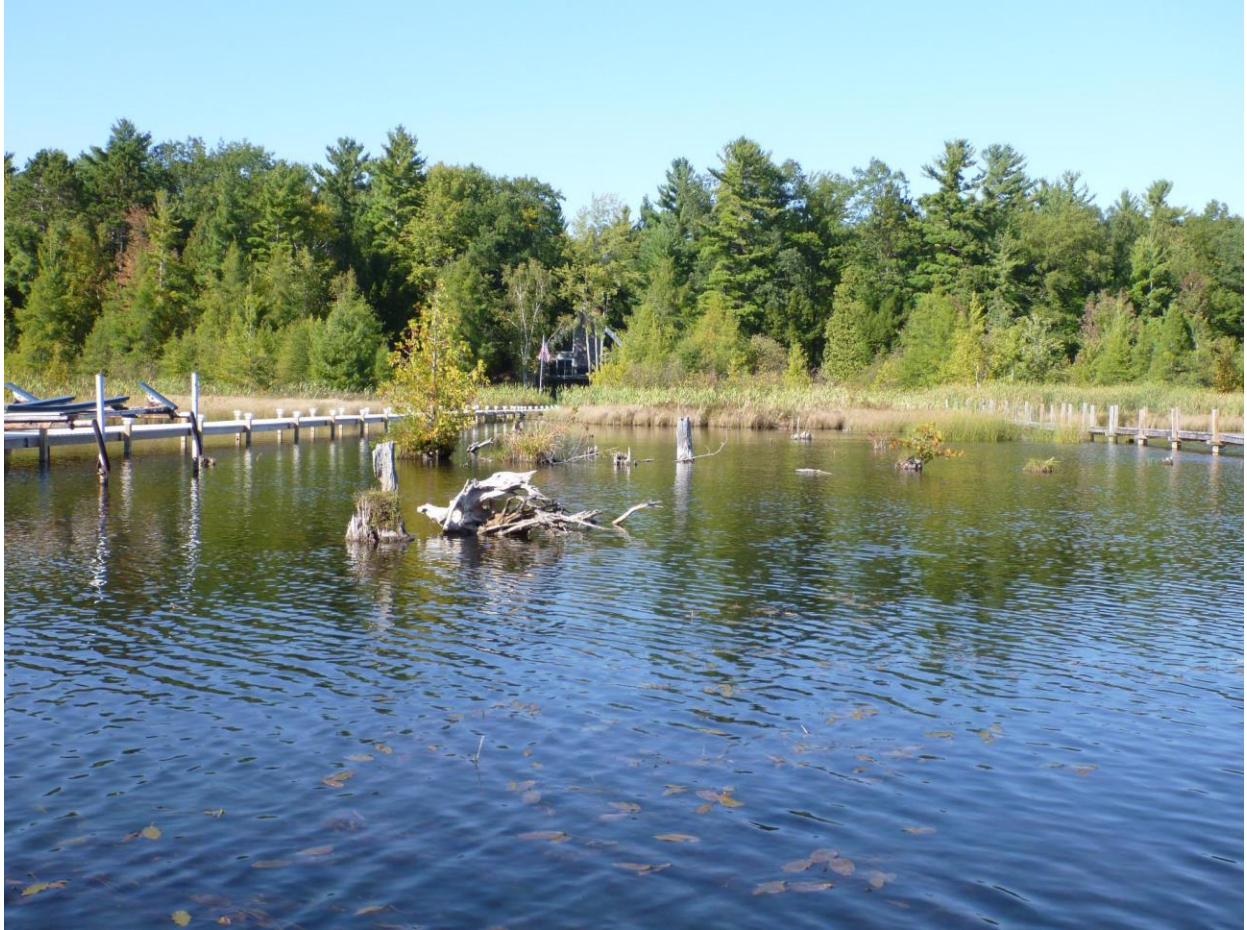
Figure 35. Image of a house on the north bank of the lower Rapid River, formerly set significantly back from the river but experiencing significant modern erosion. Other docks are visible, with homes set back far enough that they lie beyond the tree line.

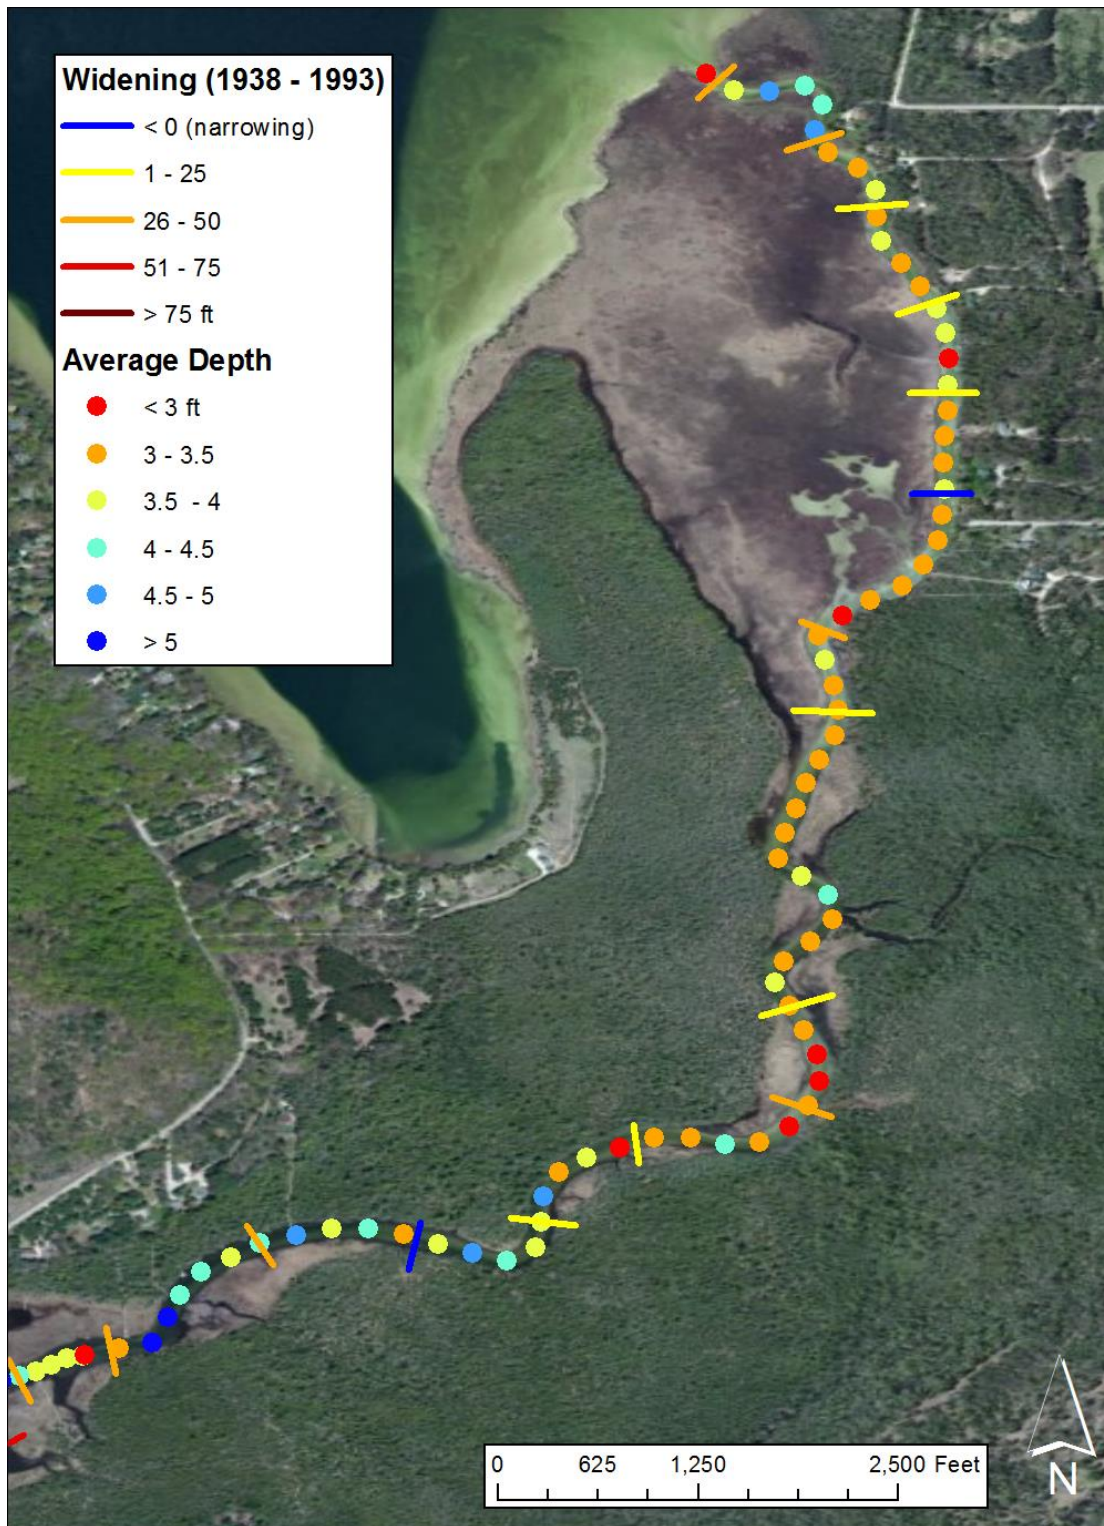
Figure 36. Map of average channel depths along the Grass River with historical channel width changes overlain.

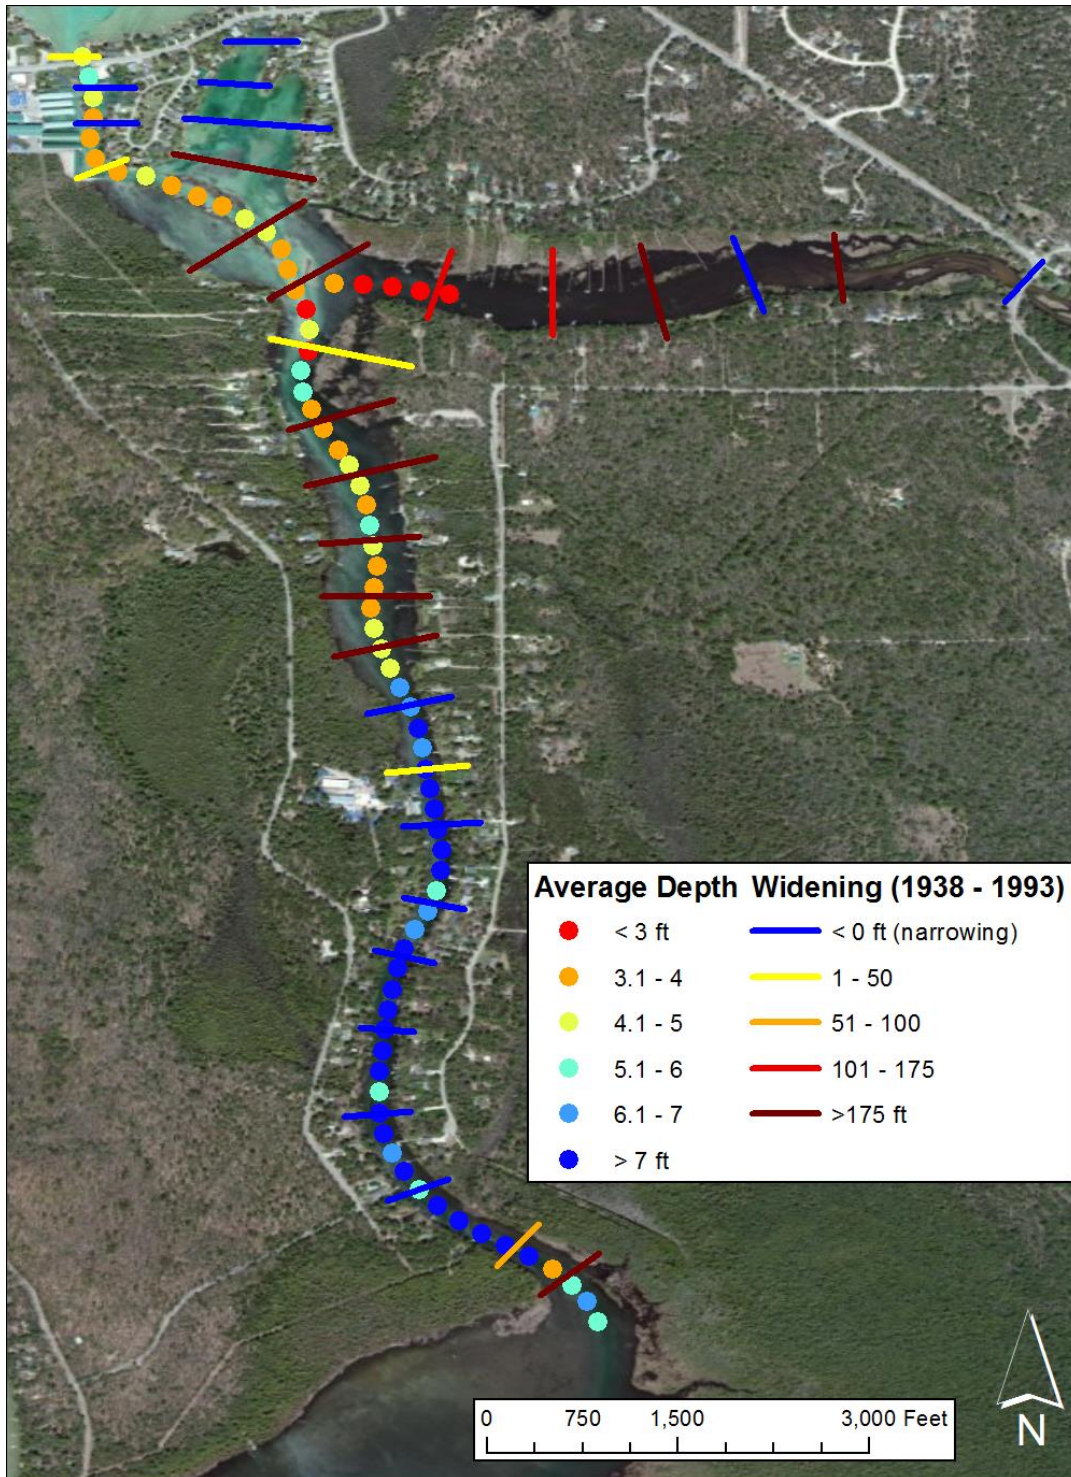
Figure 37. Map of average channel depths along the Torch and lower Rapid Rivers with historical channel width changes overlain.

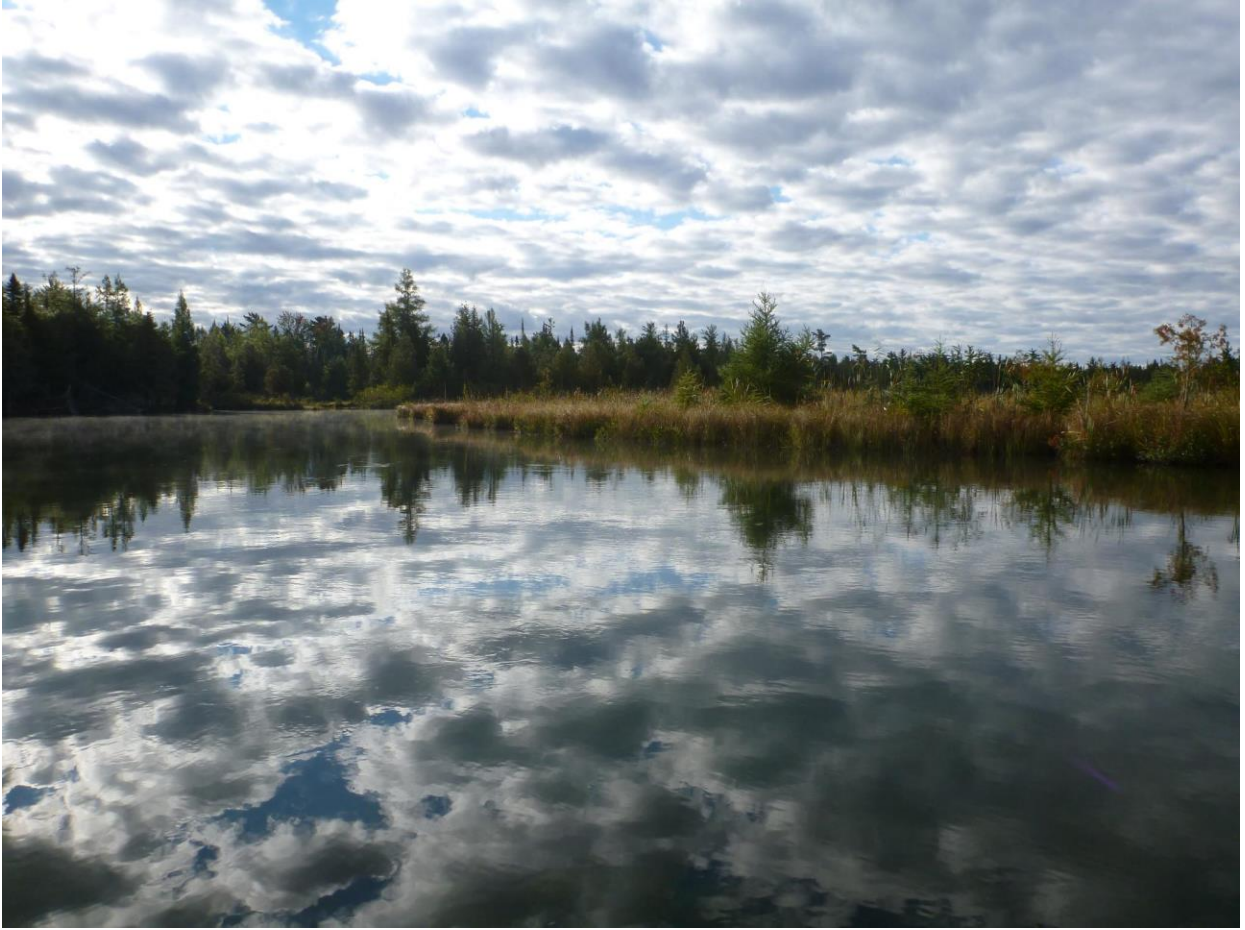
Figure 40. Image of the grassy banks of the Grass River.
