GRASS RIVER & TRIBUTARIES RESTORATION ASSESSMENT: 2011 FINDINGS

Three Lakes Association PO Box 689 Bellaire, MI 49615 www.3lakes.com by

August 31, 2011

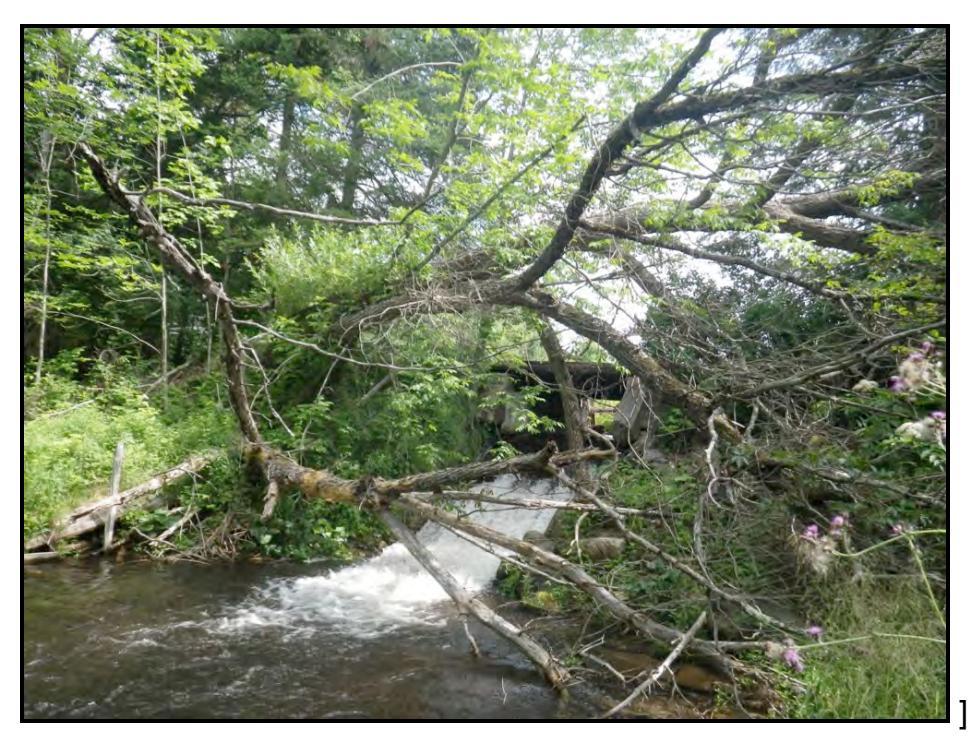
Old Hydroelectric Dam Spillway on Shanty Creek

We found an old dam on Shanty Creek below where there used to be a pond that had drained away. Though the pond is gone, the water still falls a long way when it goes over the dam and is a fish passage barrier.

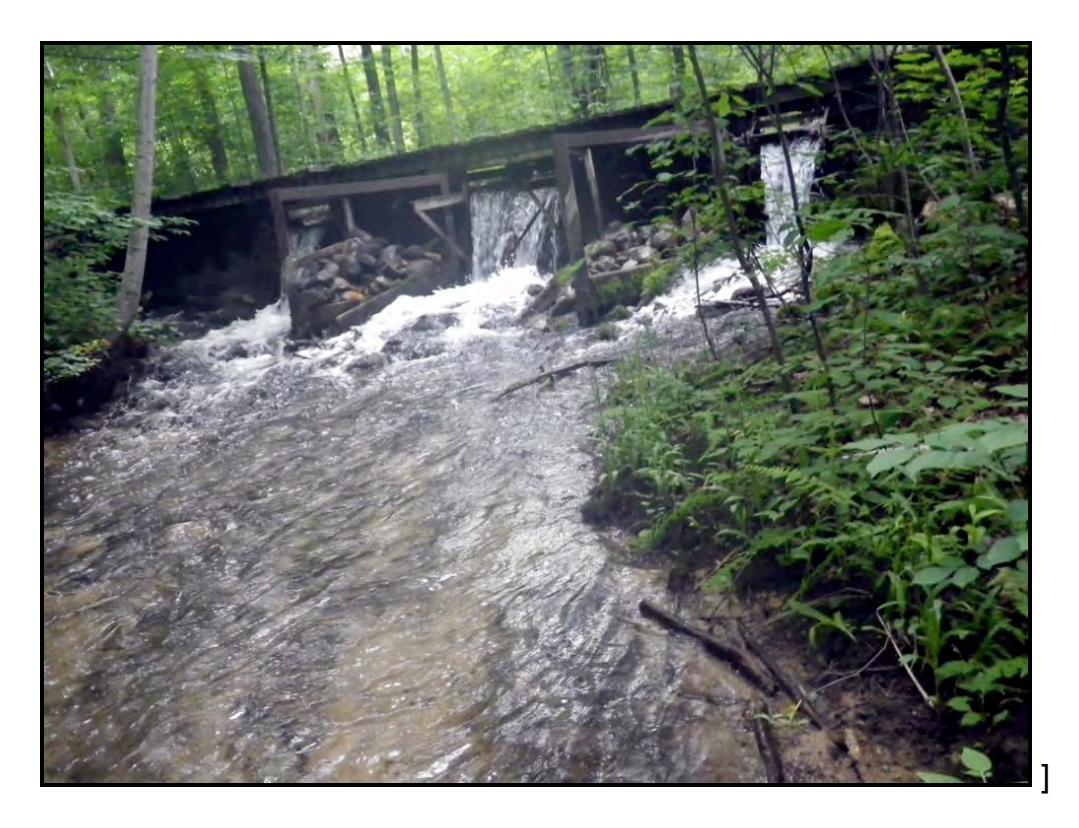
Pine Brook Iron Dam on Shanty Creek

Farther upstream on Shanty Creek, in the Pine Brook development, there is a footbridge with a slab of metal underneath it creating a 4-5 foot waterfall, and a barrier to fish passage. It may have been originally intended as a sand trap but is full and no longer effective. The supervisor for a Pine Brook homeowners' association expressed interest in future restoration actions to remove this water blockage.

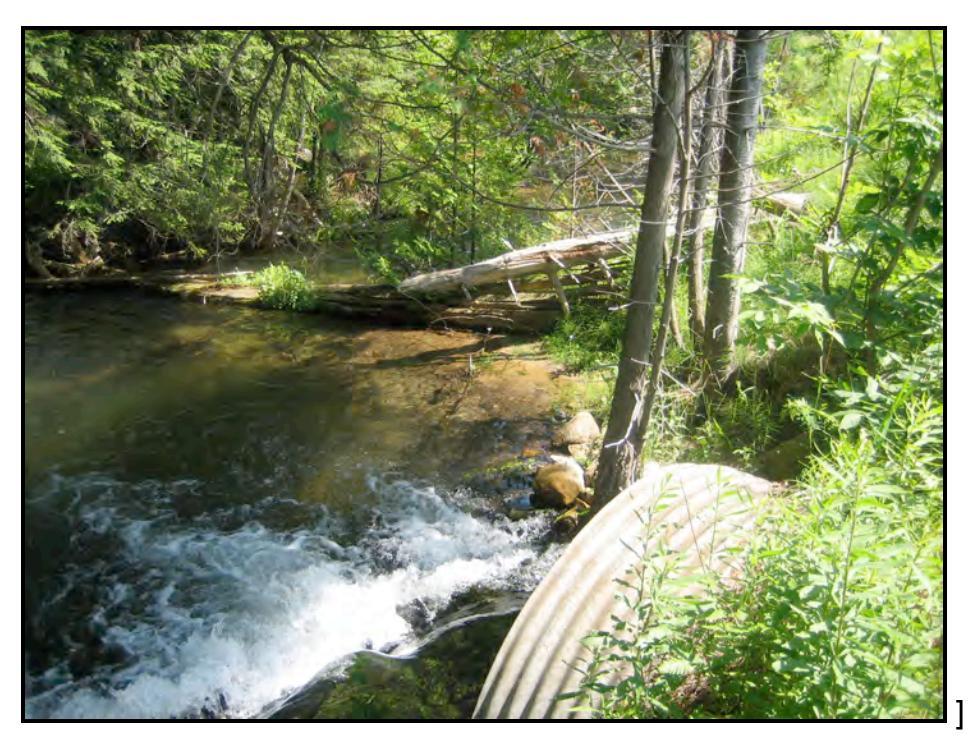
Cold Creek, Comfort Road Crossing

This culvert on Cold Creek had a perched outlet which produces another barrier to fish passage. The culvert appears to be very undersized and the water is rushing out at a great speed. There was a lot of debris up on the bank of the upstream side due to storm water overflowing the banks as well as tree die-off along the banks of the creek all the way upstream to the Tyler Road culvert.

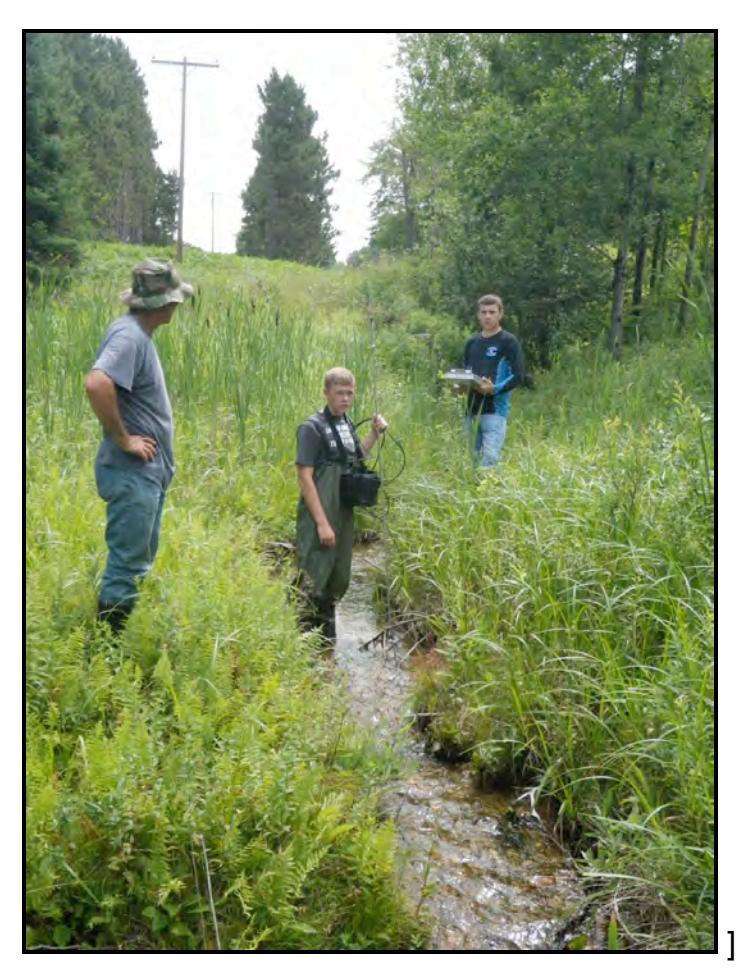
Finch Creek, Way Road Crossing

This culvert is a relatively small culvert as well. Located on Finch Creek, it backed up the water and made a pond. Some of the trees upstream have died because of high water.

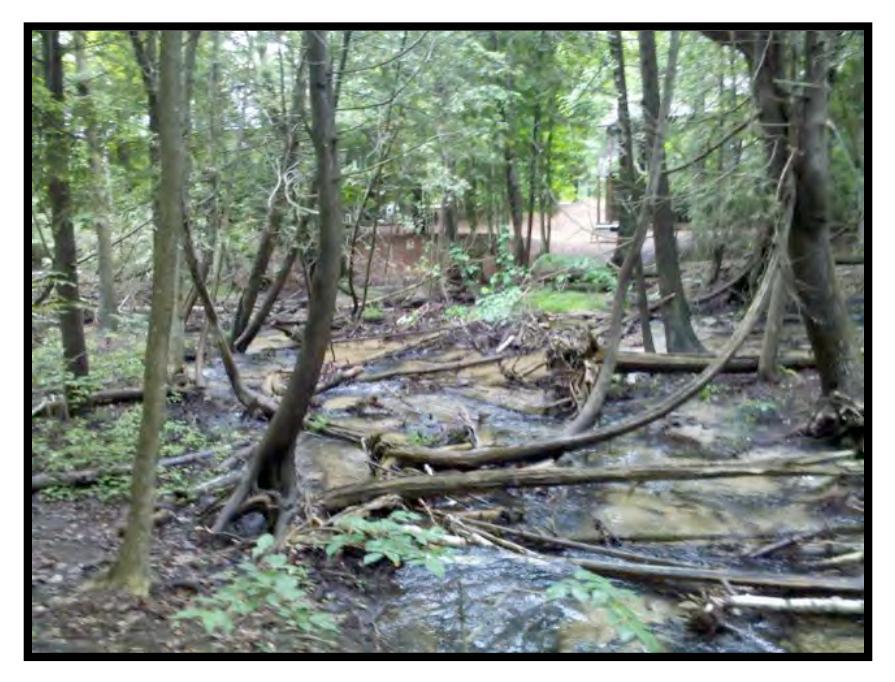
No man-made diversions to accommodate runoff were observed on Shanty Creek and from the evidence above as well as a conversation with the supervisor for Pine Brook, the stream appears burdened with excess runoff carrying sand, silt, and organic matter into Shanty Creek from development at the Shanty Creek resort and golf course. This is reshaping and relocating the stream bed through sediment deposition, widening of the stream bed, and the creation of new dry eroded channels.

An Example of consequences of stormwater erosion, Shanty Creek in the Pine Brook area

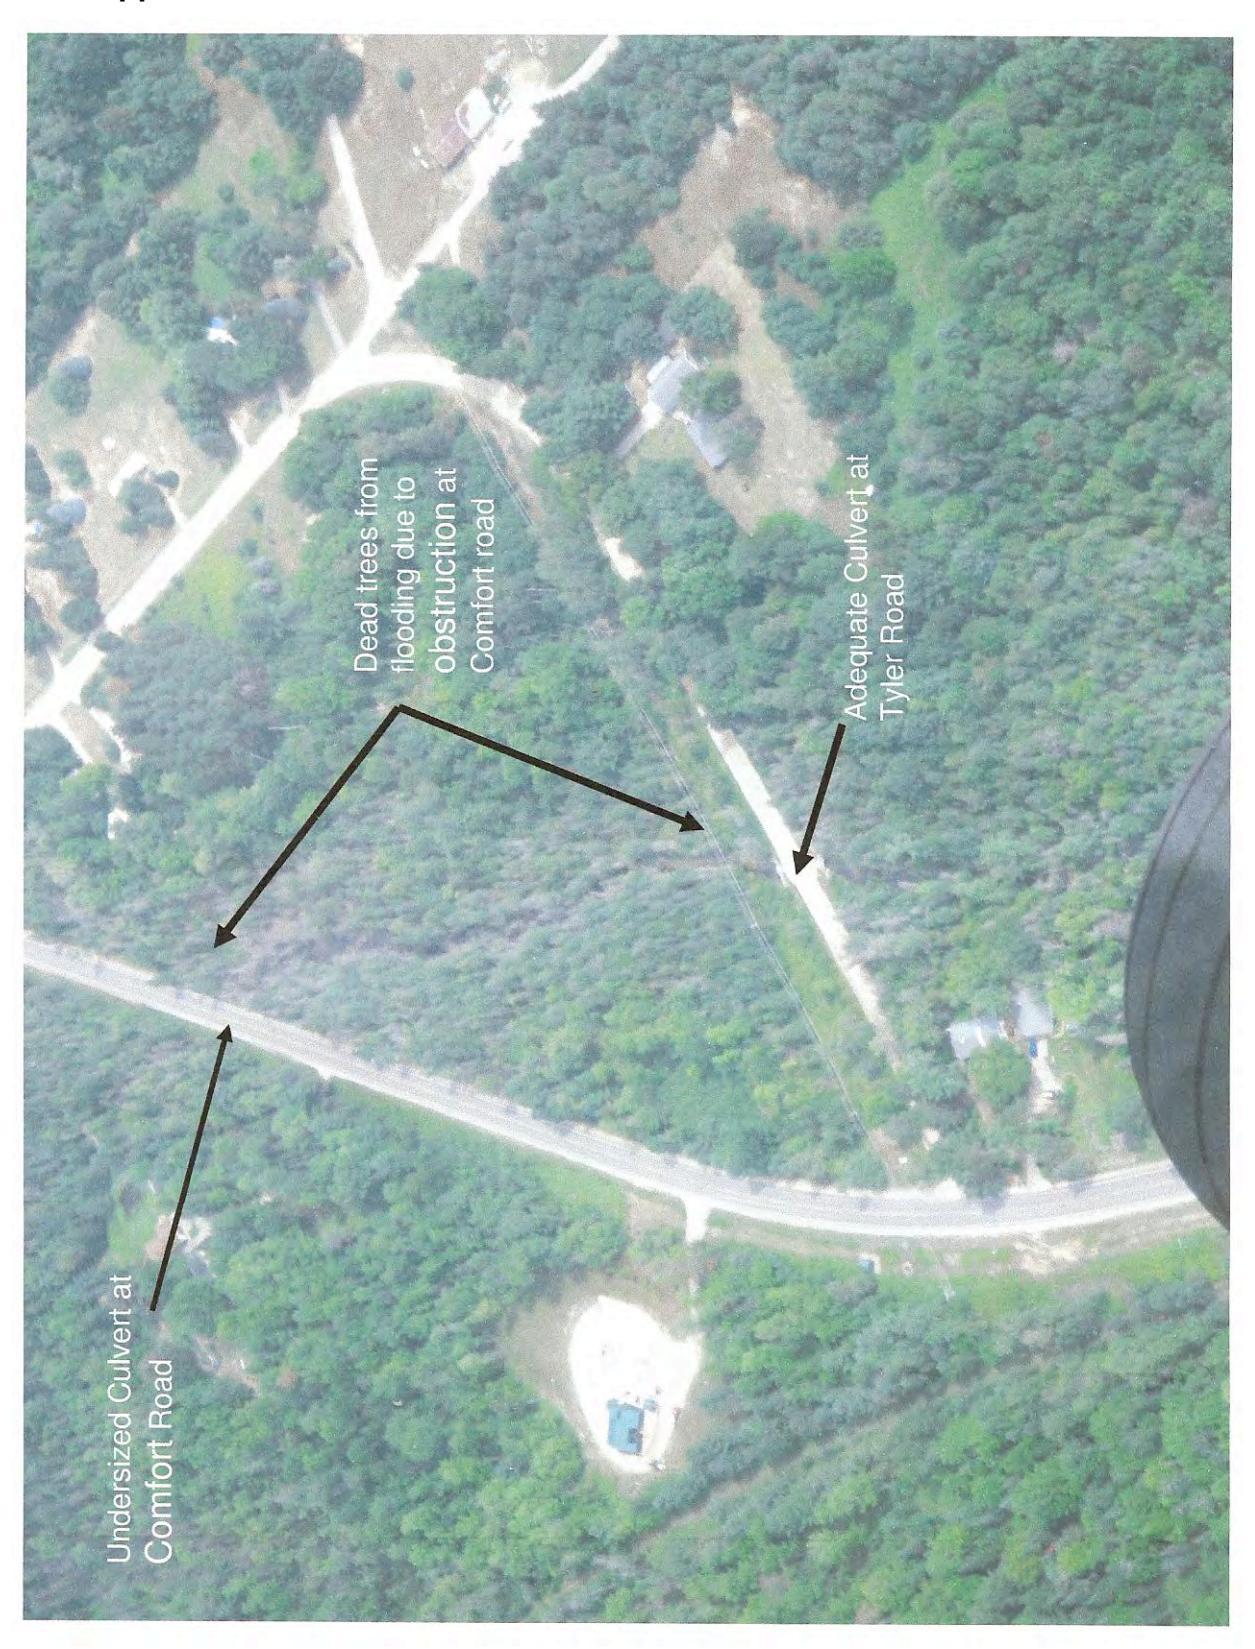
Appendix 4: Tree Die-Off from Undersized Culvert

- Twenty-four road-stream crossings were identified for these three tributaries. Several of the culverts appeared to be undersized based on observations of upstream dead trees: Elder Road on east branch of Finch Creek and Comfort Road on Cold Creek.
