A WATER QUALITY SAMPLER

The Three Lake Association's 2012 Summer Internship Program

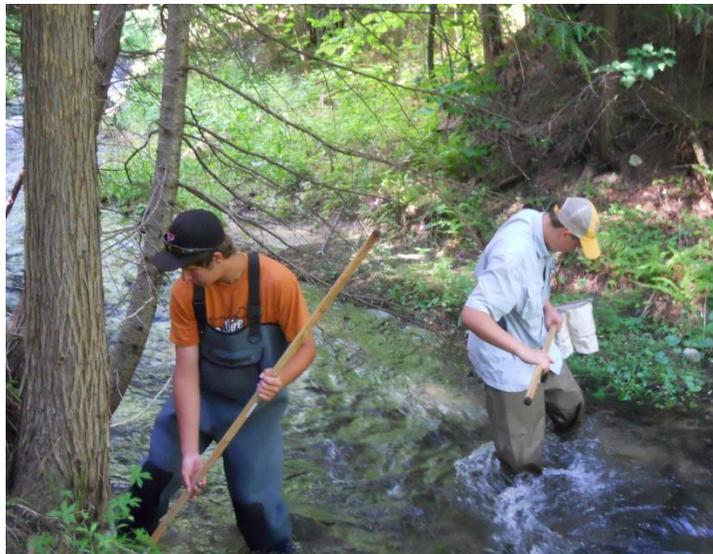
At each sampling station, we picked a location downstream, with 100 ft. of space upstream for sampling. Next, we noted the start time of a 30-minute collection interval. To collect, we stood upstream from a D-net (with a D-shaped metal frame designed for macroinvertebrate sampling) and disturbed the bottom of the stream to get the macroinvertebrates to detach and flow into the net (*figure 1*). Then we worked our way upstream, occasionally rinsing out the net into a bin, as we collected. After 30 minutes, we noted the end time and put the contents into a bin and transported the samples to a location for sorting and identification.

Figure 1. Alec and Zach collecting macroinvertebrates

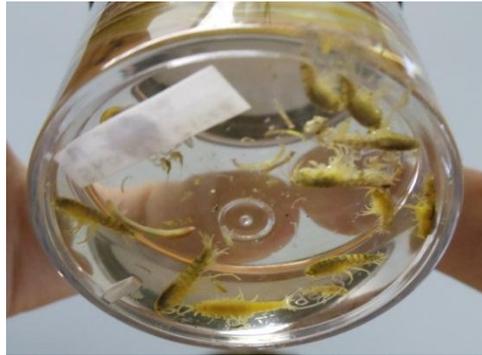
To start the identification process, we used a white tray and a thin mesh to make the dark-colored macroinvertebrates stand out, then we picked them out with tweezers and small pipettes. The organisms were identified using a dichotomous key (which gives two choices of various characteristics) to narrow down the possibilities. We recorded the macroinvertebrates onto a MiCorps datasheet (See appendix) and preserved them in a “kill” jar of ethyl alcohol (figure 2). Typically, no more than 15 specimens of each species should be collected.

Figure 2. The “kill” jar from the Shanty Creek sample

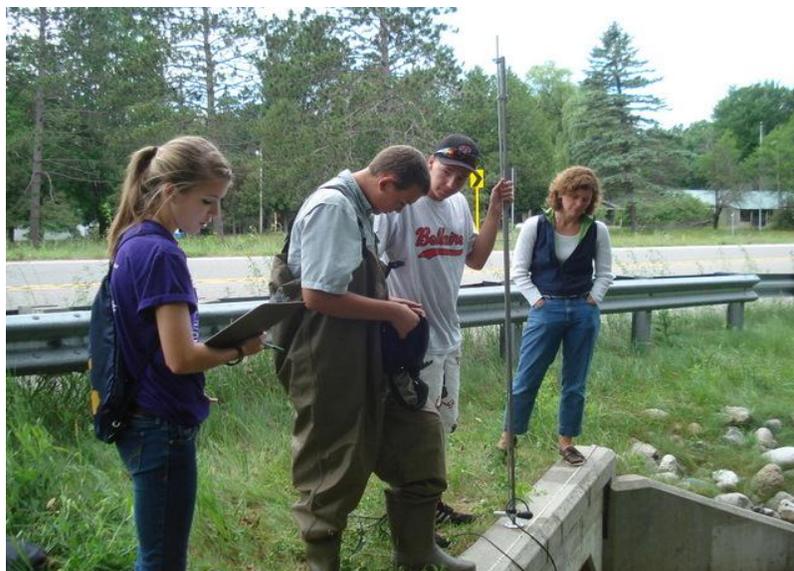
Figure 1. Determining the cross-sectional area of Shanty Creek

Stream flow rates were determined from a combination of water level and velocity measurements through a known cross-sectional area. A Global Water WL16 Data Logger was installed in Shanty Creek for long-term monitoring of the water level at the M-88 road crossing. Water velocities were measured when water levels were distinctly different using a Marsh-Birney meter. From the collected data, a relationship between water level and flow was established to a correlation coefficient of 0.94. The cross-sectional area of Shanty Creek was determined from physical measurements made of the cement rectangle culvert where the data logger was located (Figure 1). Flow rates were then determined from the long-term monitoring data and the stream channel cross-sectional area. These results were compared to historical flow data from nearby Cold Creek which, in contrast, flows through an almost all natural environment.

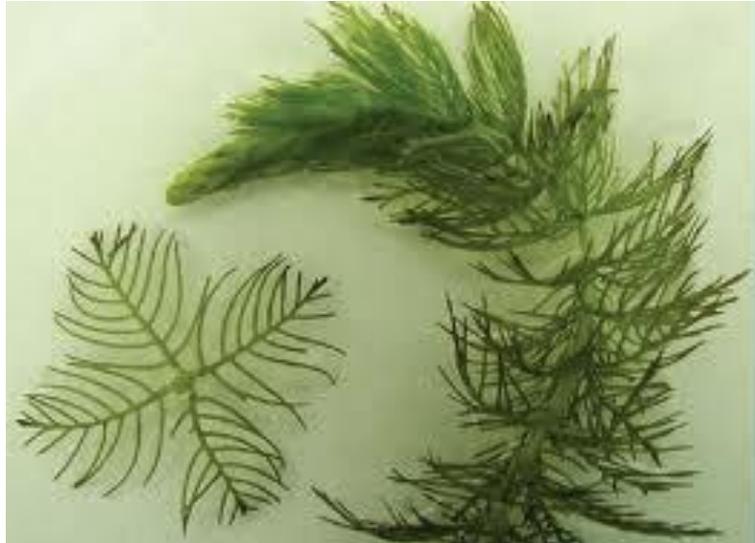
Figure 2. Native Northern milfoil

The survey provided a good opportunity to learn aquatic plant identification. Some plants are easy to identify while others require looking more carefully. Figures 2 and 3 show the similarity between the native milfoil and nonnative Eurasian milfoil. In general, the number of tiny leaflets is higher in the nonnative species, but identification can be complicated if two species hybridize.

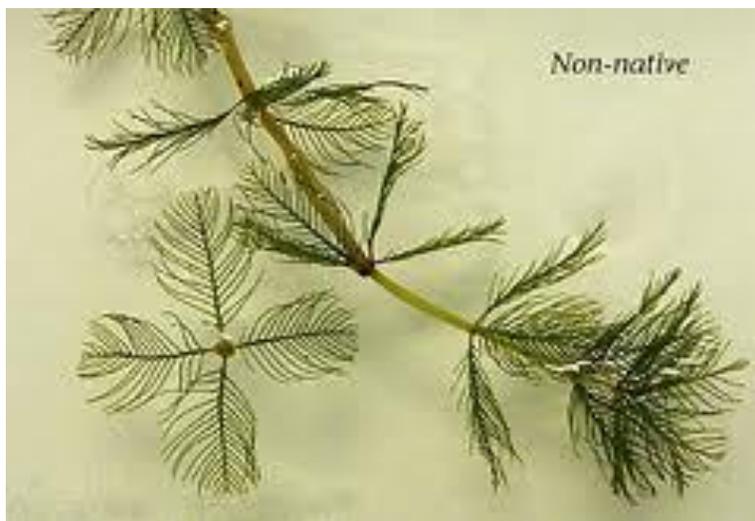
Figure 3. Nonnative Eurasian milfoil

Eurasian milfoil has been of special concern in the lakes we studied. During our survey, we found this invasive species in Clam River near Butch's Marina as it flows into Torch Lake and in Torch Lake at the Alden Marina and between Stony Point and Lone Tree Point. These are sites where remediation efforts have occurred in the past.

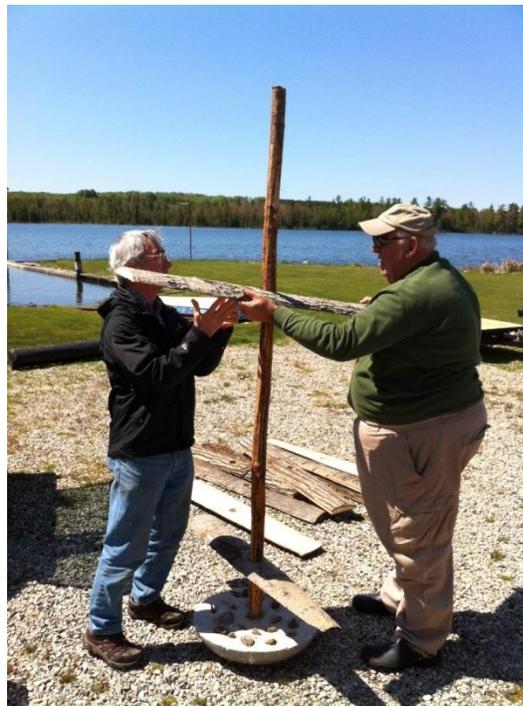
Crate shelters consist of cubical frames with wood slats and are filled with sticks to simulate natural habitat. The split log shelters are made of half-logs attached to a central rod in a helical pattern on a wooden base, similar to a small tree. The relatively large stumps used to improve fish habitat are retrieved from local forests.

Figure 1. Construction of split log shelter

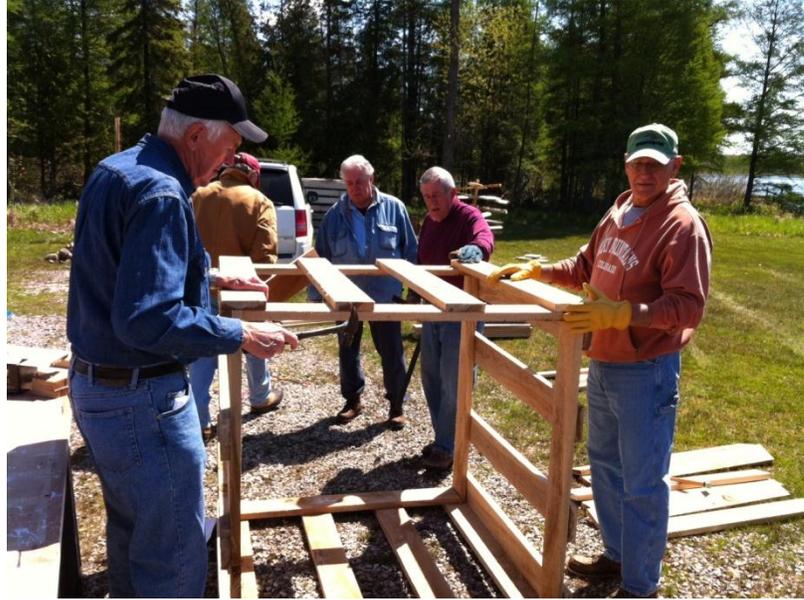
Figure 2. Construction of crate shelter

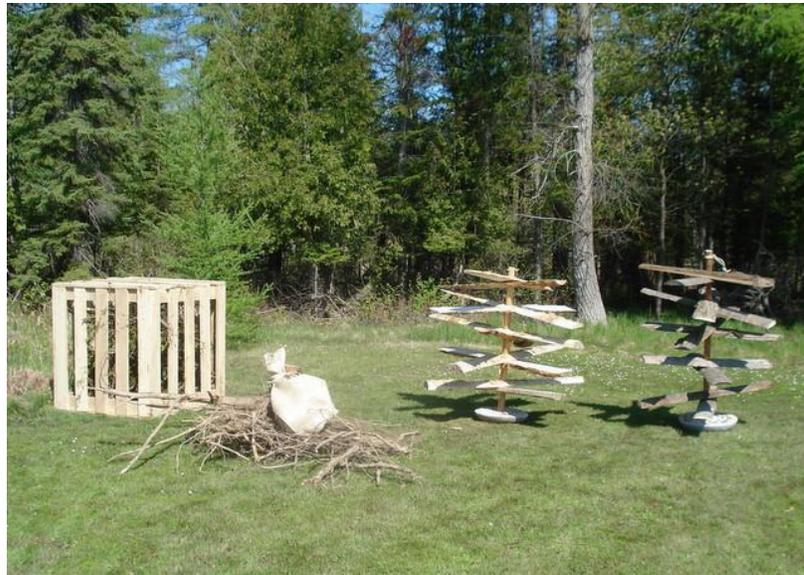
Figure 3. Finished shelters ready for deployment

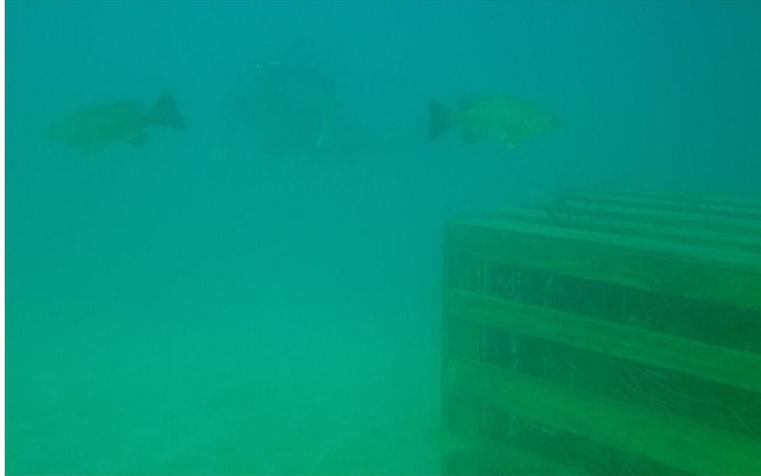
The three types of shelters have been deployed in eight locations in four lakes as the date of this writing. The five-year plan is to deploy fish shelters in up to 80 locations. Observations made by divers at the deployment locations are promising. The fish have colonized shelters in less than a week, as seen in Figure 4 on the following page.

Figure 4. Early colonization of fish shelters deployed in 2012

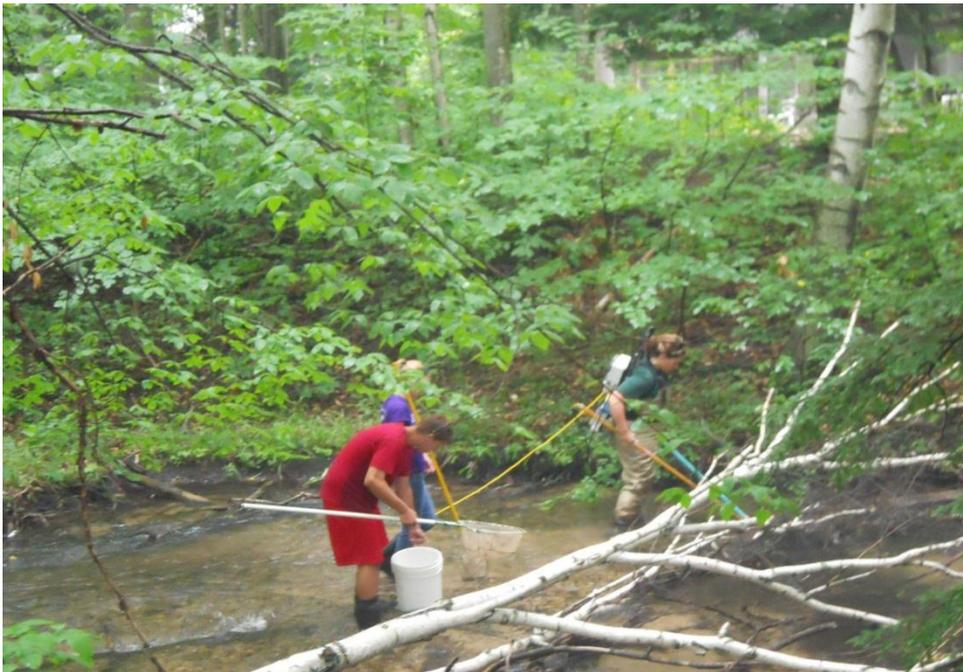
Figure 1. Electrofishing in Shanty Creek.

On July 26, 2012 Shanty Creek was shocked with a backpack electrofishing unit. The goal of this study was to collect fisheries information around the site of a small dam that could potentially be removed in the near future and to collect data from a site downstream for comparison. Three locations along Shanty Creek were shocked: 1) upstream of highway M-88 in the Pinebrook development above a small dam, 2) in the Pinebrook development below the small dam and 3) downstream of highway M-88 at an old railroad grade crossing bridge.

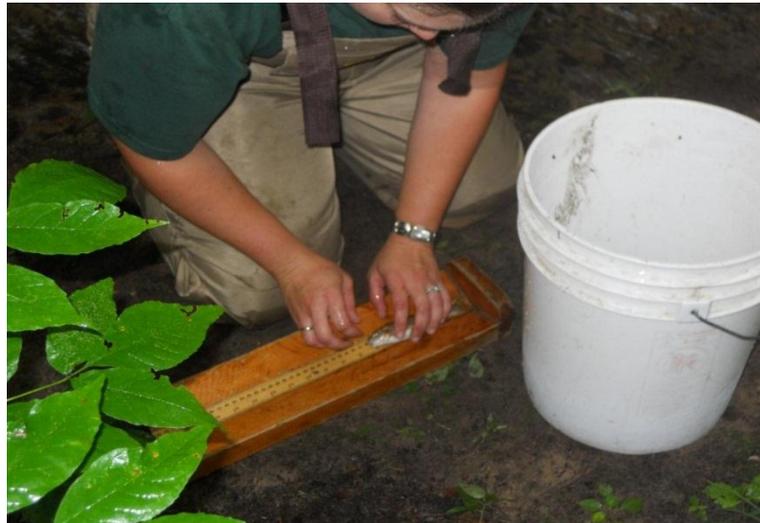
Figure 2. Measuring fish captured in Shanty Creek.

Alec Stilwell and I met Heather at the Conservation District Office in Bellaire, MI. She introduced herself, and explained the backpack electrofishing unit. Heather would be carrying a large sack on her back with a shocker connected to it; a button on the pole would cause an electric field in the water, which would stun the fish once they swam into it. The fish were caught with the assistance of Alec and me and then were later measured and identified, as shown below.

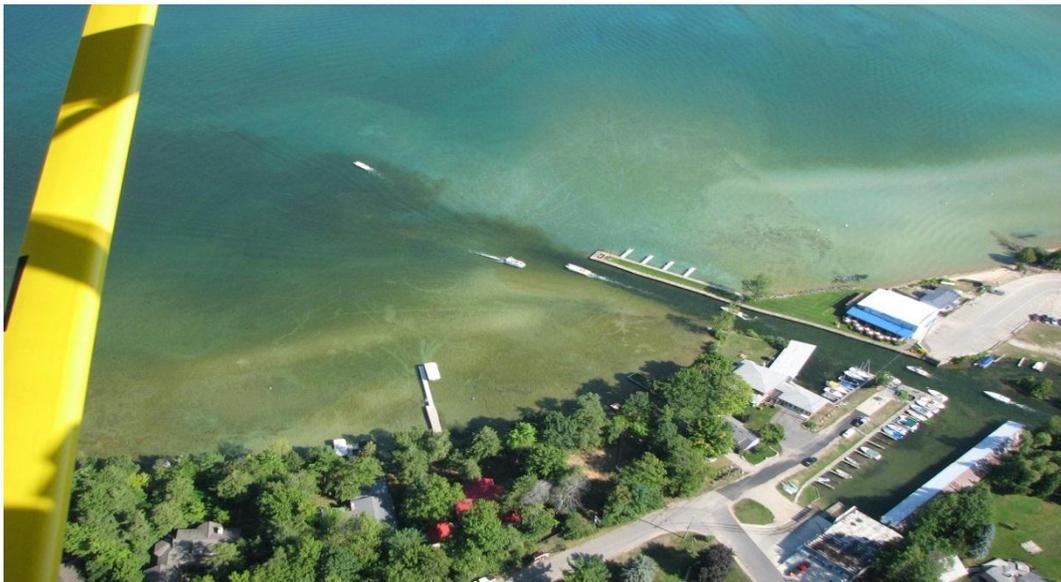
Many people have wondered why the water flowing out of Clam River into Torch Lake is a greenish-brown color. As can be seen in Figure 1, there is a distinct difference in the color of water flowing from Clam River into Torch Lake. Concerns about the Clam Lake plume arose during the fall of 2011 when Three Lakes Association (TLA) was reviewing a permit application submitted by Dewitt Marine to fill a small portion of wetland on the shoreline of Clam Lake.

Figure 1. Aerial view of Clam River as it discharges into Torch Lake on August 13, 2012.

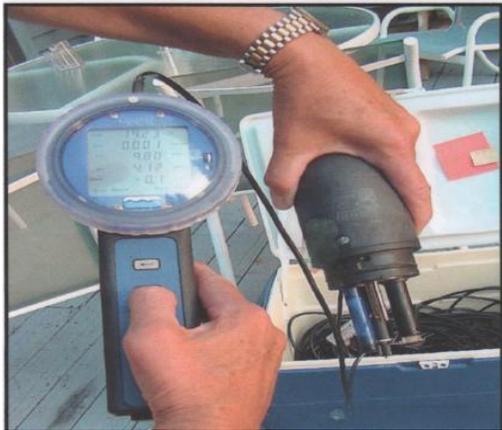
We also used a Hydro-Lab that measured conductivity, pH, dissolved oxygen and temperature. The Hydro-Lab has underwater sensors that can send data back to a small screen (Figure 2).

Figure 2. Hydro-Lab with receiving apparatus

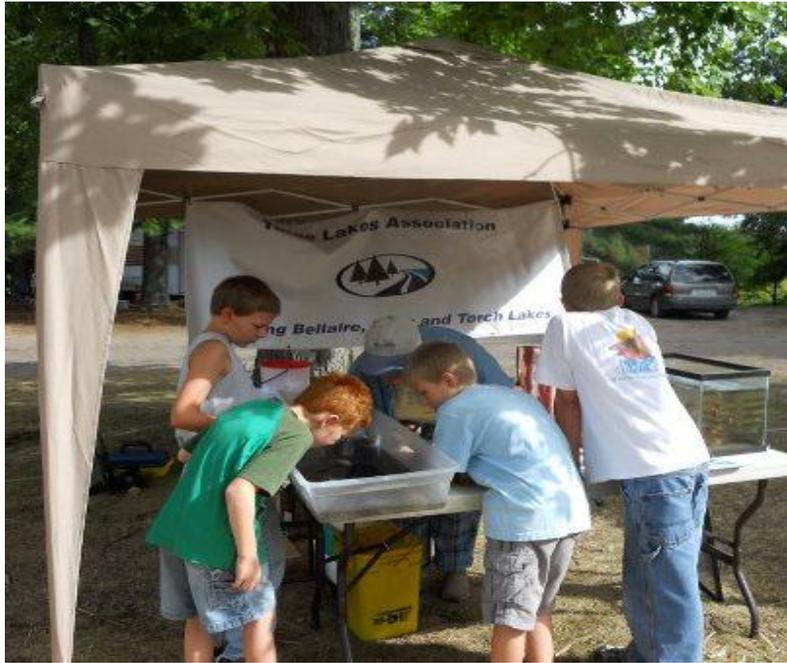
Figure 1. Kids learn about macroinvertebrates in our simulated “stream” at the county fair.
