**Understanding the Hydrologic Landscape to Assess
Trajectories of Sediment Sources and Stream Condition in
the Grass and Rapid River Watersheds**

Final Report

5/13/2014

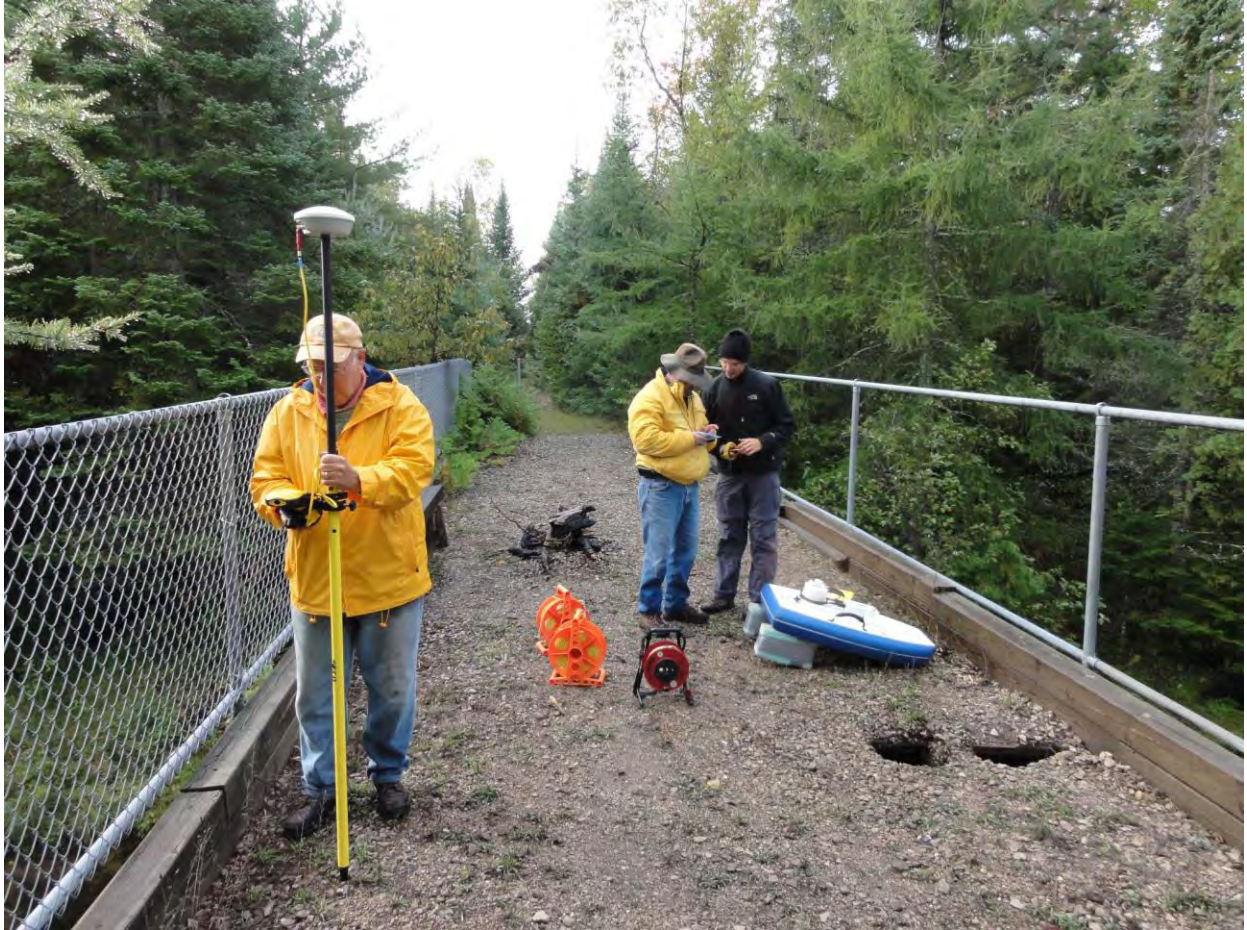
Figure 1. Bob Kingon of the Elk-Skegemog Lake Association collecting a GPS measurement on the Cut River. In the background, Lon Cooper (in yellow) and Anthony Kendall (in black) prepare for a stream discharge measurement using the ADCP (white and blue boat).

The first team, consisting of Bob Kingon and Dean Branson, used a Trimble GeoXH mapping GPS instrument (see Figure 1). The Trimble GeoXH has an accuracy of around 60 cm, thus the lat/lon/elevation of a point can be determined to somewhere around 2 feet. The instrument was placed at the water line of each road crossing, if accessible. Otherwise, a fixed point on a bridge or culvert was used for measurement, and the distance to the water surface was measured and input as an elevation offset in the instrument.

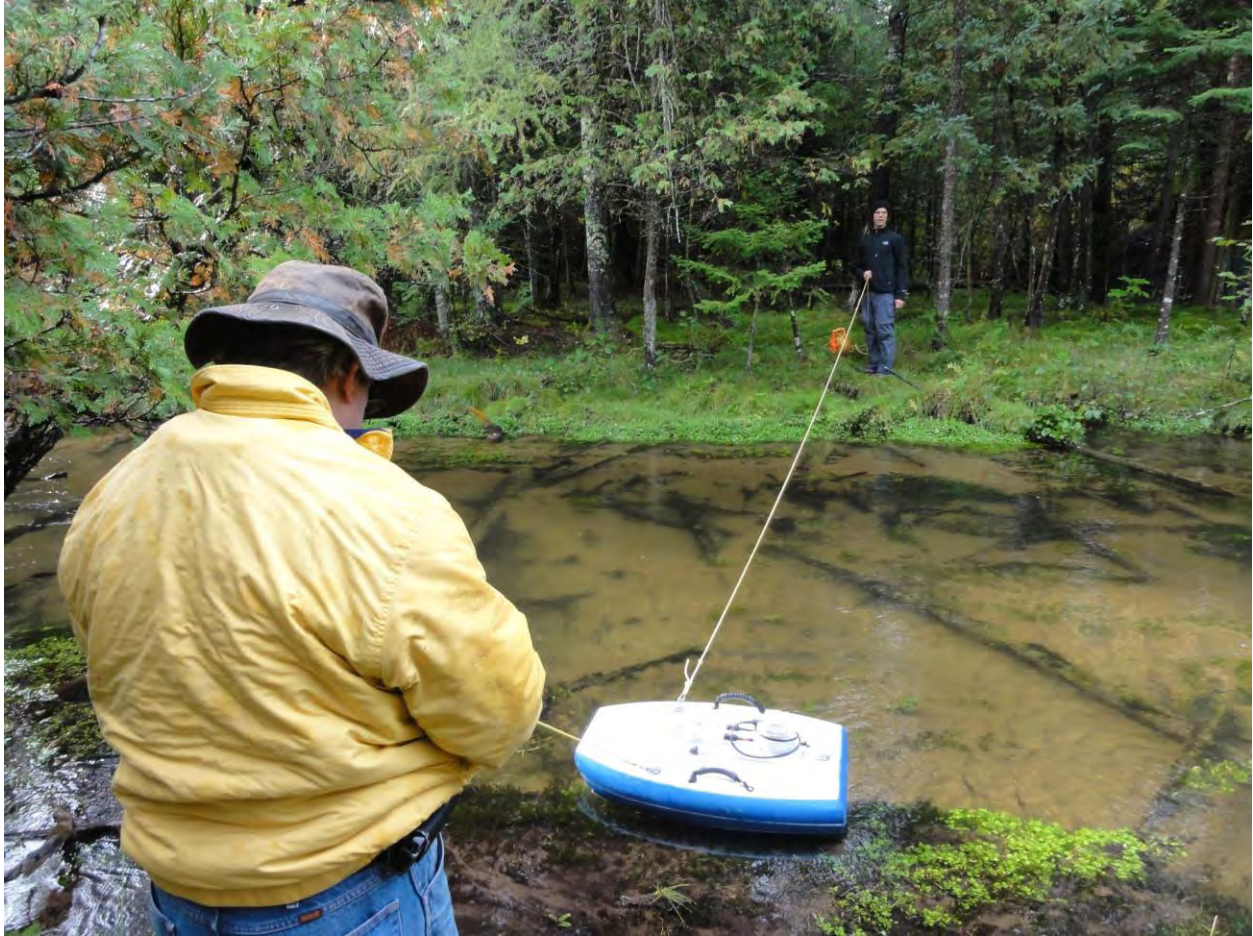
Figure 2. Lon Cooper and Anthony Kendall pulling the ADCP across Shanty Creek, a tributary of the Grass River, the measure stream discharge and channel geometry.

The second team, Anthony Kendall and Lon Cooper, measured stream discharge using a Sontek RiverSurveyor S5 Acoustic Current Doppler Profiler (ADCP) (see Figure 2). The Sontek S5 is a state-of-the-art instrument that measures the depth of the water column beneath it along

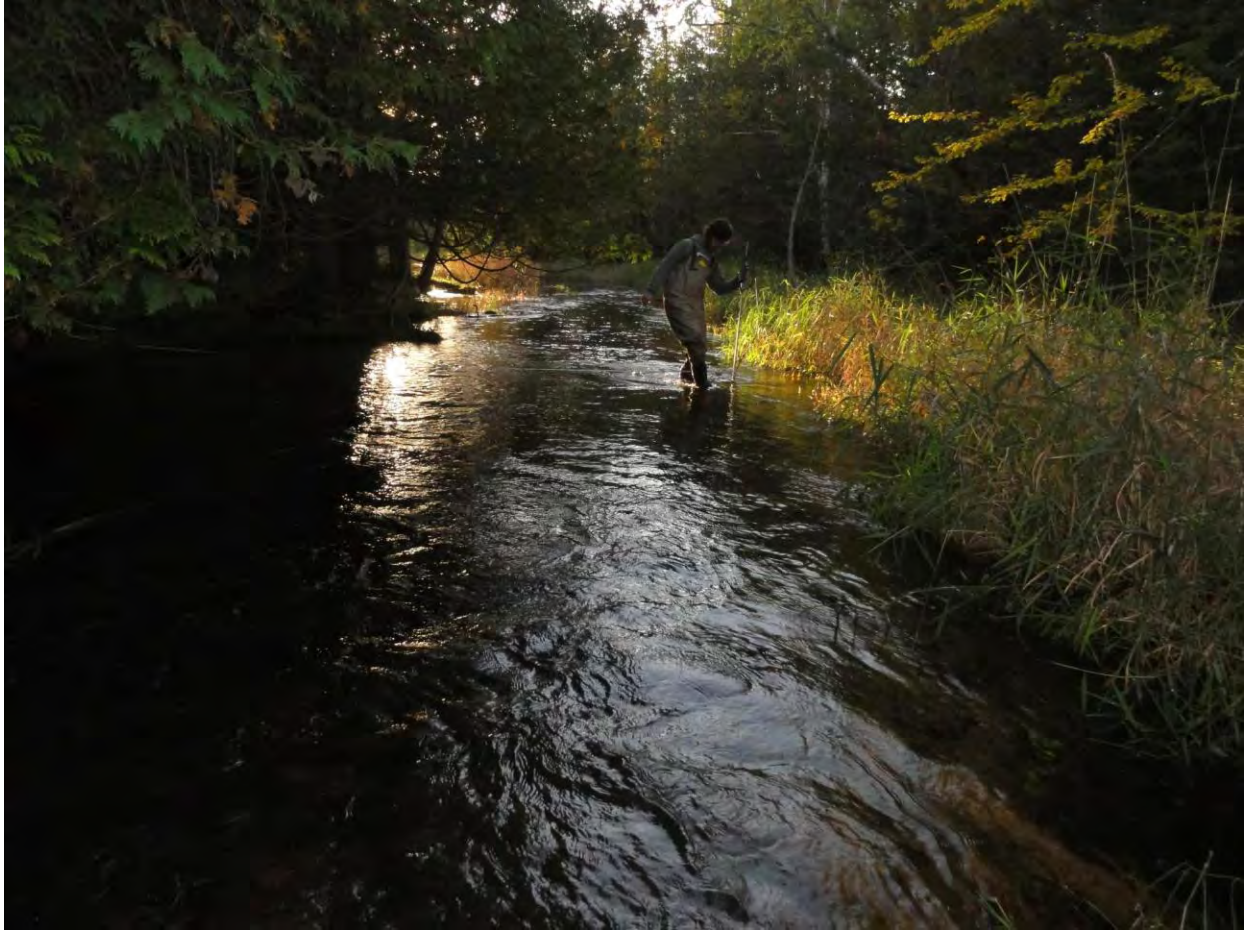
Figure 4. Blaze Budd measuring discharge using the wading method (with the OTT ADCM) along the upper Rapid River near sunset.

Team three consisted of Blaze Budd and Kevin Cronk using two different instruments to measure stream discharge: a Marsh McBirnie FlowMate2000 and an OTT Acoustic Doppler Current Meter (ADCM). These two instruments function differently, but essentially are both used to measure stream velocity at a discrete number of points (15-20) across a channel while being held by a wading operator. The “wading method” is traditionally the most common means of measuring stream discharge, and can be used in streams shallower than the ADCP can float.

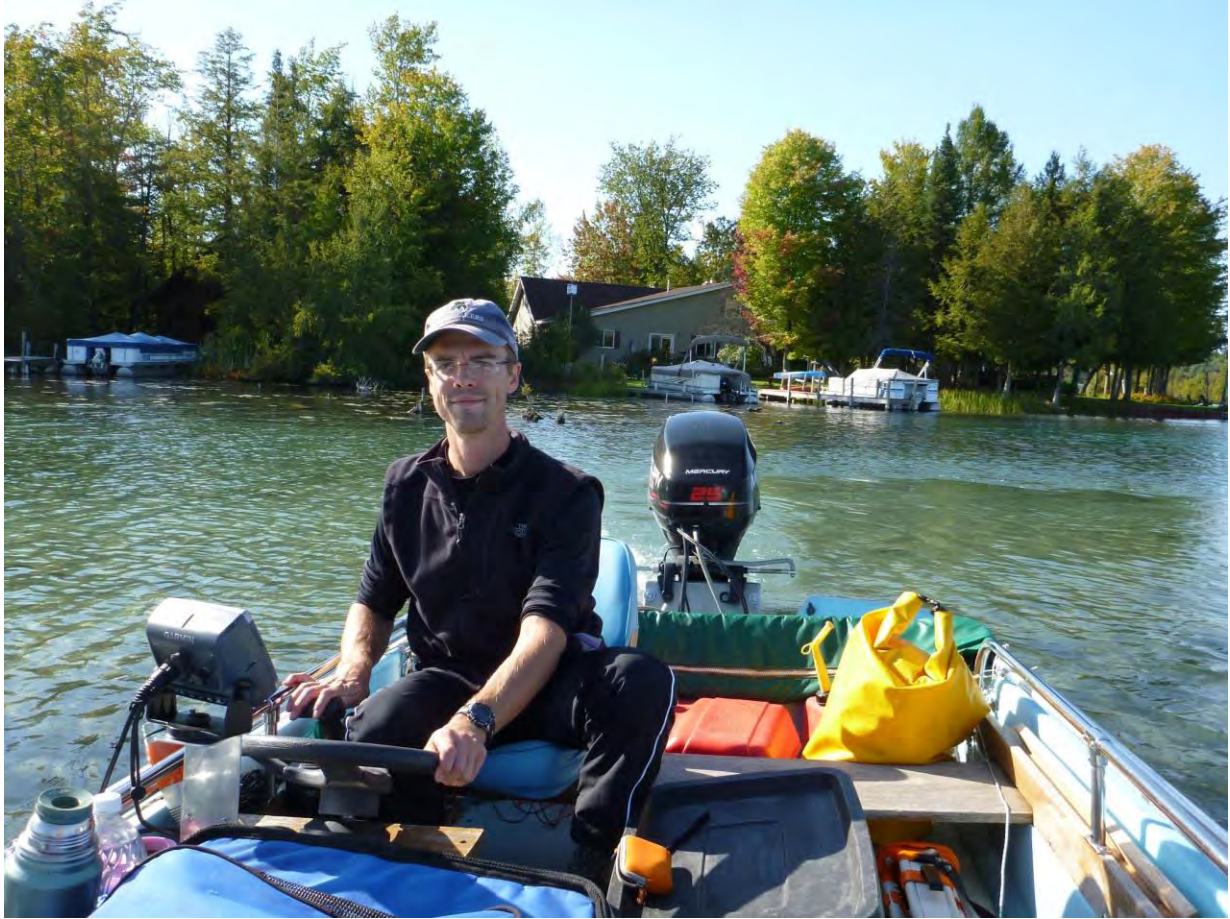
Figure 6. Anthony Kendall driving MSU's boat on the Torch River. The zig-zag pattern of navigation along the channel is visible in the wake trail behind the boat.

The boat was then driven in three separate survey patterns: 1) a zig-zag longitudinal (down-channel) transect, interrupted every so often by a 2) perpendicular cross-section, and followed ultimately by 3) a detailed weave pattern survey of key targeted areas. The first set of surveys was conducted along the Torch River and the lower Rapid River (Figure 6). We conducted a weave survey at the mouth of the Torch River where it empties into Skegemog Lake. The following day, we conducted the same set of surveys along the Grass River, culminating with a weave survey of the outlet into Clam Lake at the Grass River Natural Area dock. This set of surveys was timed to coincide with survey-grade GPS surveys conducted by Brett Fessel and Frank Dituri (see the section below).

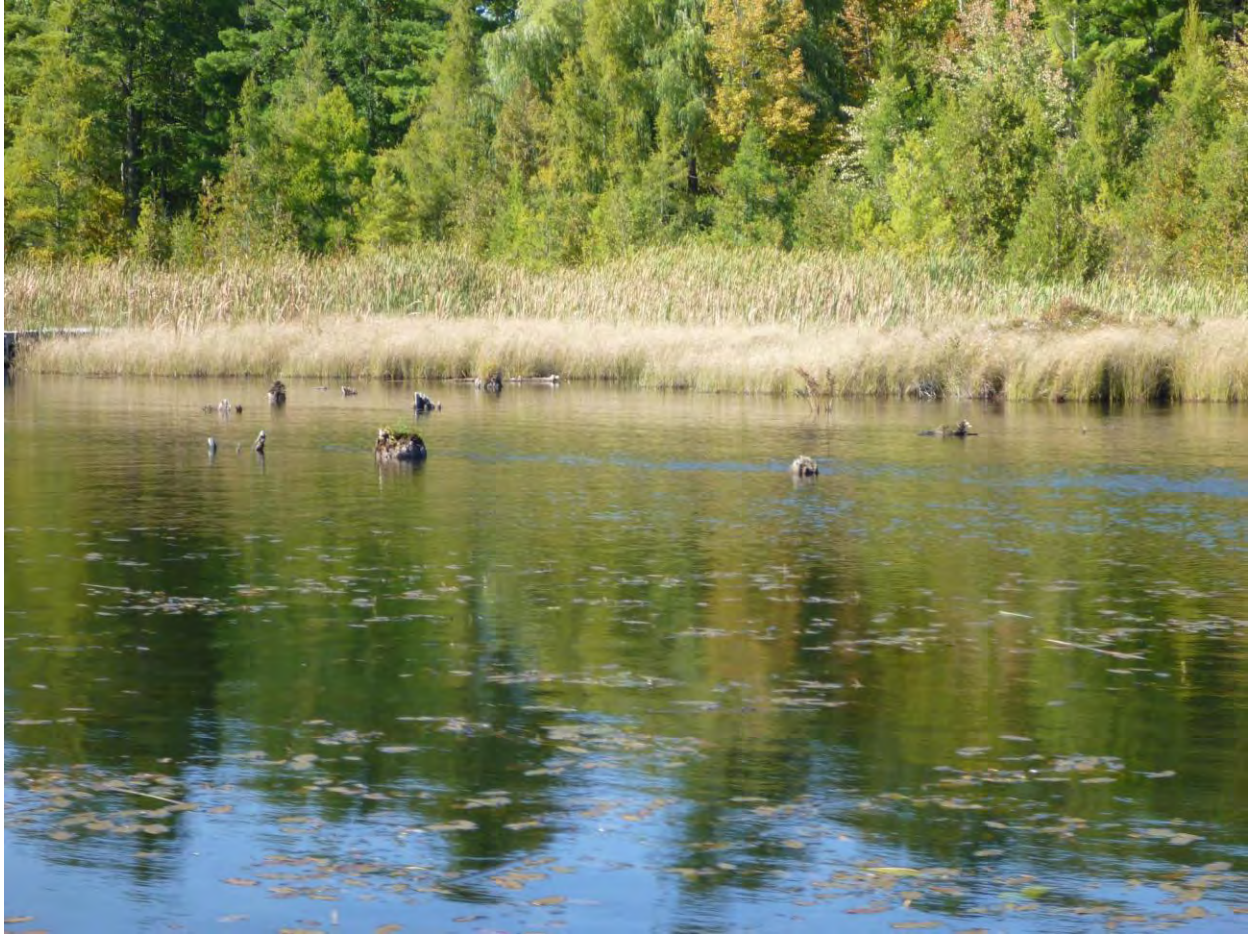
Figure 8. Image of severe bank erosion along the lower Rapid River. The stumps in the foreground were once on shore.

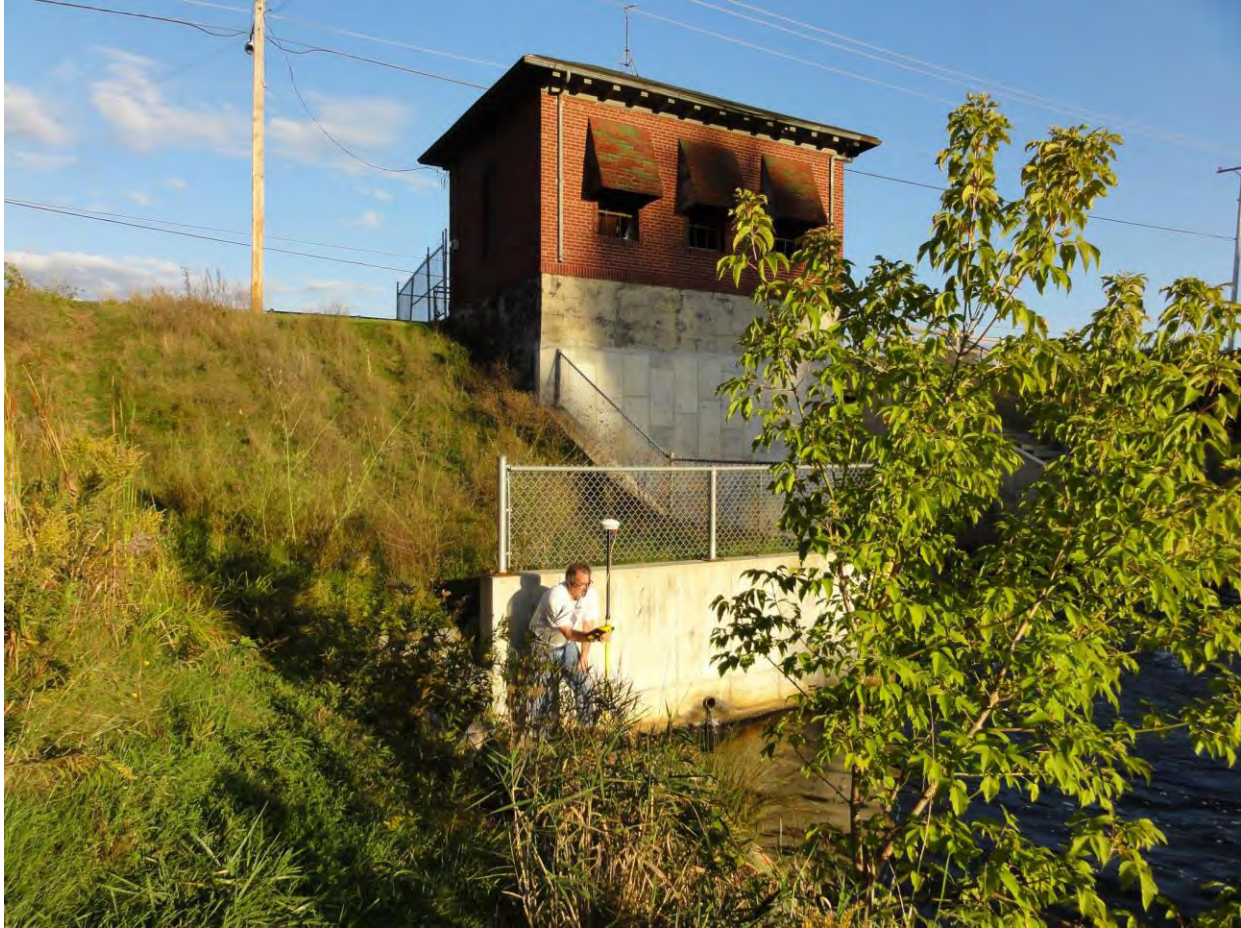
Figure 9. Lon Cooper surveying the water line at the outlet of Craven Pond (Blair Lake).

Additionally, the MSU completed an elevation survey of Elk, Skegemog, Torch, Clam, Bellaire, and Intermediate Lakes, as well as Blair Pond (Figure 9). However, the expected accuracy of this instrument was insufficient to accurately determine the gradient from Bellaire to Elk Lake.

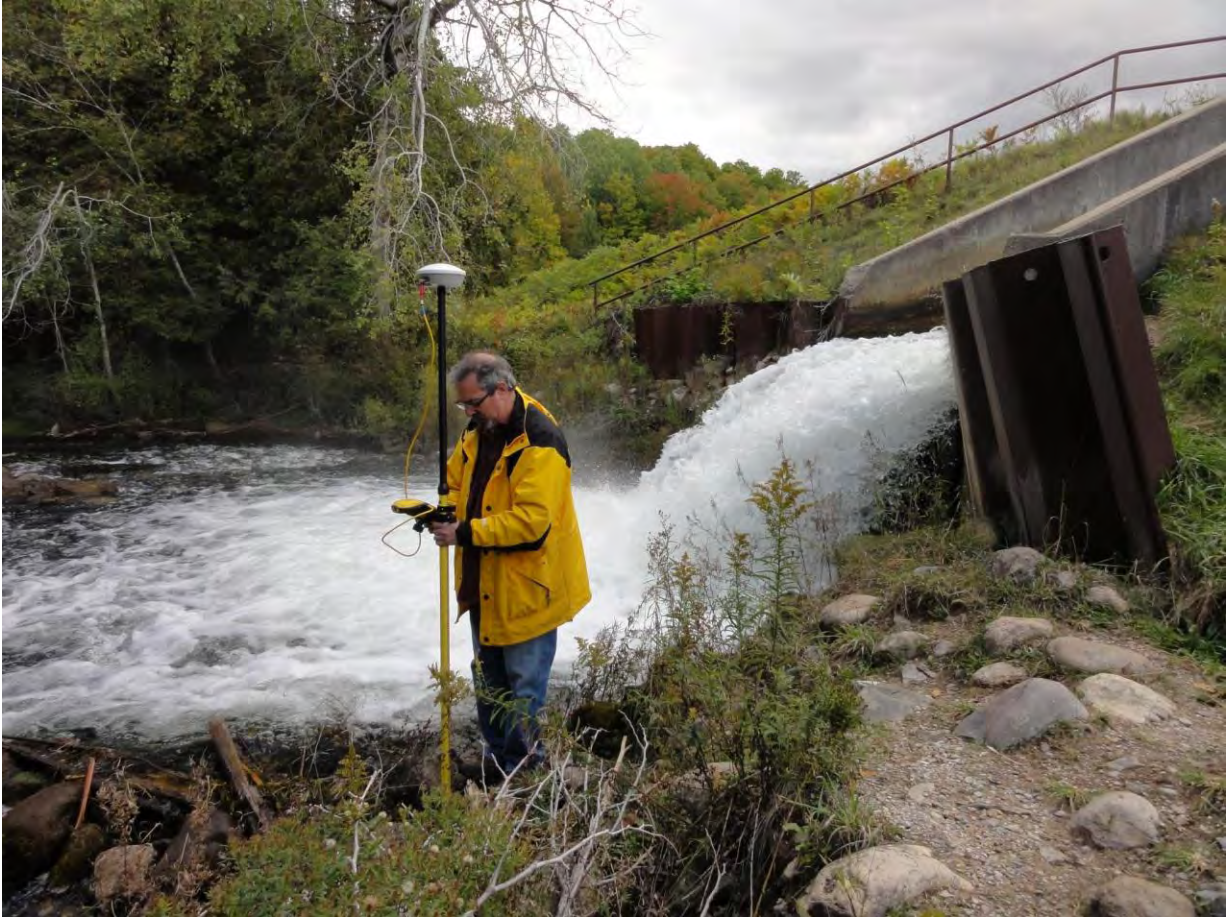
Figure 10. Lon Cooper collecting a GPS elevation measurement below the secondary spillway of Rugg Dam.

The MSU team collected detailed measurements of the Rugg Pond Dam, including GPS elevations of the dam’s hydraulic features (Figure 10) and a bathymetric survey of the pond itself (Figure 42).

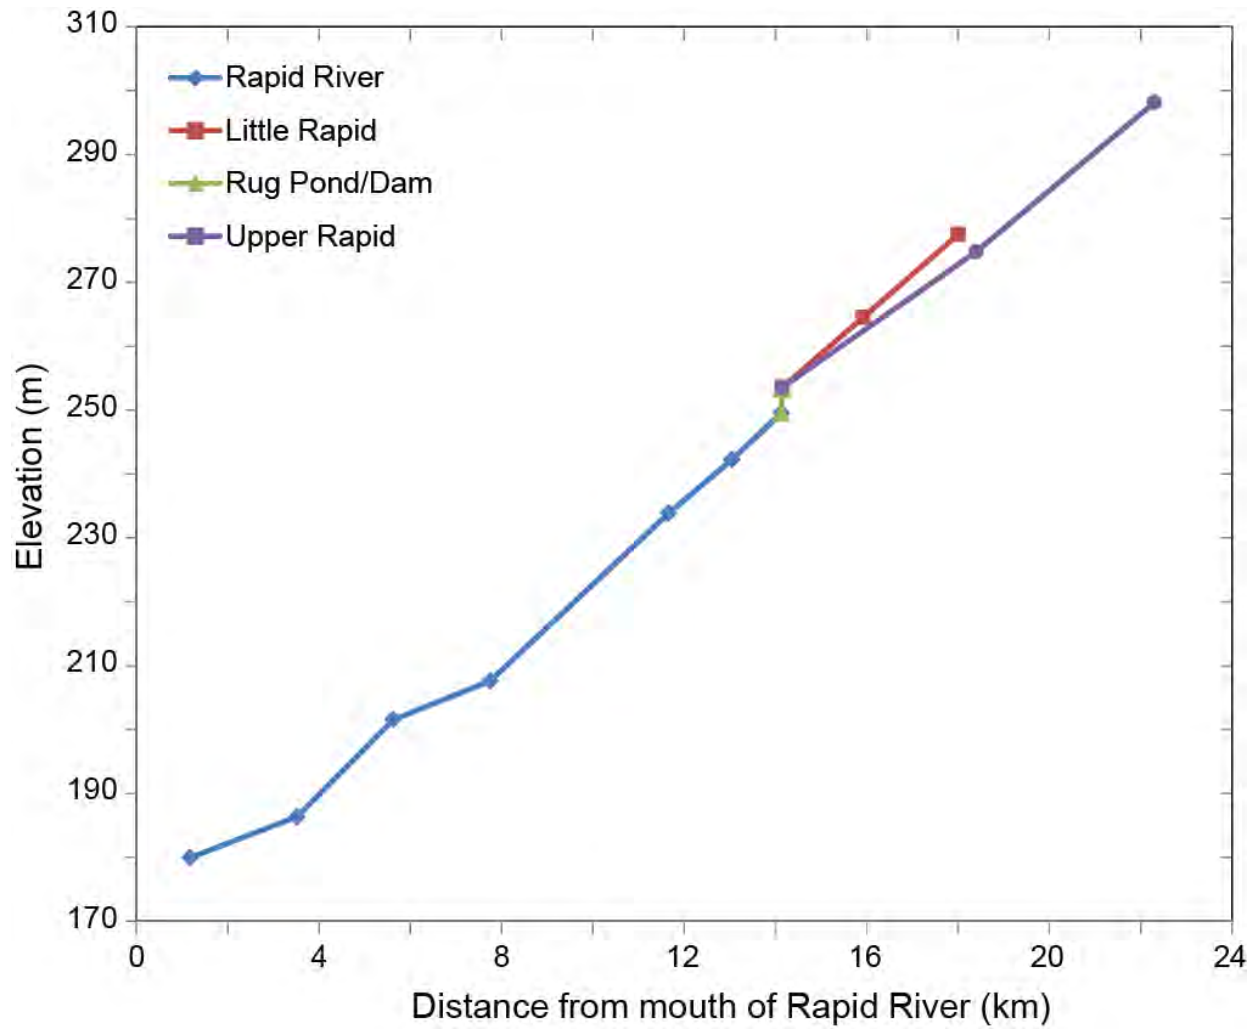
Figure 13. Plot of GPS-surveyed elevations at road crossings along Rapid River, including Rugg Pond Dam.

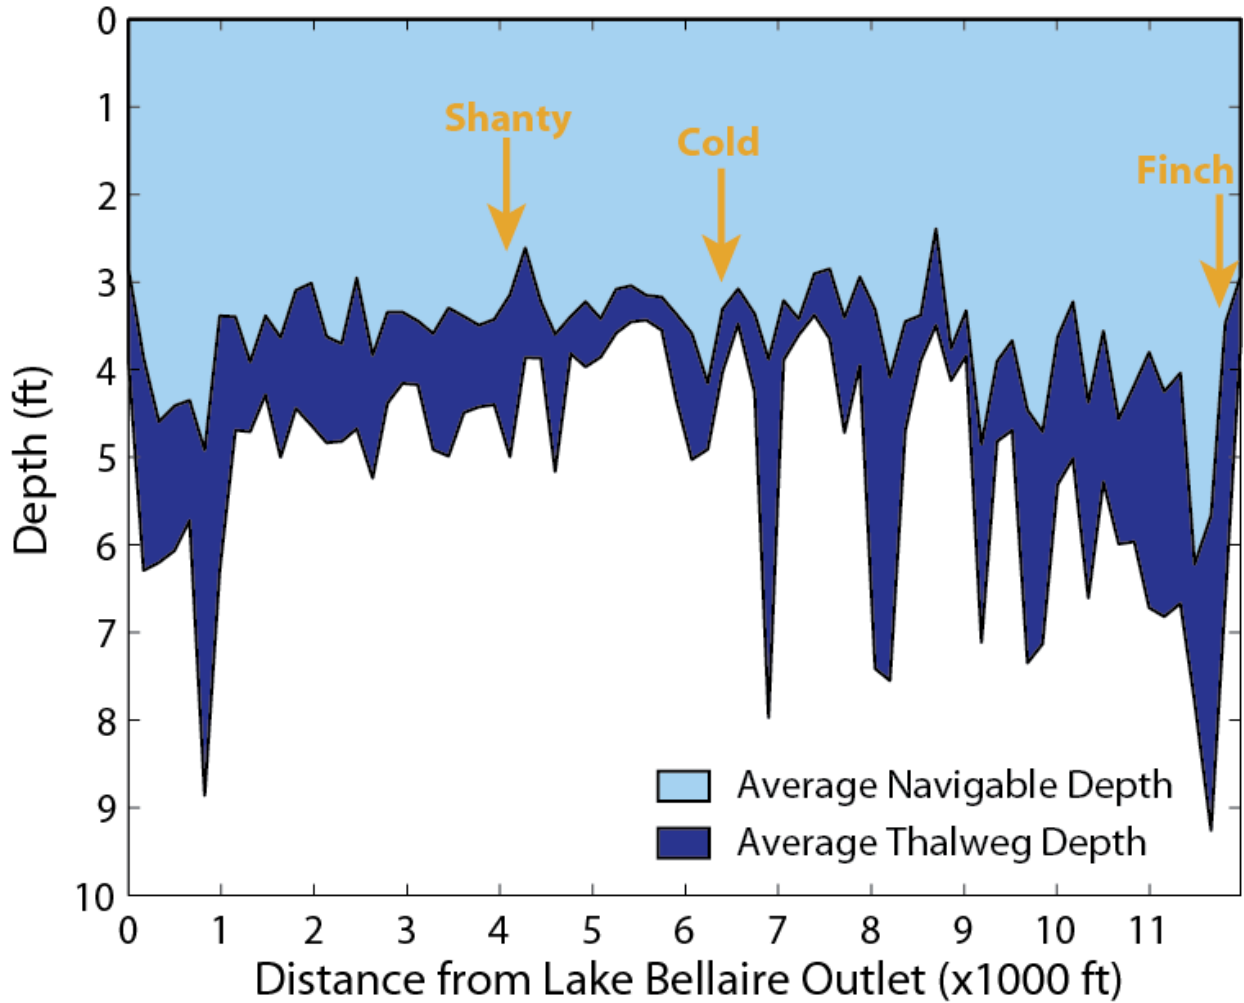
Figure 16. Plot of 50-meter average navigable channel depth along the Grass River, and average thalweg depth. The thalweg depth was calculated as the deepest point along each 50 meters of distance along the channel median.

To compare bulk trends in the overall channel depth, the average navigable depth and thalweg (maximum) depth was calculated for each 50 meter channel segment (Figures 16 and 19). Plotted in Figure 16 are the average navigable depth and thalweg depth (diagrammed in

Figure 7) along the ~12,000 channel feet between lakes Bellaire and Clam. Highlighted on the plot are the confluence locations with Shanty, Cold, and Finch Creeks. Clearly visible at each confluence is a decrease in both average navigable and thalweg depths. These are not, however, remarkable decreases relative to others in the channel. Nevertheless, each confluence was accompanied by a distinct plume of sediment, visible on the water (Figure 17) and in the raw satellite imagery (Figure 18). The river responds to these sediment plumes by shifting the thalweg and widening the channel, and also by pushing that sediment downstream. The smoothed data do not show this effect as clearly as the raw data.

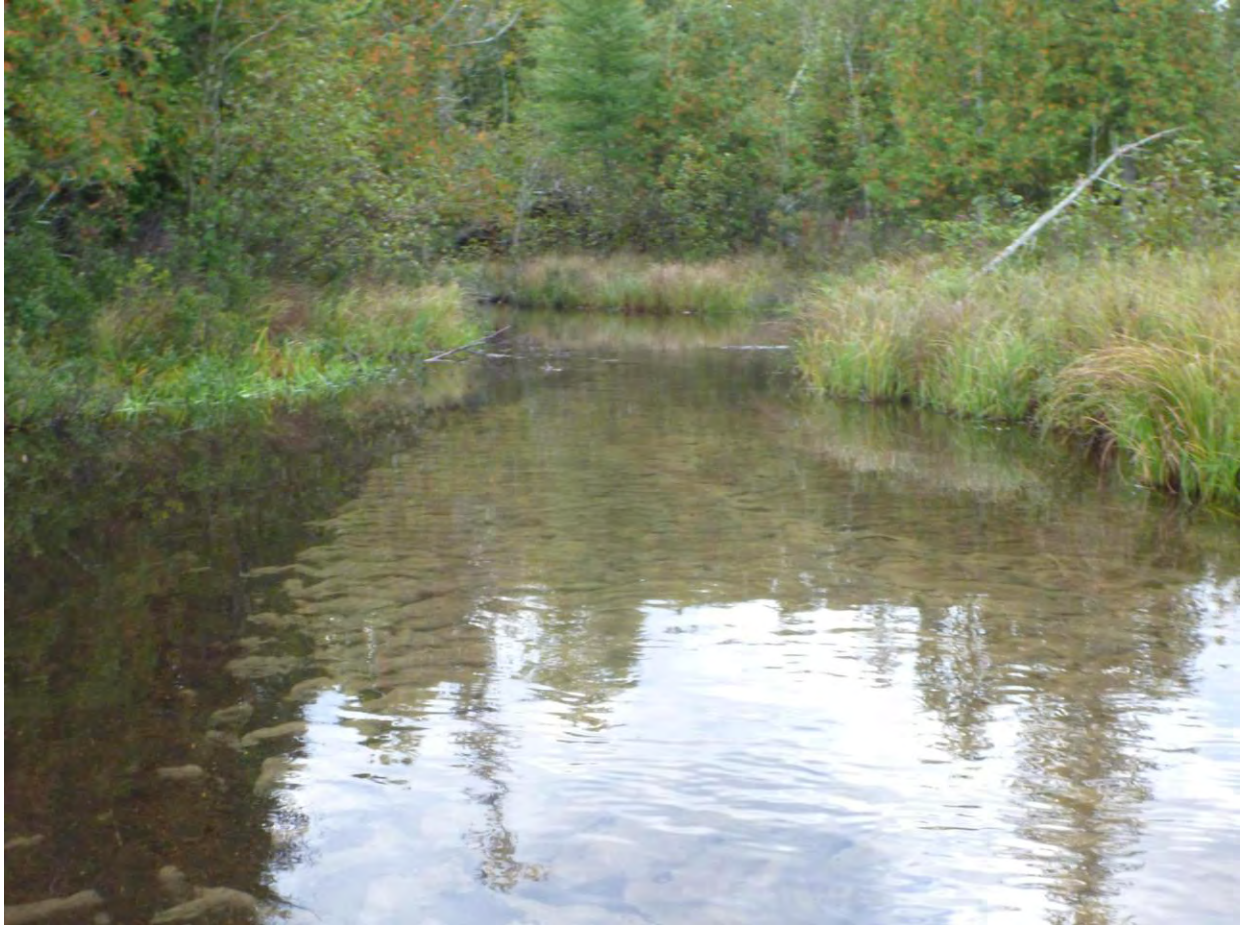
Figure 17. Image of the confluence of Shanty Creek and Grass River. The perspective looks upstream at Shanty Creek. Note the active sand sediment plume from Shanty Creek on the right of the image. Note that this location differs from the Shanty Creek confluence on most maps, as shown in Figure 18 below.

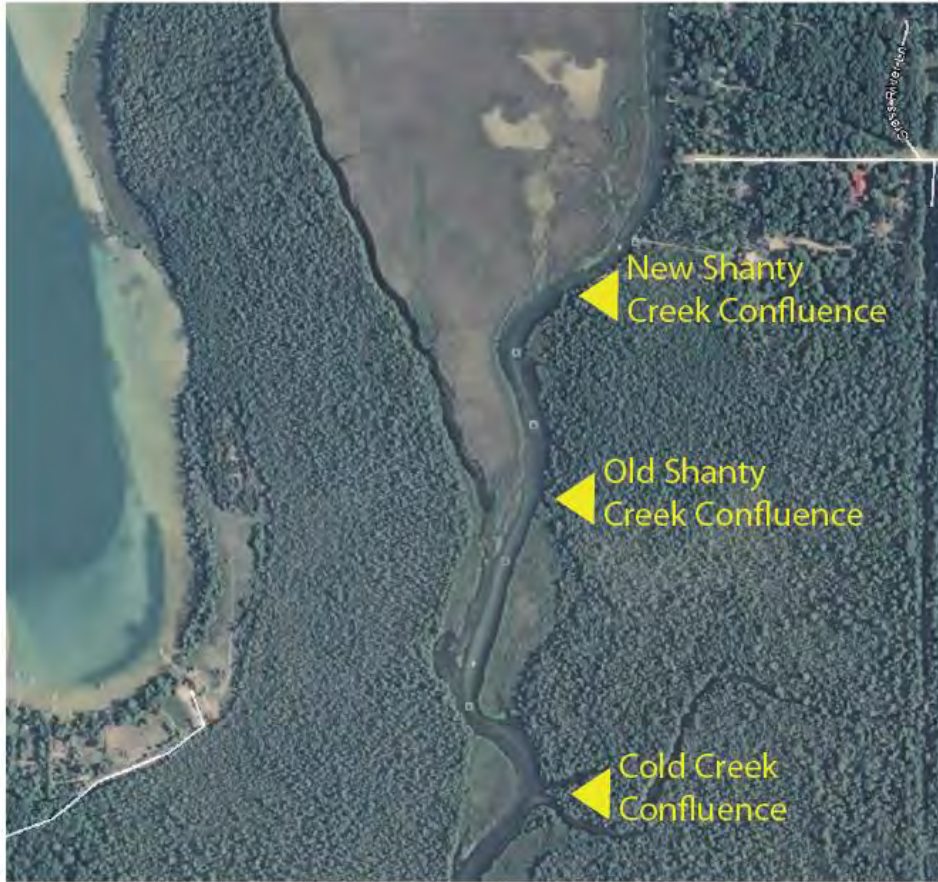
Figure 18. Plot of observed location of the Shanty Creek confluence on recent satellite imagery (Copyright Google), compared to the historical (mapped) confluence.

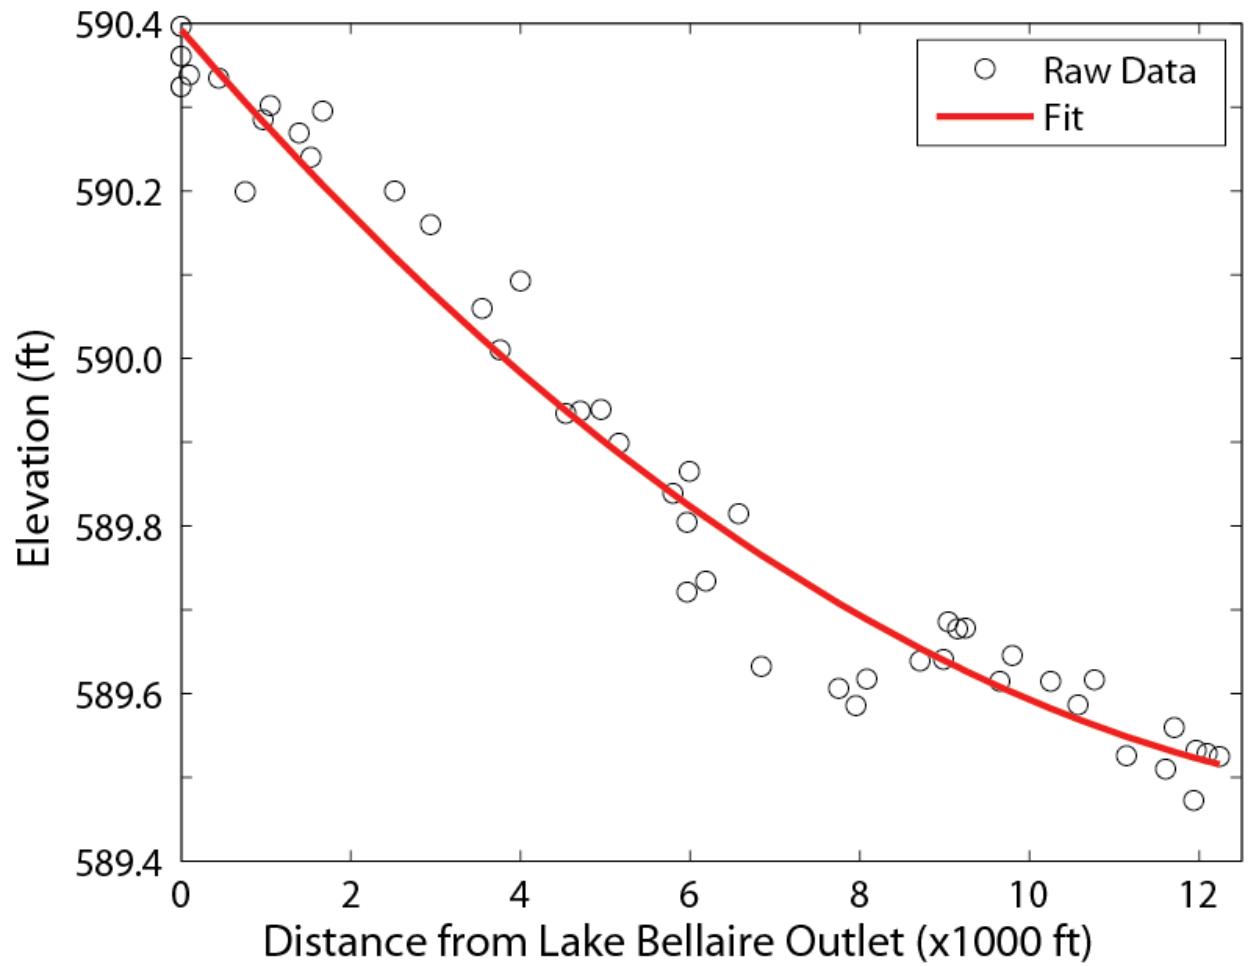
Figure 20. Plot of GPS elevations collected along the Grass River transect, including both raw data and a second-order polynomial fit.

Survey-grade GPS data of water surface elevations are plotted in Figure 20. Note the points between 6,000 and 8,000 feet down channel likely represent either a mislabeling of river bottom measurements as water surface, or errors in data resulting from postprocessing. To minimize the effects of these disturbances, and to assign an elevation to all points on the channel, a second-order polynomial was fit to the entire channel data series. The fit was reasonably good for this function, though it likely over-represents the gradient early in the channel, and under-represents later gradients.

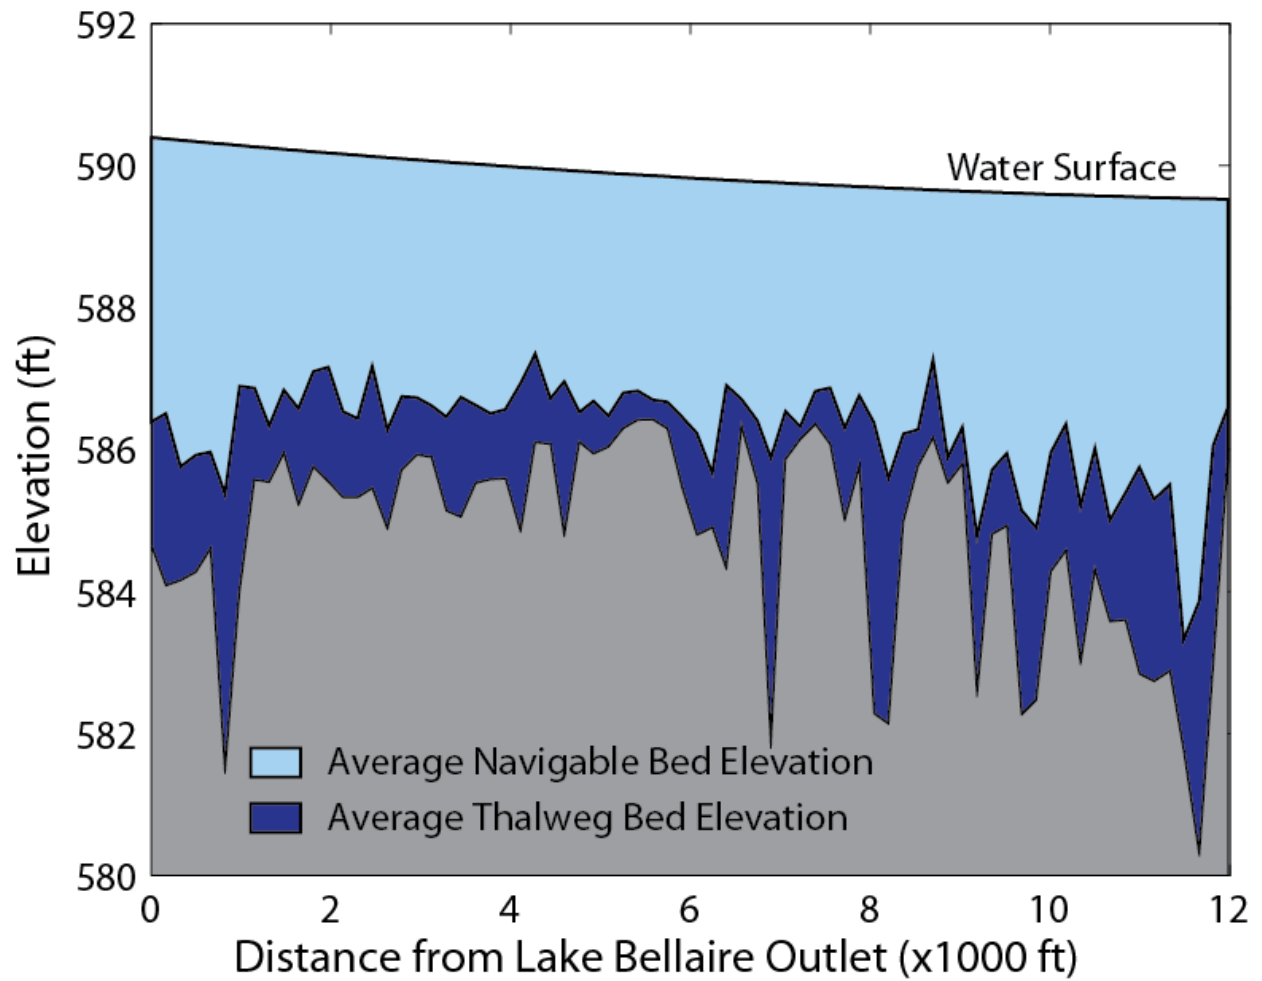
Figure 21. Plot of average navigable stream bed elevation and thalweg bed elevation, given by the polynomial fit in Figure 20. Similarly to Figure 16, the data are averaged for 50-meter lengths of channel.

As a result of the shallow gradient, flow along the entire Grass River channel is limited by the level of Torch Lake. To visualize this, a smooth second-order polynomial derived from the elevation data in Figure 20 was applied to each of the 50-meter average navigable depth and thalweg depth points, allowing those to be transformed from simple depths to absolute elevations. These are plotted in Figure 21. This makes clear that the bottom of the river bed at the Lake Bellaire outlet (the start of Grass River) is well below the water surface at the Grass River outlet into Clam Lake. The hydraulic resistance caused by the low gradient can be simply visualized by imagining that the water entering at the Lake Bellaire outlet is essentially directly pushing against the water in Clam Lake, rather than flowing unrestricted downslope.

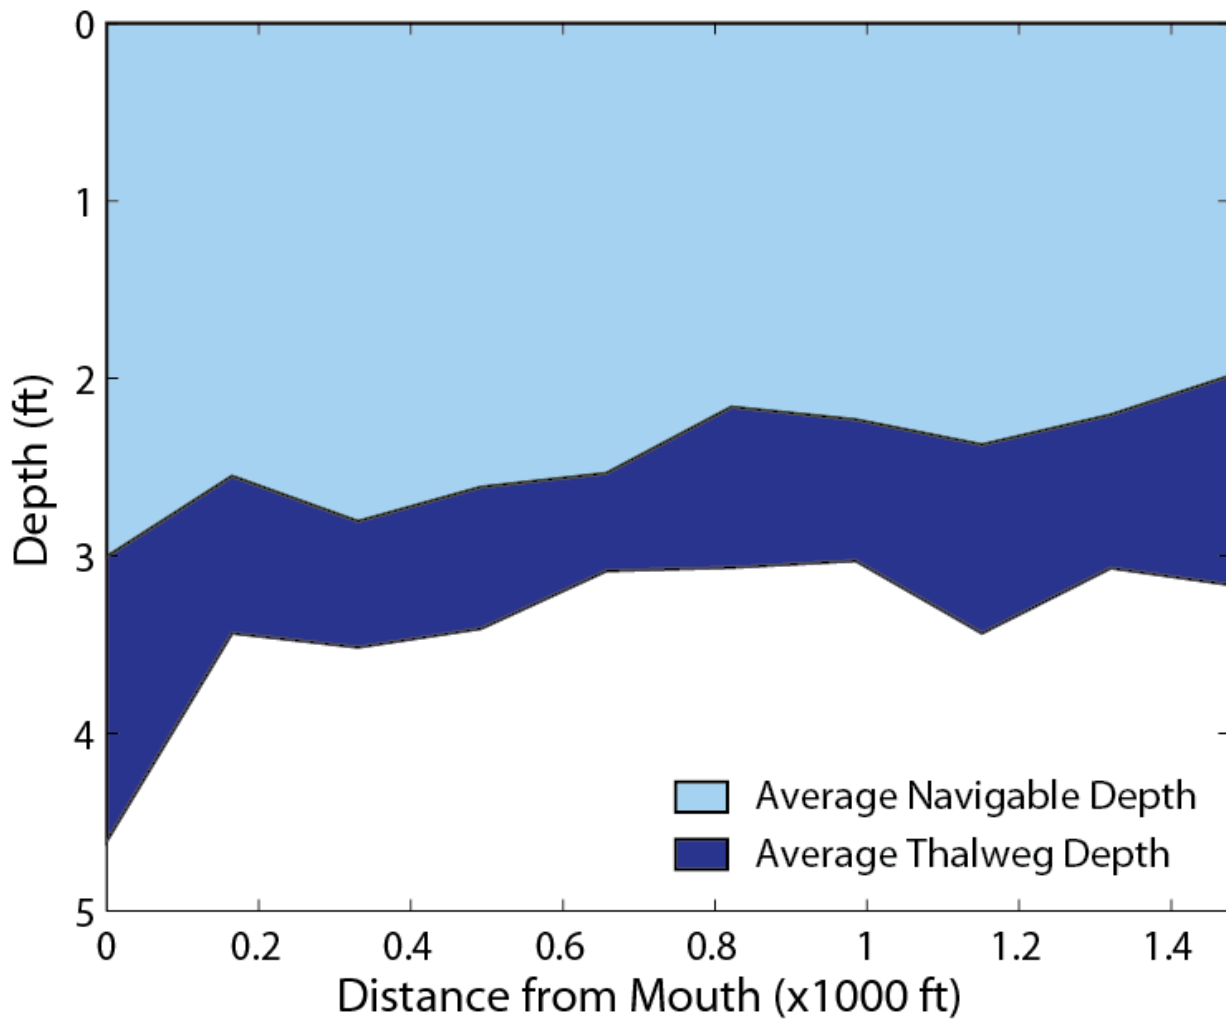
Figure 24. Plot of 50-meter average navigable channel depth along the lower Rapid River, and average thalweg depth.

Torch and Rapid river boat tracks are plotted in Figure 23. These tracks show acute navigational issues along the entire lower Rapid River segment (see Figure 24). Indeed, the navigable section proved shorter than anticipated prior to the field data collection. Visible in the satellite imagery basemap are very long docks reaching out to the boat track. The navigable width was very short narrow, and our zig-zag pattern was limited by channel depths along much of this segment.

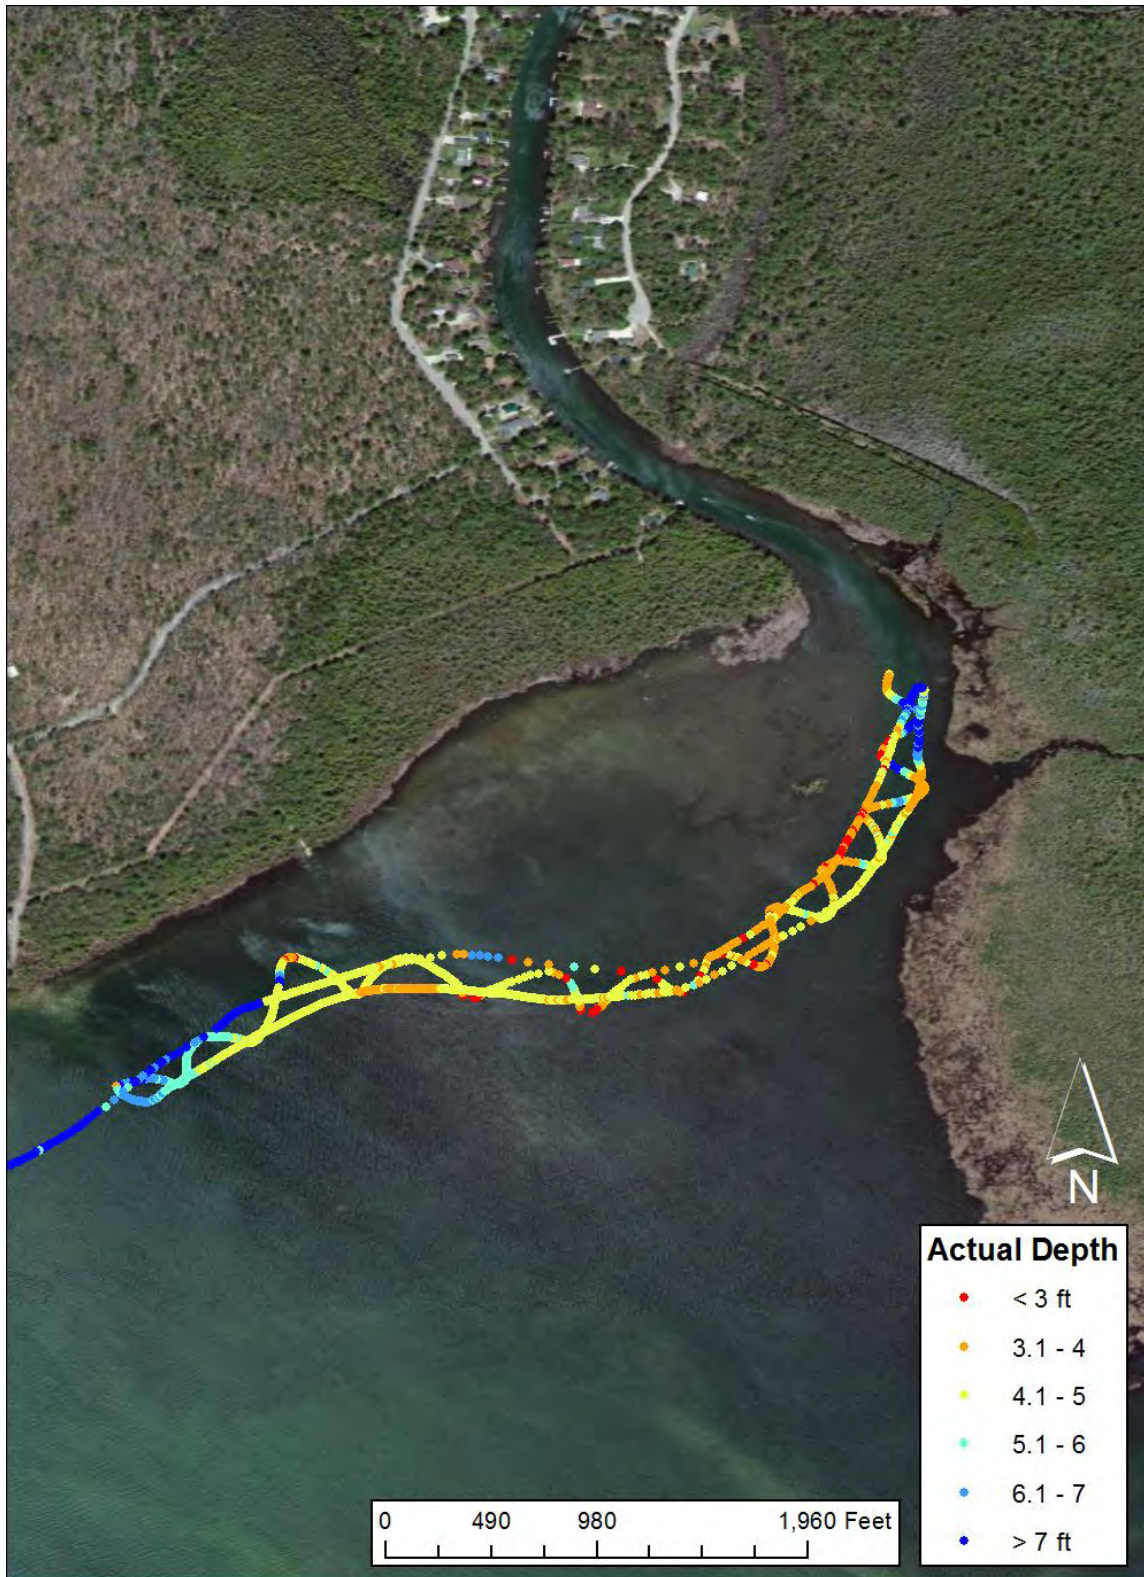
Figure 27. Map of detailed channel depths at the Torch River outlet into Skegemog Lake.

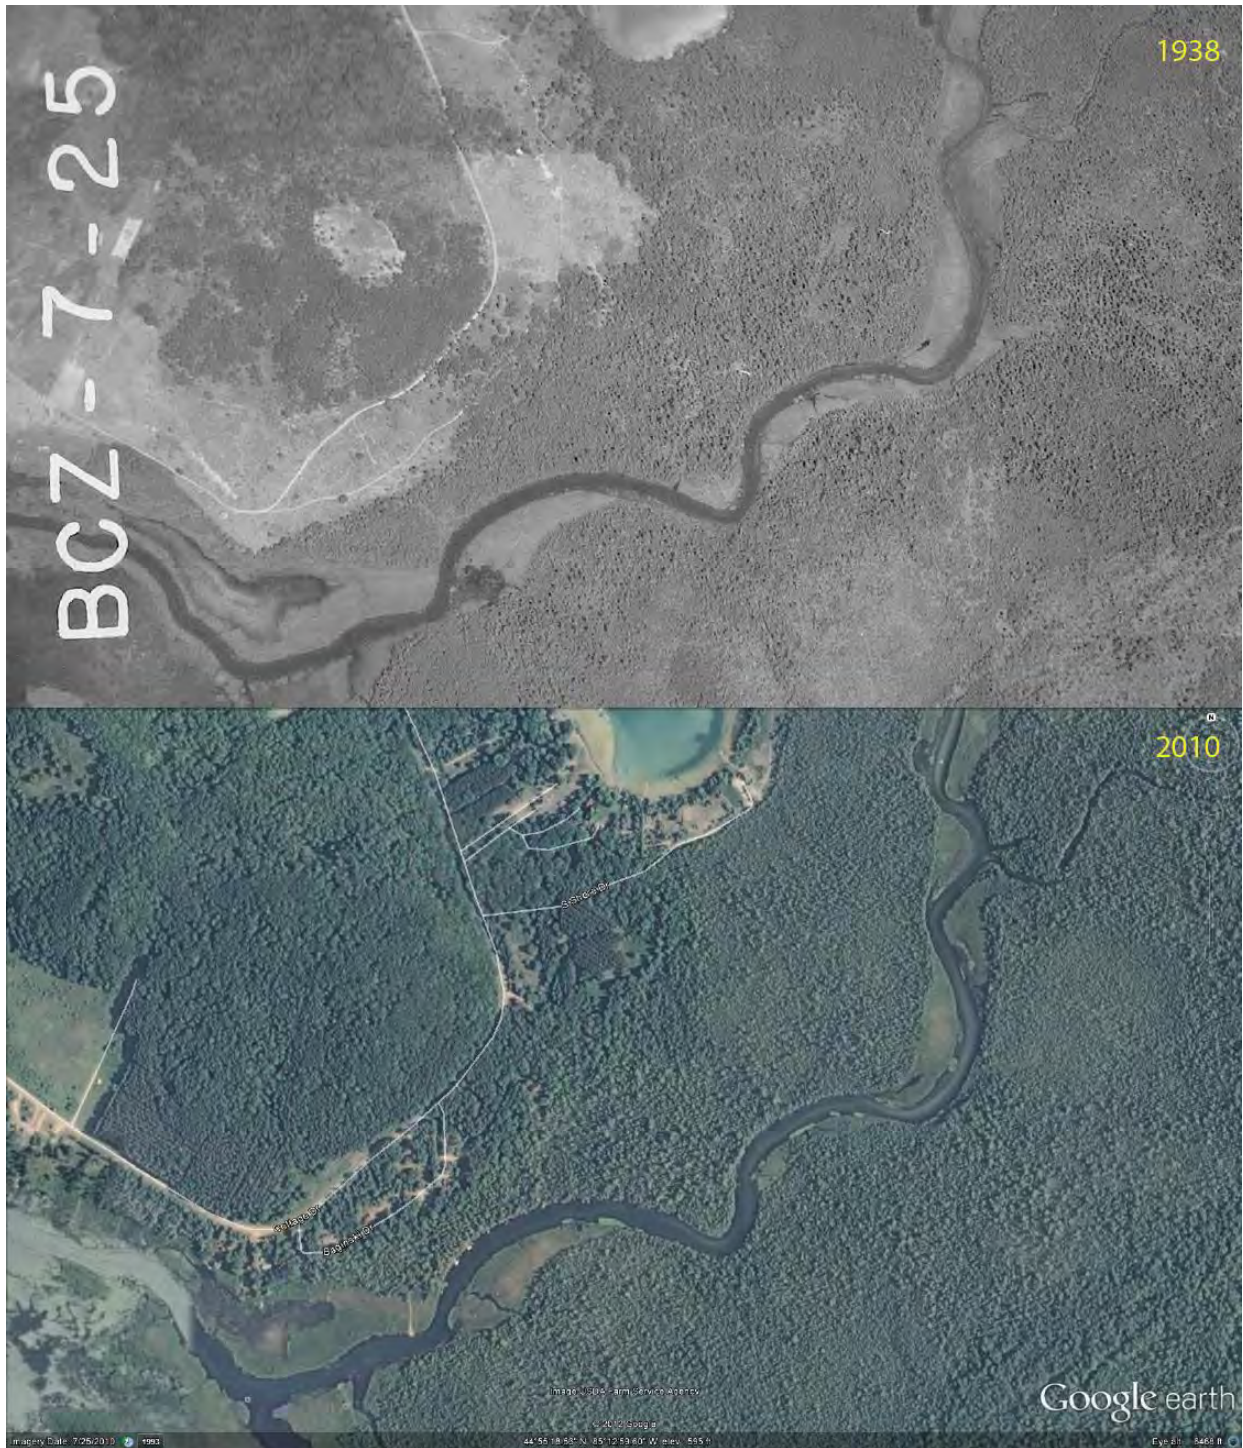
Figure 28. Comparison of the same frame (Grass River at the mouth into Clam Lake) between 1938 and 2010. The 2010 channel is significantly wider, and new mid-channel sediment features have developed downstream of Cold Creek.
