**Understanding the Hydrologic Landscape to Assess
Trajectories of Sediment Sources and Stream Condition in
the Grass and Rapid River Watersheds**

Final Report

5/13/2014

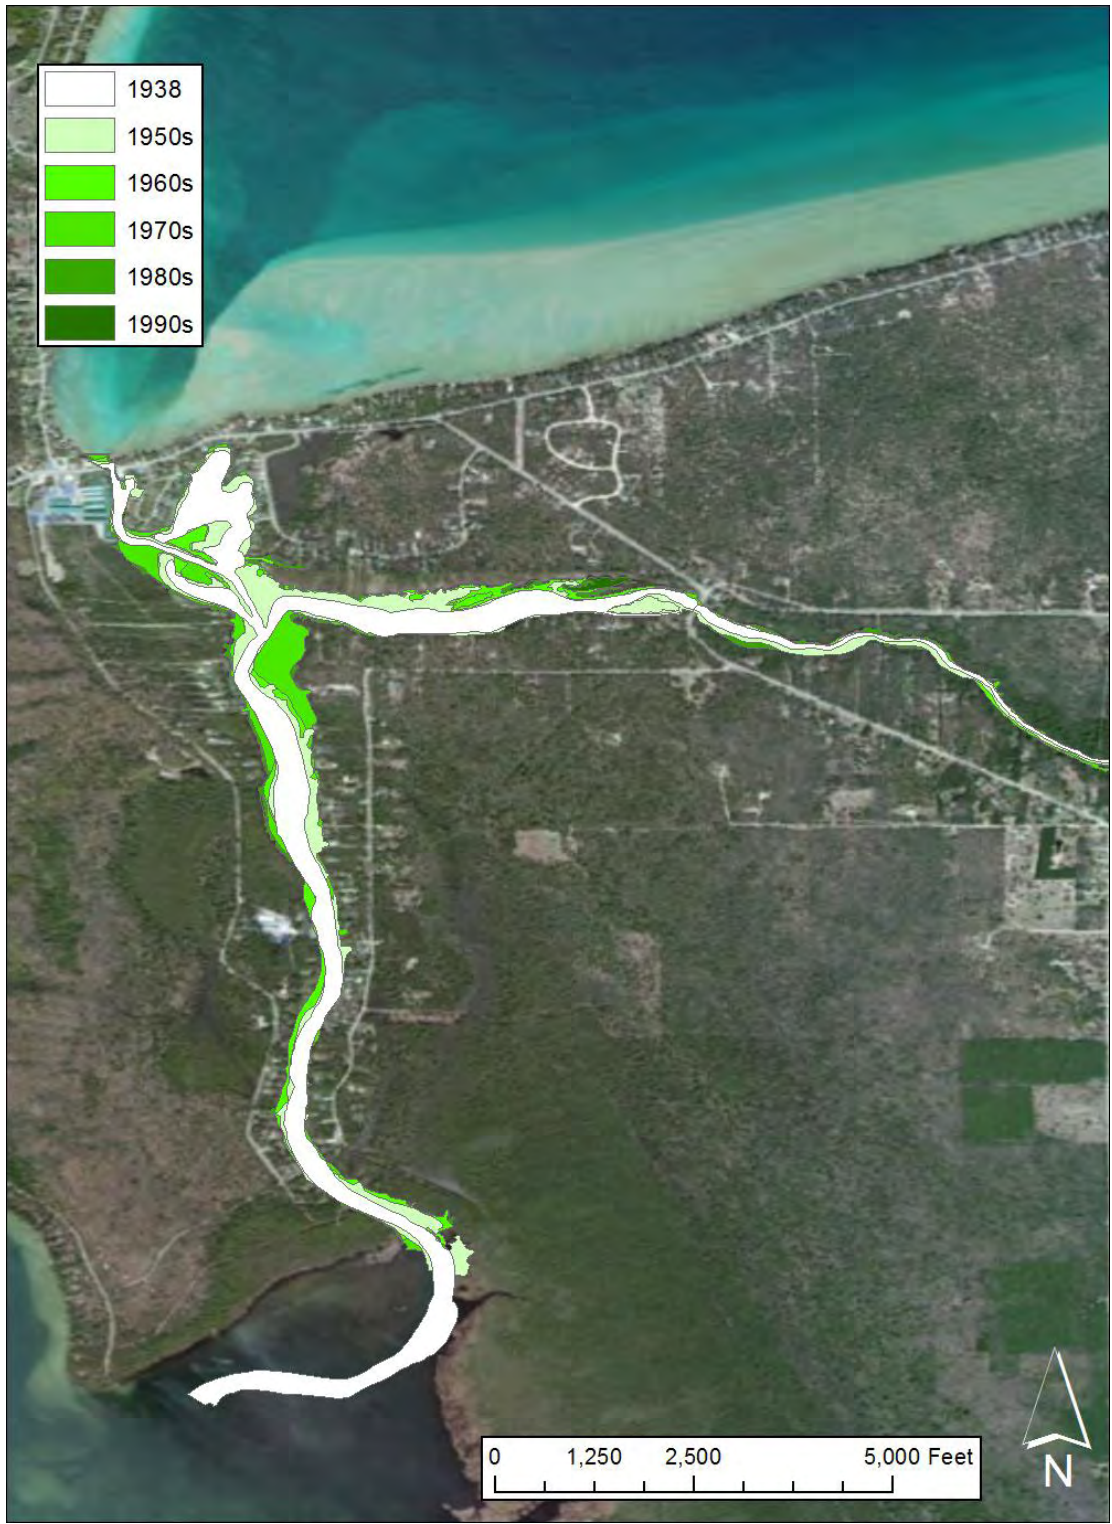
Figure 31. Map of Torch and lower Rapid Rivers showing channel changes through time as mapped with aerial imagery. Caveats about channel position discussed in Figure 29 apply here as well.

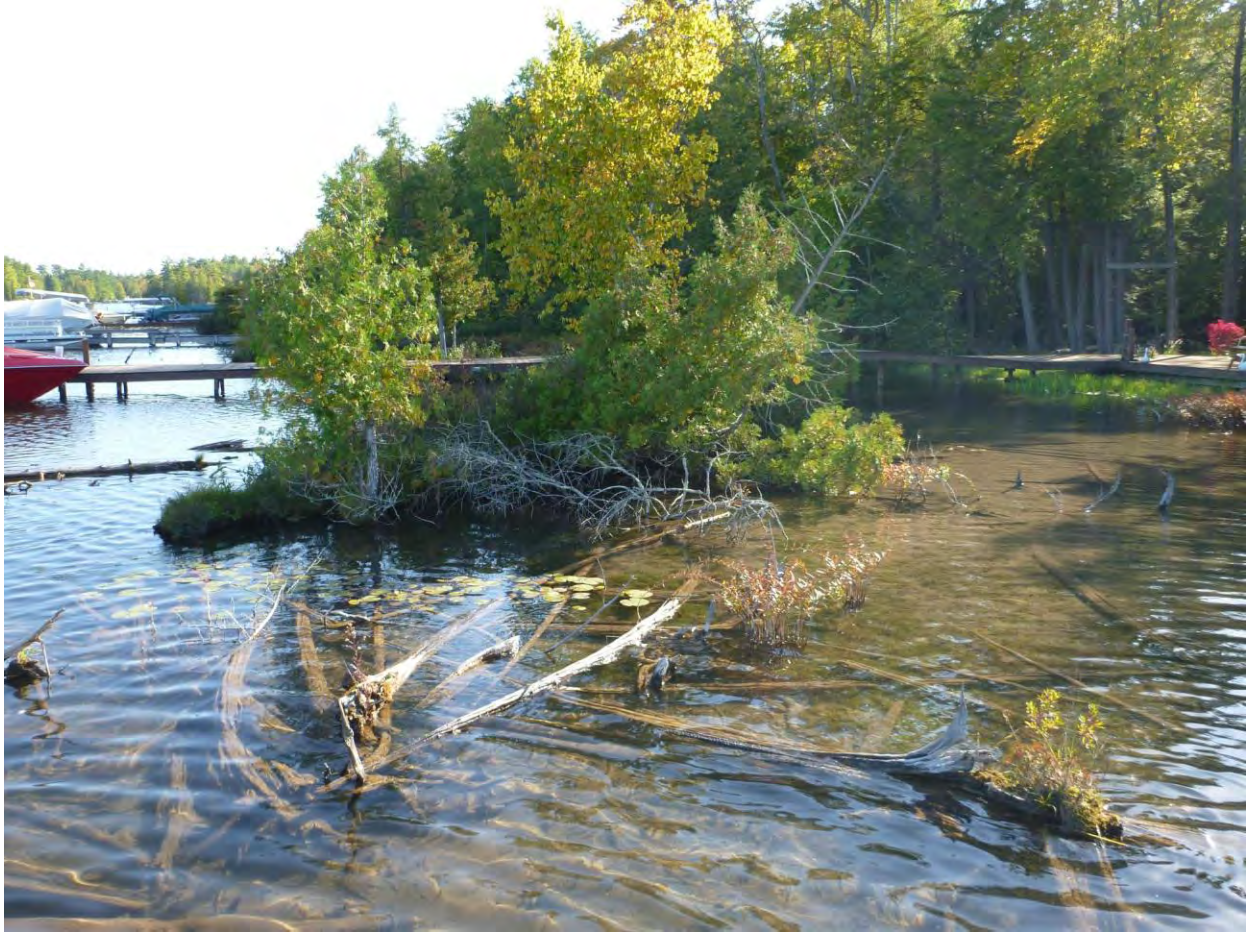
Figure 33. Image showing significant recent bank erosion just downstream of the Rapid River confluence with Torch River.

This spatial pattern is striking because it closely mirrors a dramatic difference in bank condition and stream depth observed during our Torch and Rapid River longitudinal surveys. Figure 33 was taken just below the Rapid River confluence with Torch River and shows massive recent bank erosion, leaving only the stumps and root structures of dead trees and a small island with younger trees still persisting. This stands in stark contrast to Figure 34 where no such in-channel vegetation was visible, instead replaced by long stretches of armored banks and characterized by much deeper channel depths (Figure 26).

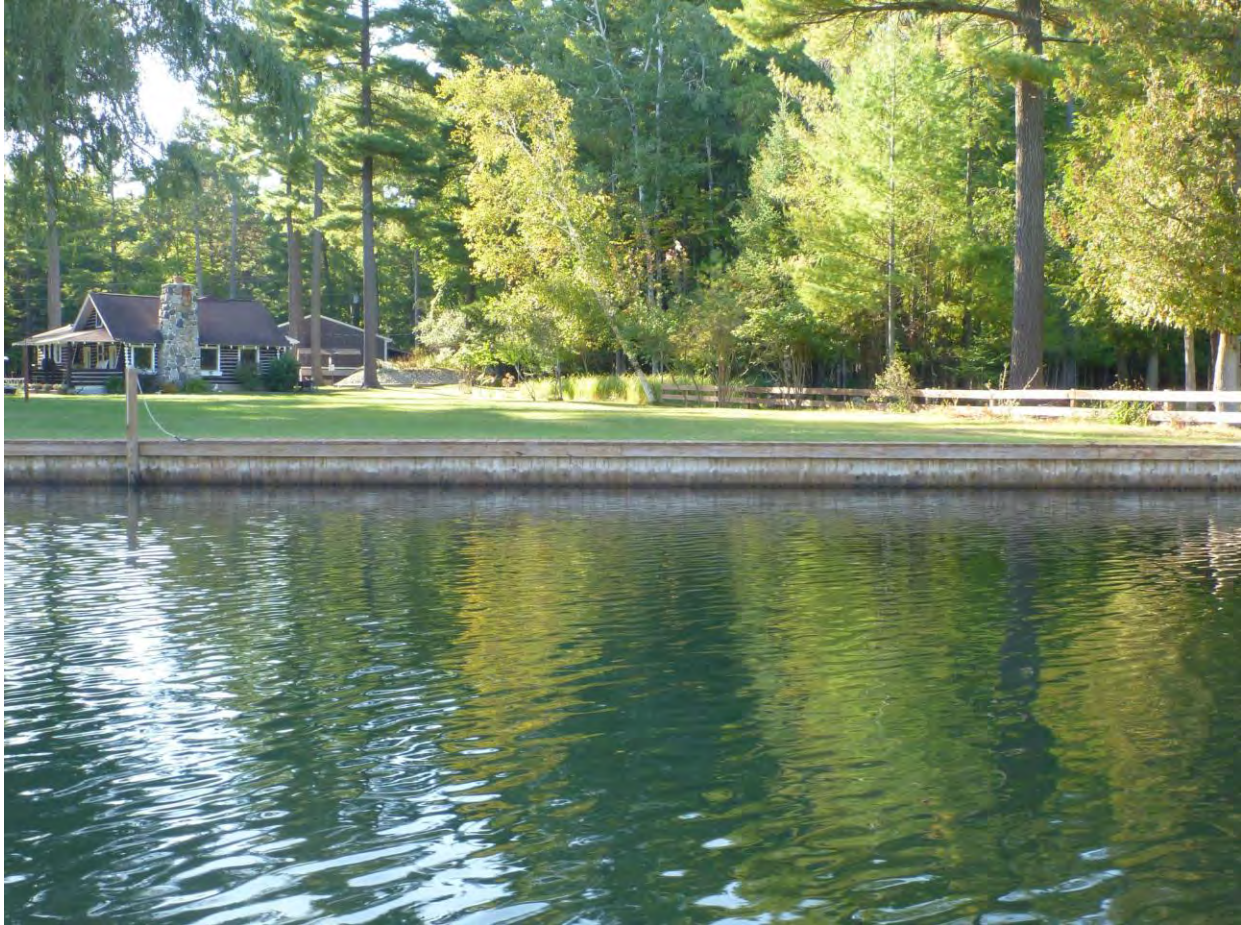
Figure 34. Image further downstream from Figure 33, in the middle Torch River. Visible is the completely armored bank of a wooden seawall.

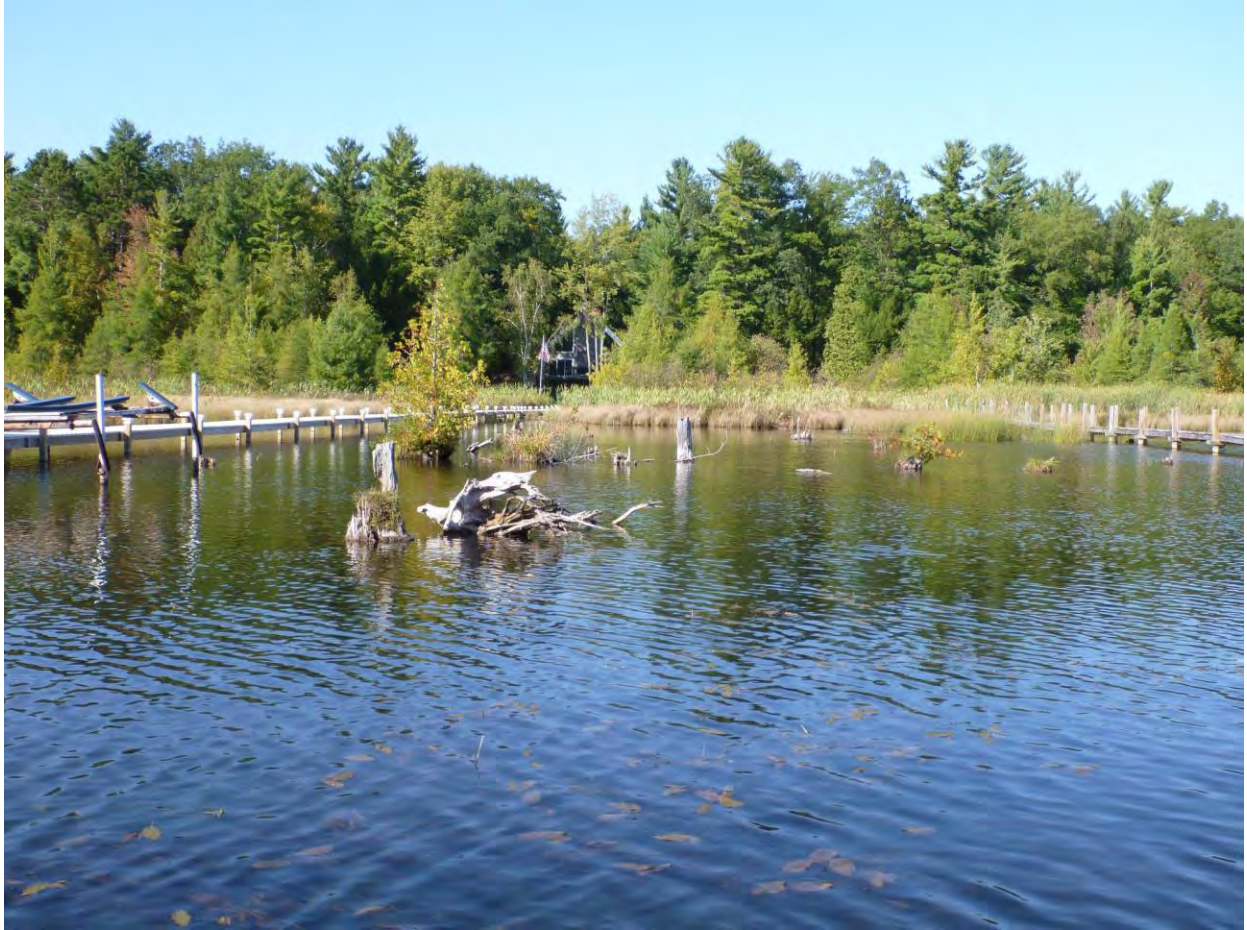
Figure 35. Image of a house on the north bank of the lower Rapid River, formerly set significantly back from the river but experiencing significant modern erosion. Other docks are visible, with homes set back far enough that they lie beyond the tree line.

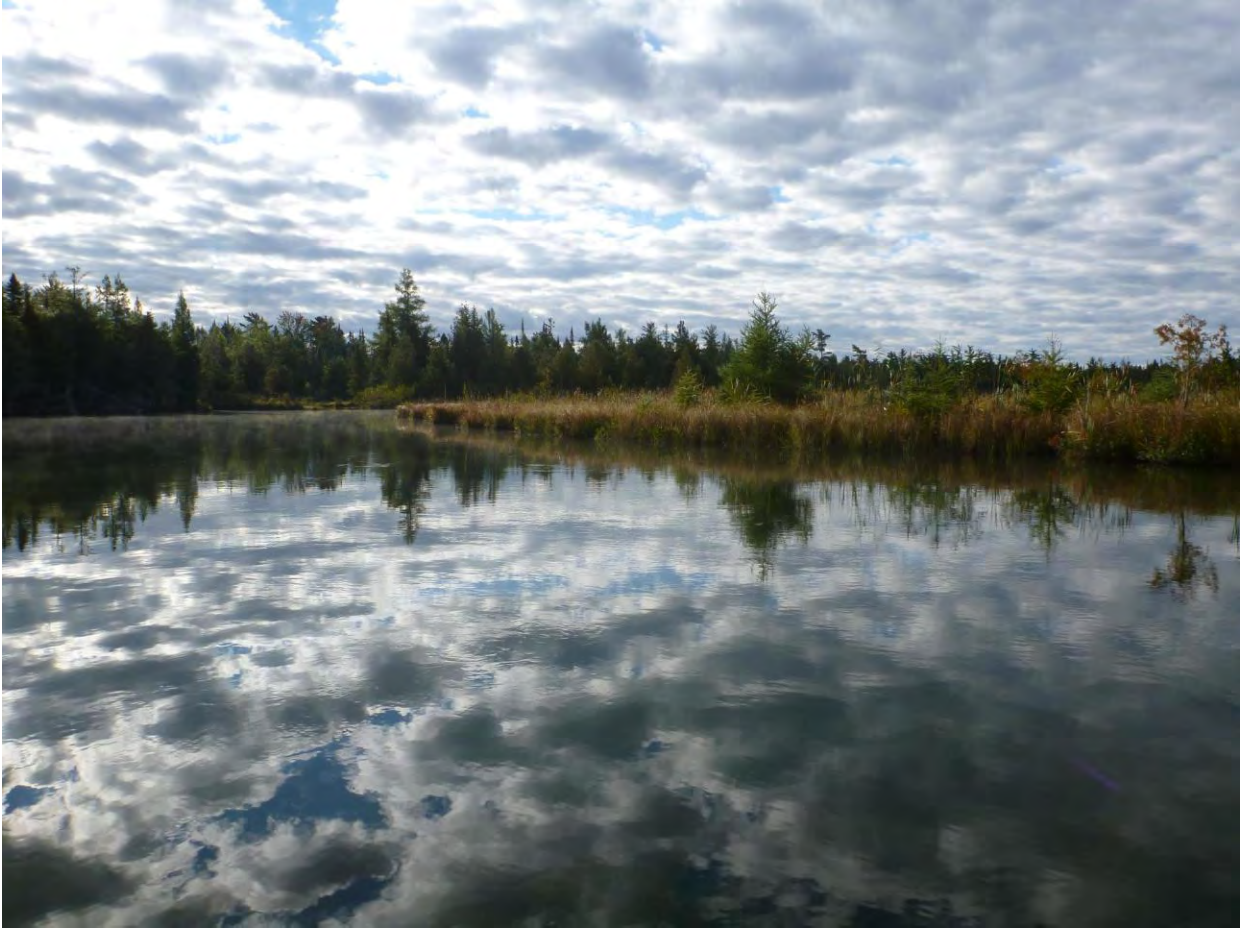
Figure 40. Image of the grassy banks of the Grass River.

Any efforts to fix a perceived problem must not lead to further, perhaps unintended, negative consequences. In particular, the Grass River and portions of the Rapid and Torch have stretches of pristine shoreline vegetation (Figure 40), and present wildlife (Figure 41). The general character of the shoreline needs to be fully characterized to determine the suitability for shoreline modification at that location. Shoreline can provide aesthetic, ecological, economic, and erosion protective value.

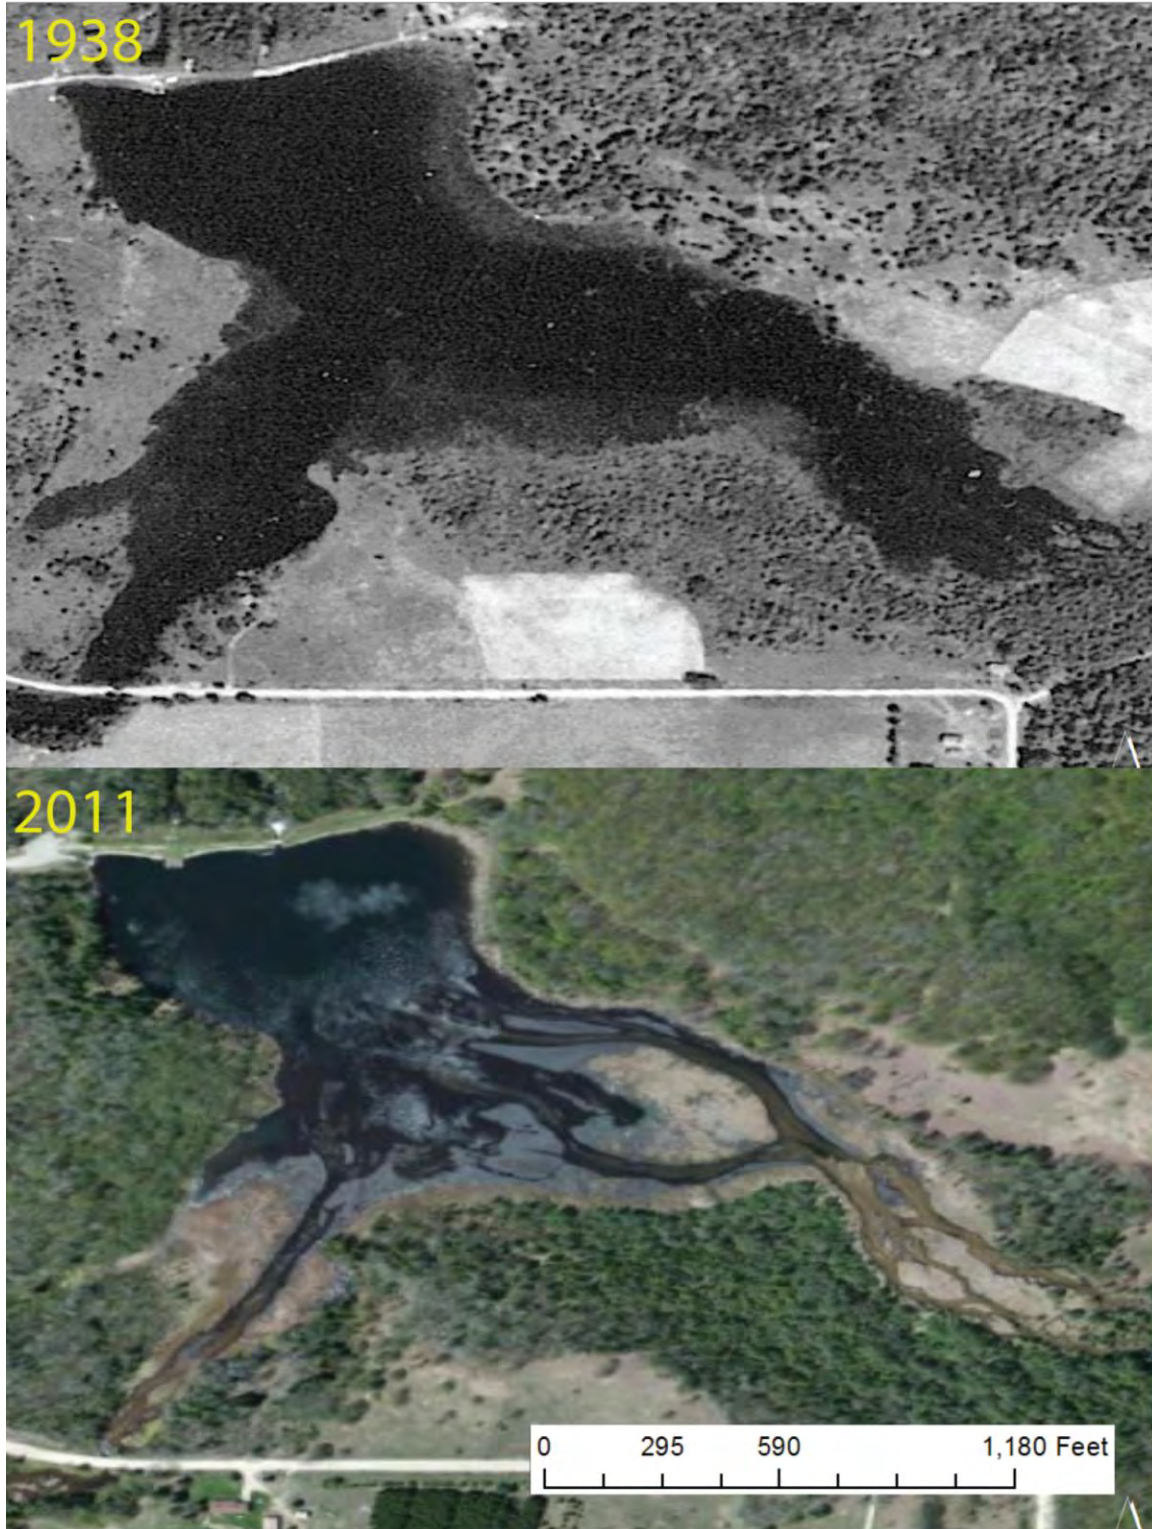
Figure 43. Comparison of aerial and satellite imagery from 1938 and 2011 of Rugg Pond.
