**Understanding the Hydrologic Landscape to Assess
Trajectories of Sediment Sources and Stream Condition in
the Grass and Rapid River Watersheds**

Final Report

5/13/2014

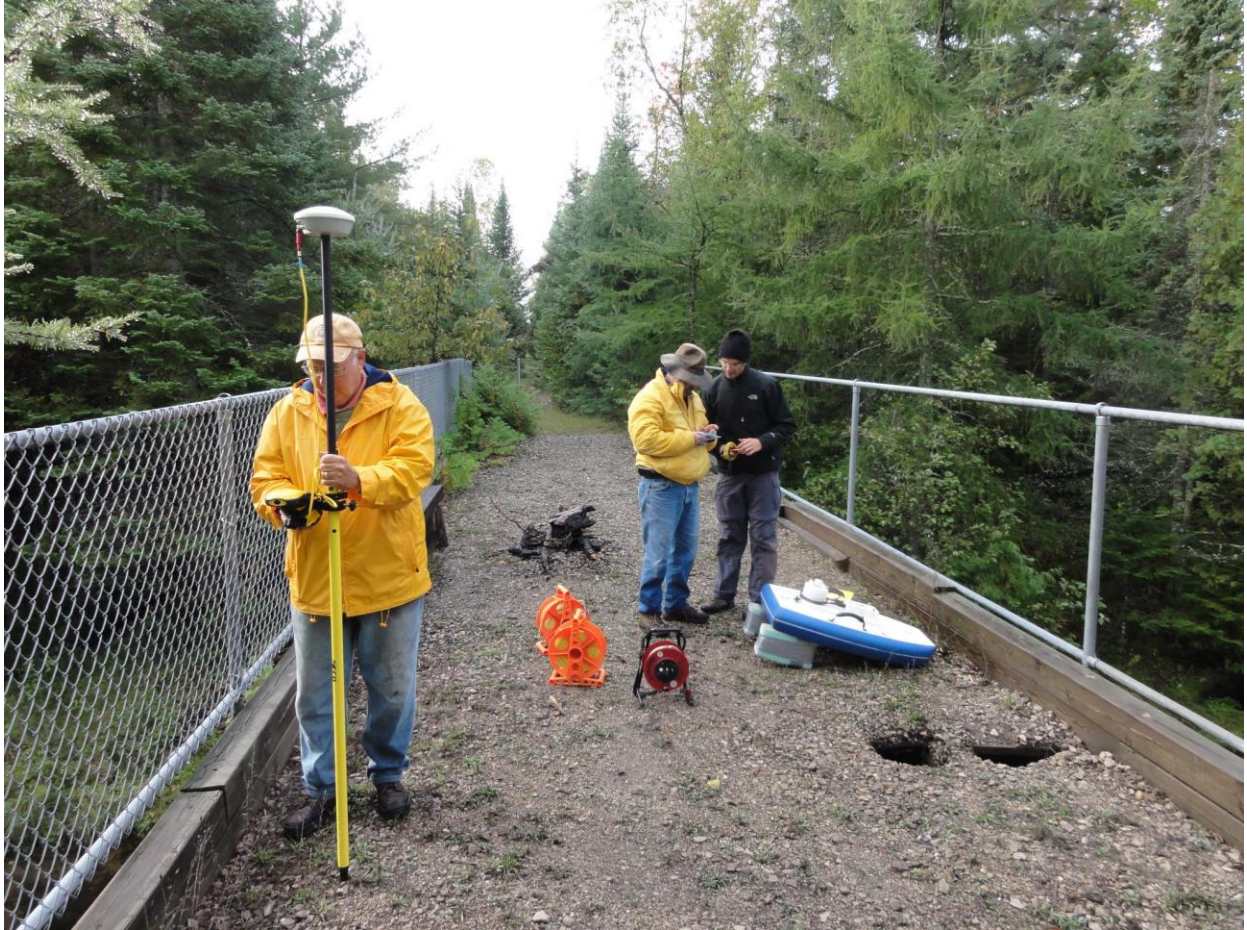
Figure 1. Bob Kingon of the Elk-Skegemog Lake Association collecting a GPS measurement on the Cut River. In the background, Lon Cooper (in yellow) and Anthony Kendall (in black) prepare for a stream discharge measurement using the ADCP (white and blue boat).

The first team, consisting of Bob Kingon and Dean Branson, used a Trimble GeoXH mapping GPS instrument (see Figure 1). The Trimble GeoXH has an accuracy of around 60 cm, thus the lat/lon/elevation of a point can be determined to somewhere around 2 feet. The instrument was placed at the water line of each road crossing, if accessible. Otherwise, a fixed point on a bridge or culvert was used for measurement, and the distance to the water surface was measured and input as an elevation offset in the instrument.

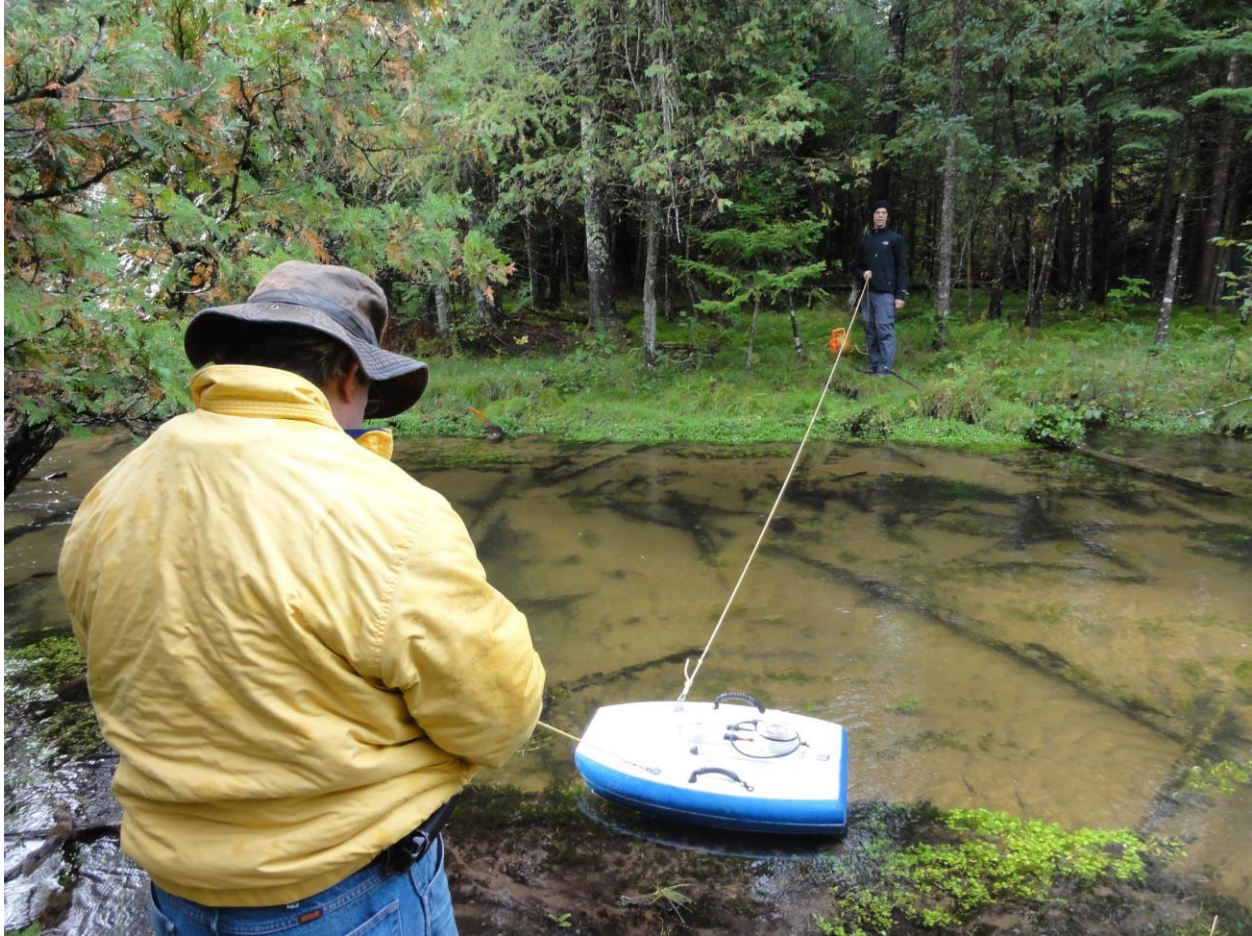
Figure 2. Lon Cooper and Anthony Kendall pulling the ADCP across Shanty Creek, a tributary of the Grass River, the measure stream discharge and channel geometry.

The second team, Anthony Kendall and Lon Cooper, measured stream discharge using a Sontek RiverSurveyor S5 Acoustic Current Doppler Profiler (ADCP) (see Figure 2). The Sontek S5 is a state-of-the-art instrument that measures the depth of the water column beneath it along

with the velocity of water in several vertical intervals (called bins). Mounted on a boat, such as the small Hydroboard in Figure 2, or alongside a boat as in Figure 5, the instrument tracks its motion along the river channel and will build a complete picture of the stream channel velocity and discharge (Figure 3).

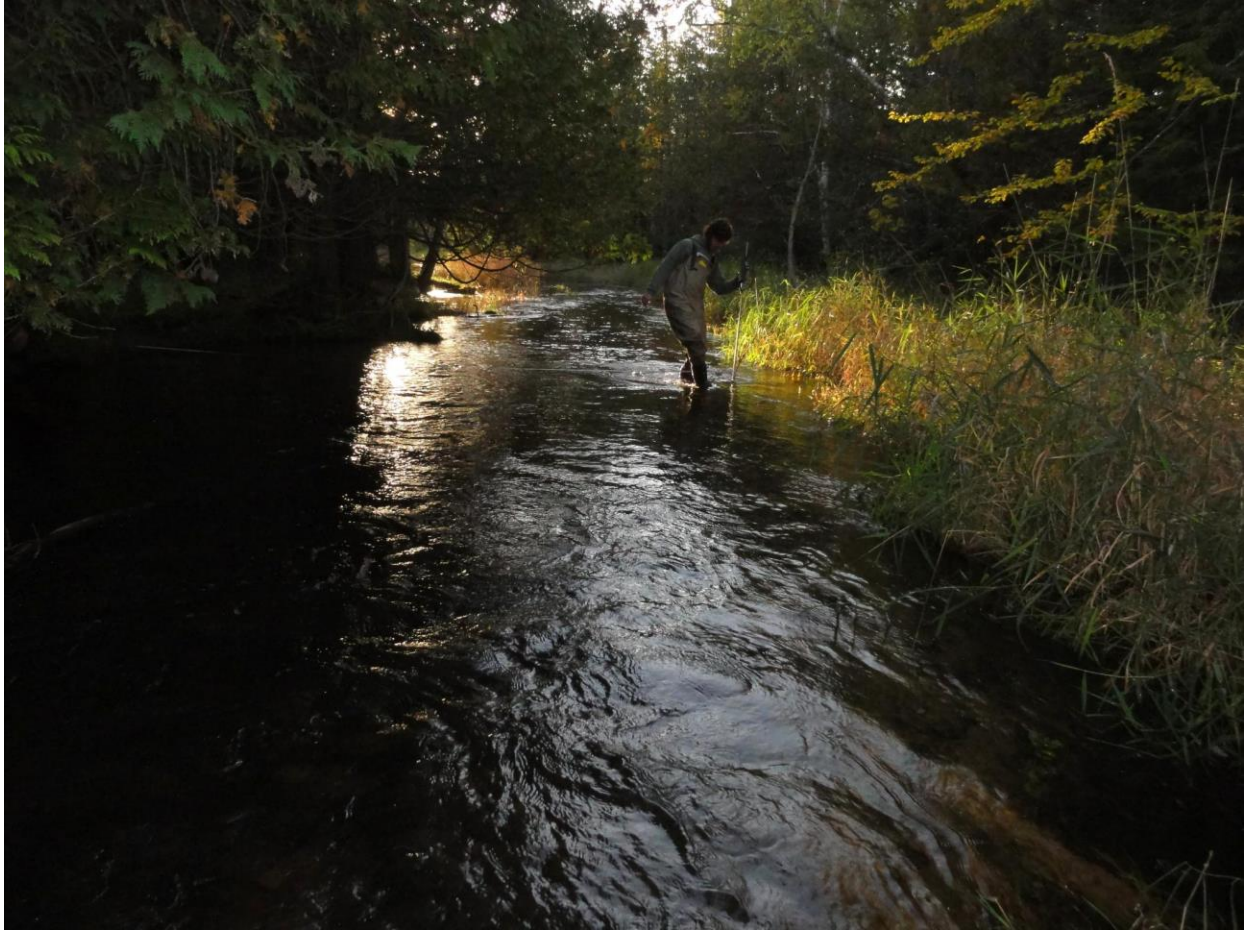
Figure 4. Blaze Budd measuring discharge using the wading method (with the OTT ADCM) along the upper Rapid River near sunset.

Team three consisted of Blaze Budd and Kevin Cronk using two different instruments to measure stream discharge: a Marsh McBirnie FlowMate2000 and an OTT Acoustic Doppler Current Meter (ADCM). These two instruments function differently, but essentially are both used to measure stream velocity at a discrete number of points (15-20) across a channel while being held by a wading operator. The “wading method” is traditionally the most common means of measuring stream discharge, and can be used in streams shallower than the ADCP can float.

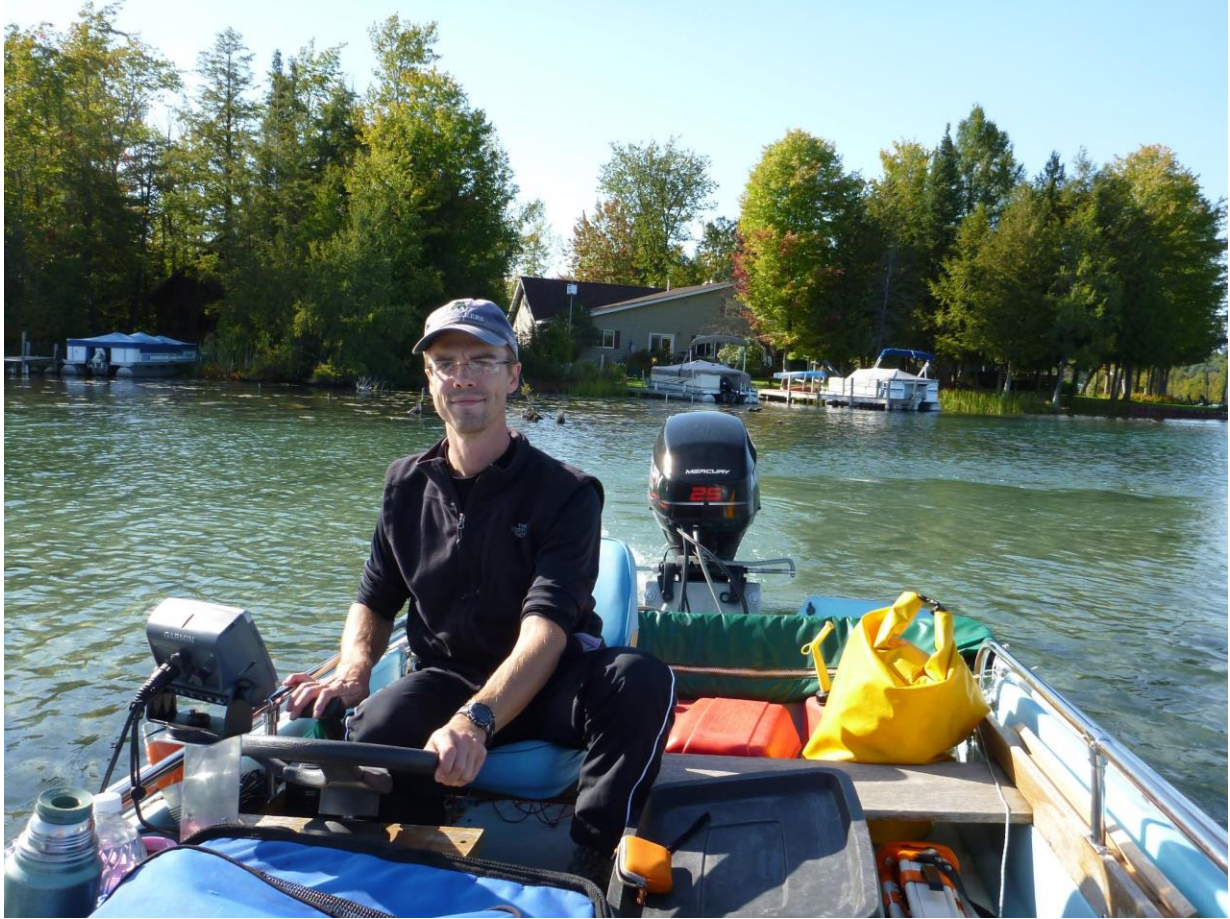
Figure 6. Anthony Kendall driving MSU's boat on the Torch River. The zig-zag pattern of navigation along the channel is visible in the wake trail behind the boat.

The boat was then driven in three separate survey patterns: 1) a zig-zag longitudinal (down-channel) transect, interrupted every so often by a 2) perpendicular cross-section, and followed ultimately by 3) a detailed weave pattern survey of key targeted areas. The first set of surveys was conducted along the Torch River and the lower Rapid River (Figure 6). We conducted a weave survey at the mouth of the Torch River where it empties into Skegemog Lake. The following day, we conducted the same set of surveys along the Grass River, culminating with a weave survey of the outlet into Clam Lake at the Grass River Natural Area dock. This set of surveys was timed to coincide with survey-grade GPS surveys conducted by Brett Fessel and Frank Dituri (see the section below).

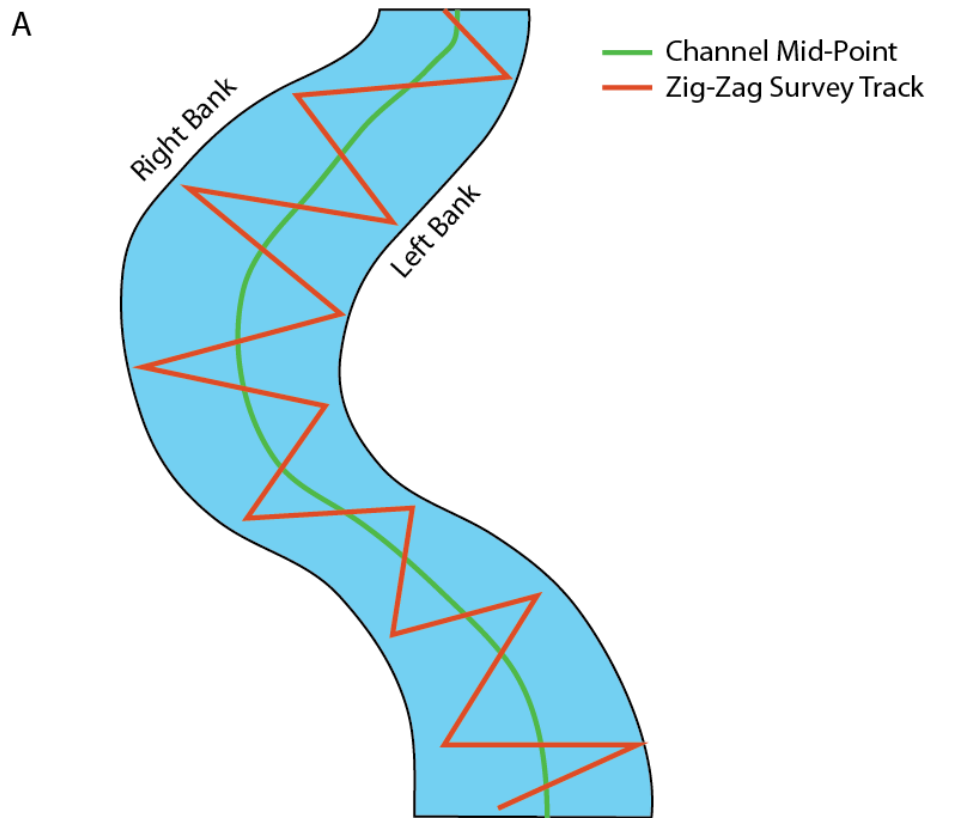
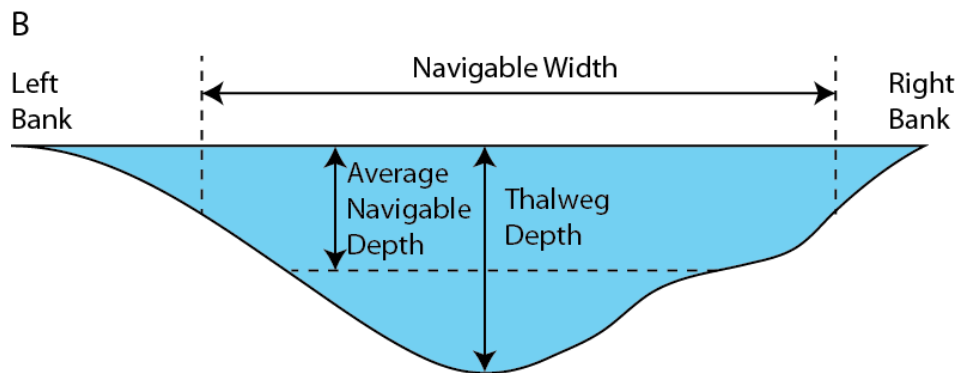
Figure 7. Schematic diagram of key post-processed channel data concepts. Part A shows a map view, illustrating the channel mid-point line and conceptual zig-zag survey track path. Part B is a cross-sectional view illustrating the navigable width of the stream, the average navigable depth, and the thalweg depth. By convention, the Right Bank is on the right while facing downstream.

To compare bulk trends in the overall channel depth, the average navigable depth and thalweg (maximum) depth was calculated for each 50 meter channel segment (Figures 16 and 19). Plotted in Figure 16 are the average navigable depth and thalweg depth (diagrammed in

Figure 7) along the ~12,000 channel feet between lakes Bellaire and Clam. Highlighted on the plot are the confluence locations with Shanty, Cold, and Finch Creeks. Clearly visible at each confluence is a decrease in both average navigable and thalweg depths. These are not, however, remarkable decreases relative to others in the channel. Nevertheless, each confluence was accompanied by a distinct plume of sediment, visible on the water (Figure 17) and in the raw satellite imagery (Figure 18). The river responds to these sediment plumes by shifting the thalweg and widening the channel, and also by pushing that sediment downstream. The smoothed data do not show this effect as clearly as the raw data.

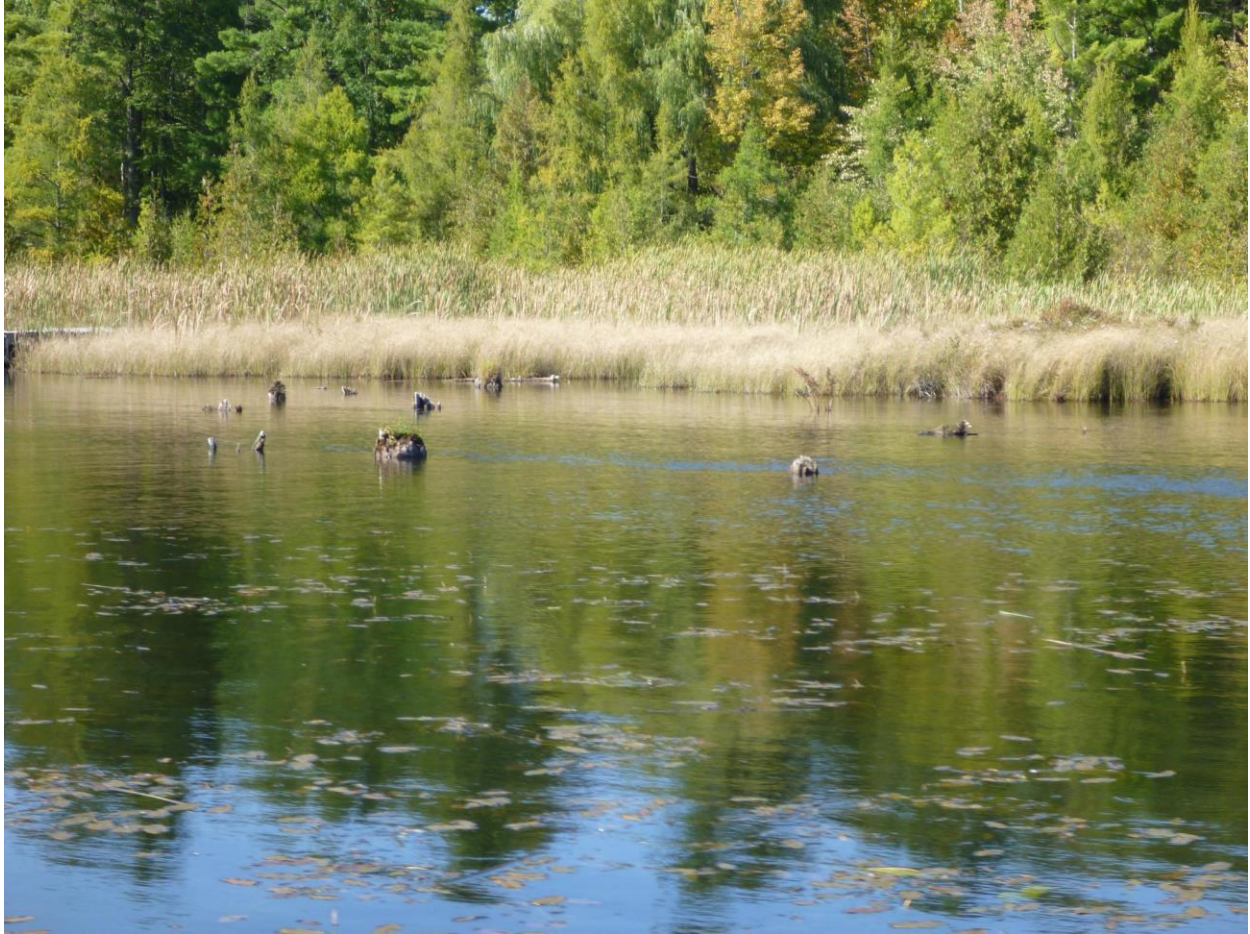
Figure 8. Image of severe bank erosion along the lower Rapid River. The stumps in the foreground were once on shore.

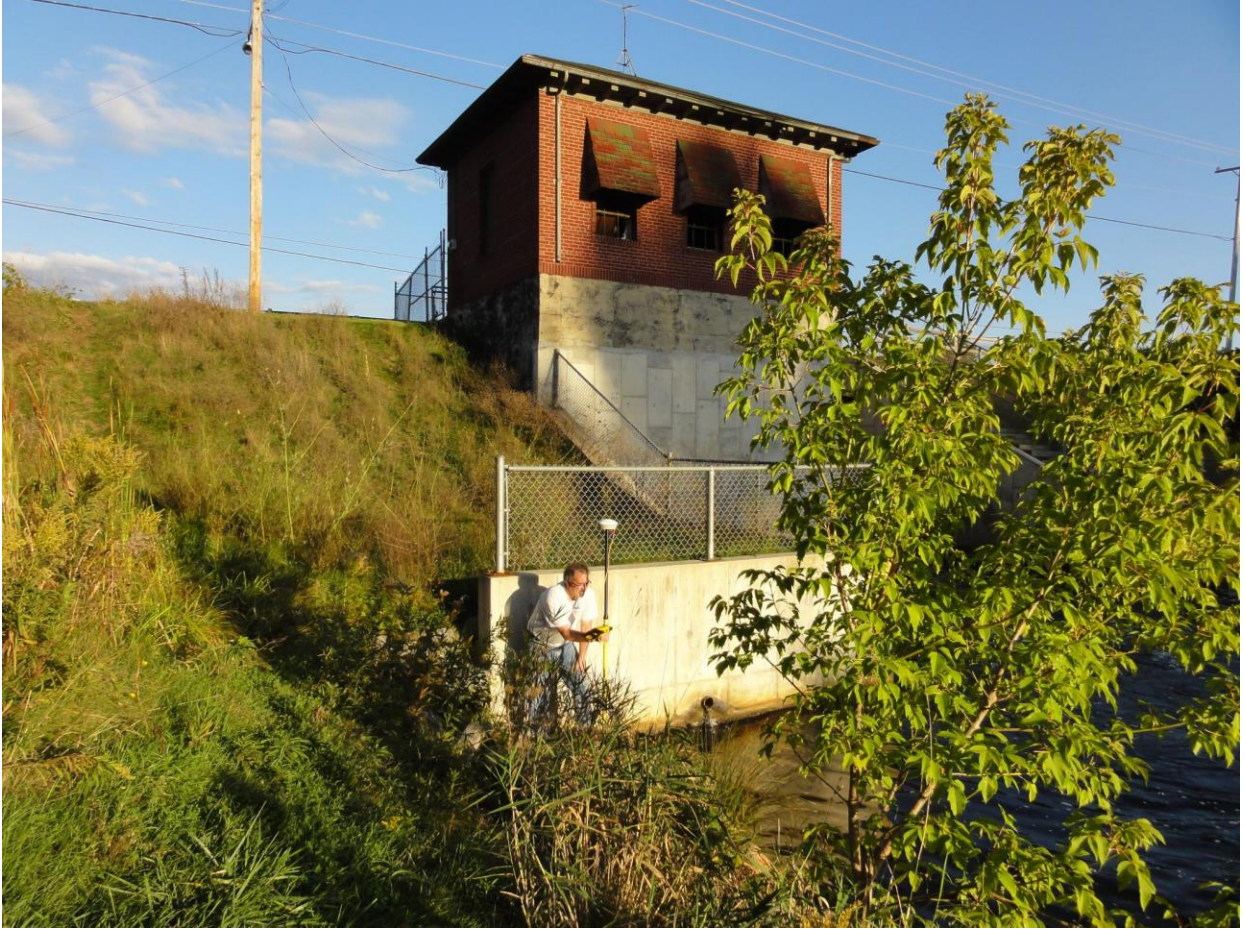
Figure 9. Lon Cooper surveying the water line at the outlet of Craven Pond (Blair Lake).

Additionally, the MSU completed an elevation survey of Elk, Skegemog, Torch, Clam, Bellaire, and Intermediate Lakes, as well as Blair Pond (Figure 9). However, the expected accuracy of this instrument was insufficient to accurately determine the gradient from Bellaire to Elk Lake.
