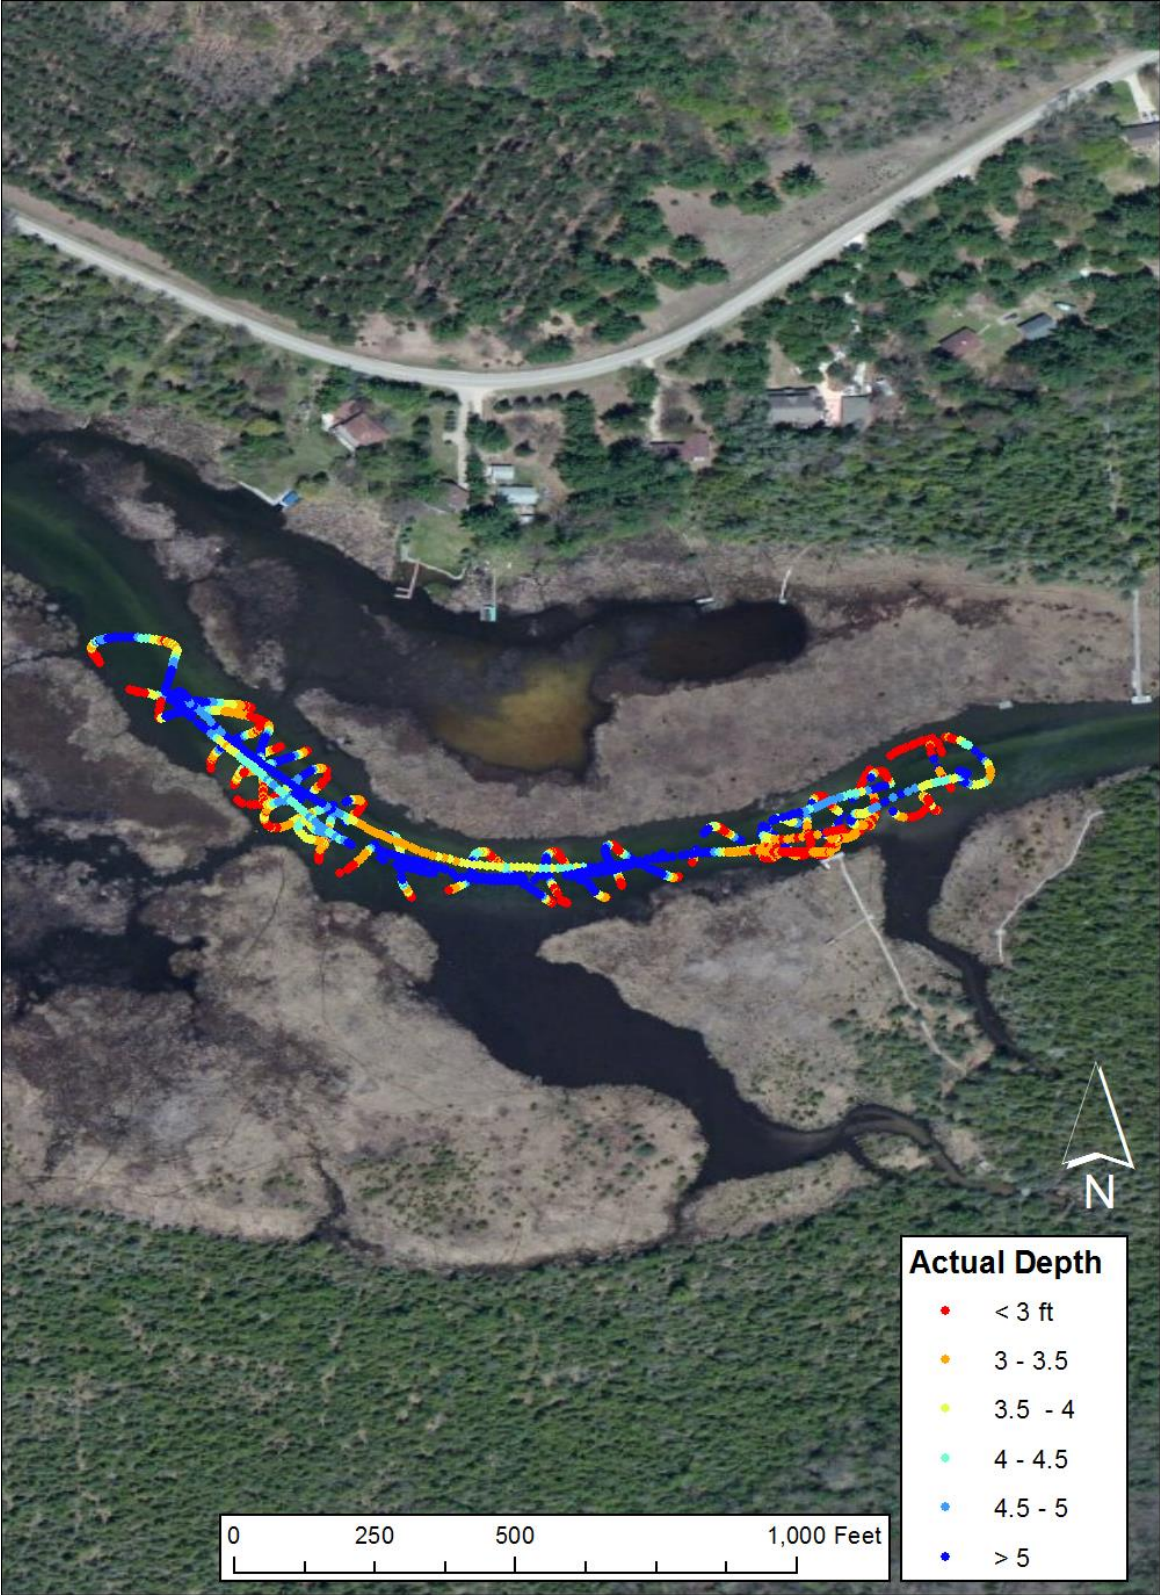
Figure 22. Map of detailed channel depths at the Grass River outlet into Clam Lake.

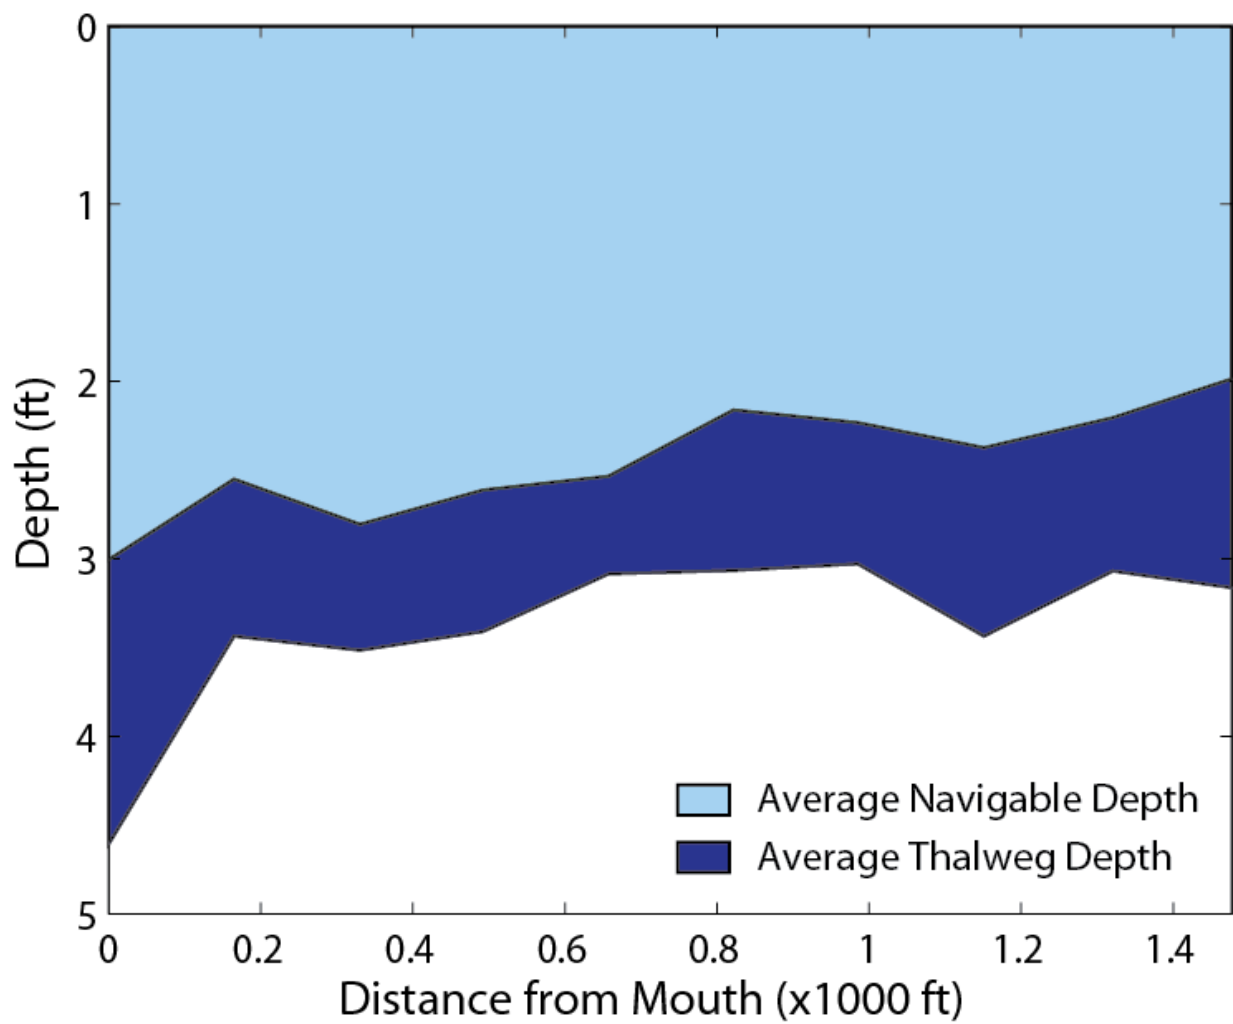
Figure 24. Plot of 50-meter average navigable channel depth along the lower Rapid River, and average thalweg depth.

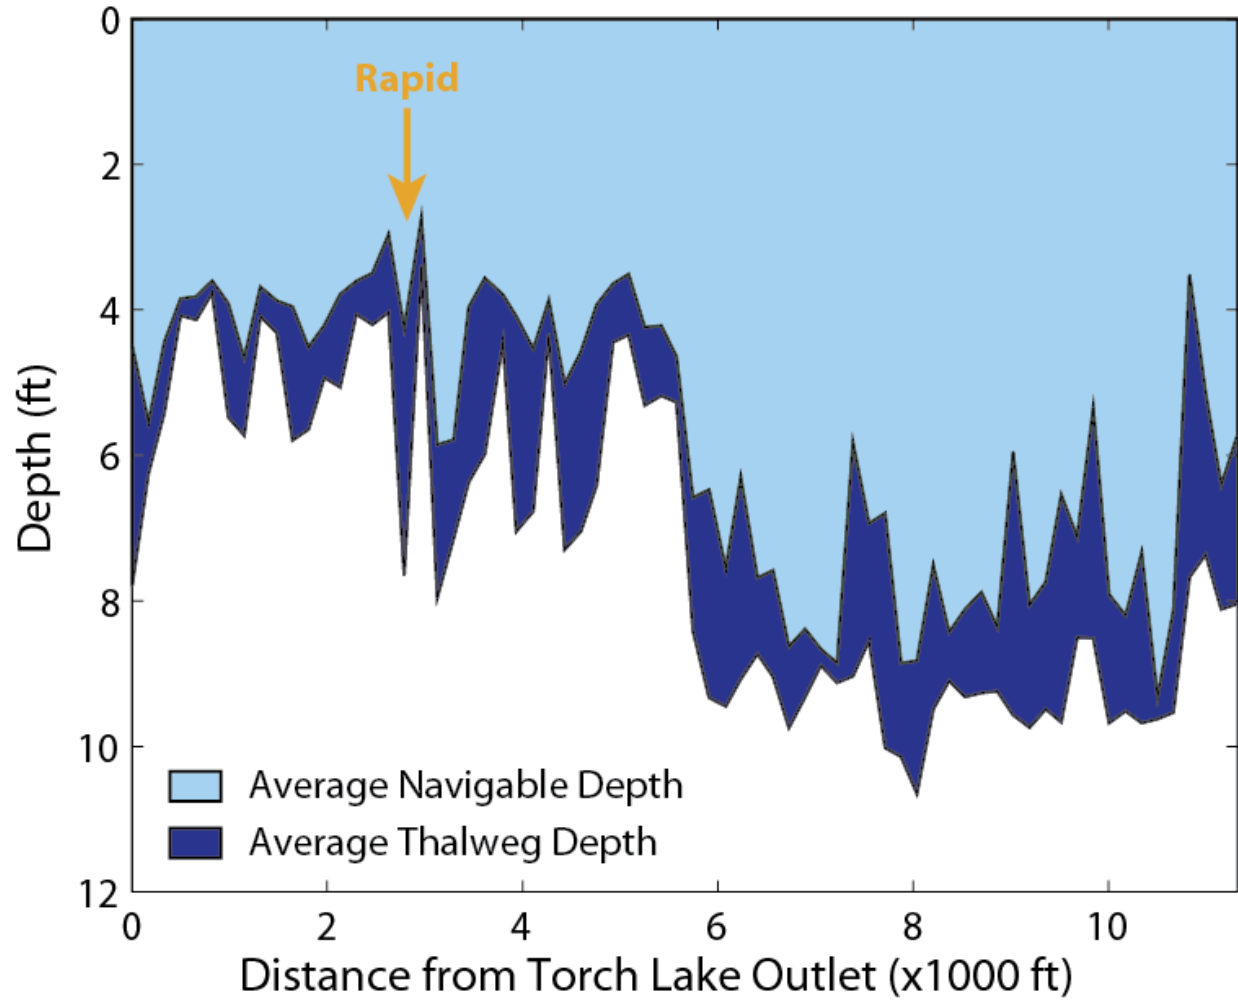
Figure 25. Plot of 50-meter average navigable channel depth along the Torch River, and average thalweg depth.

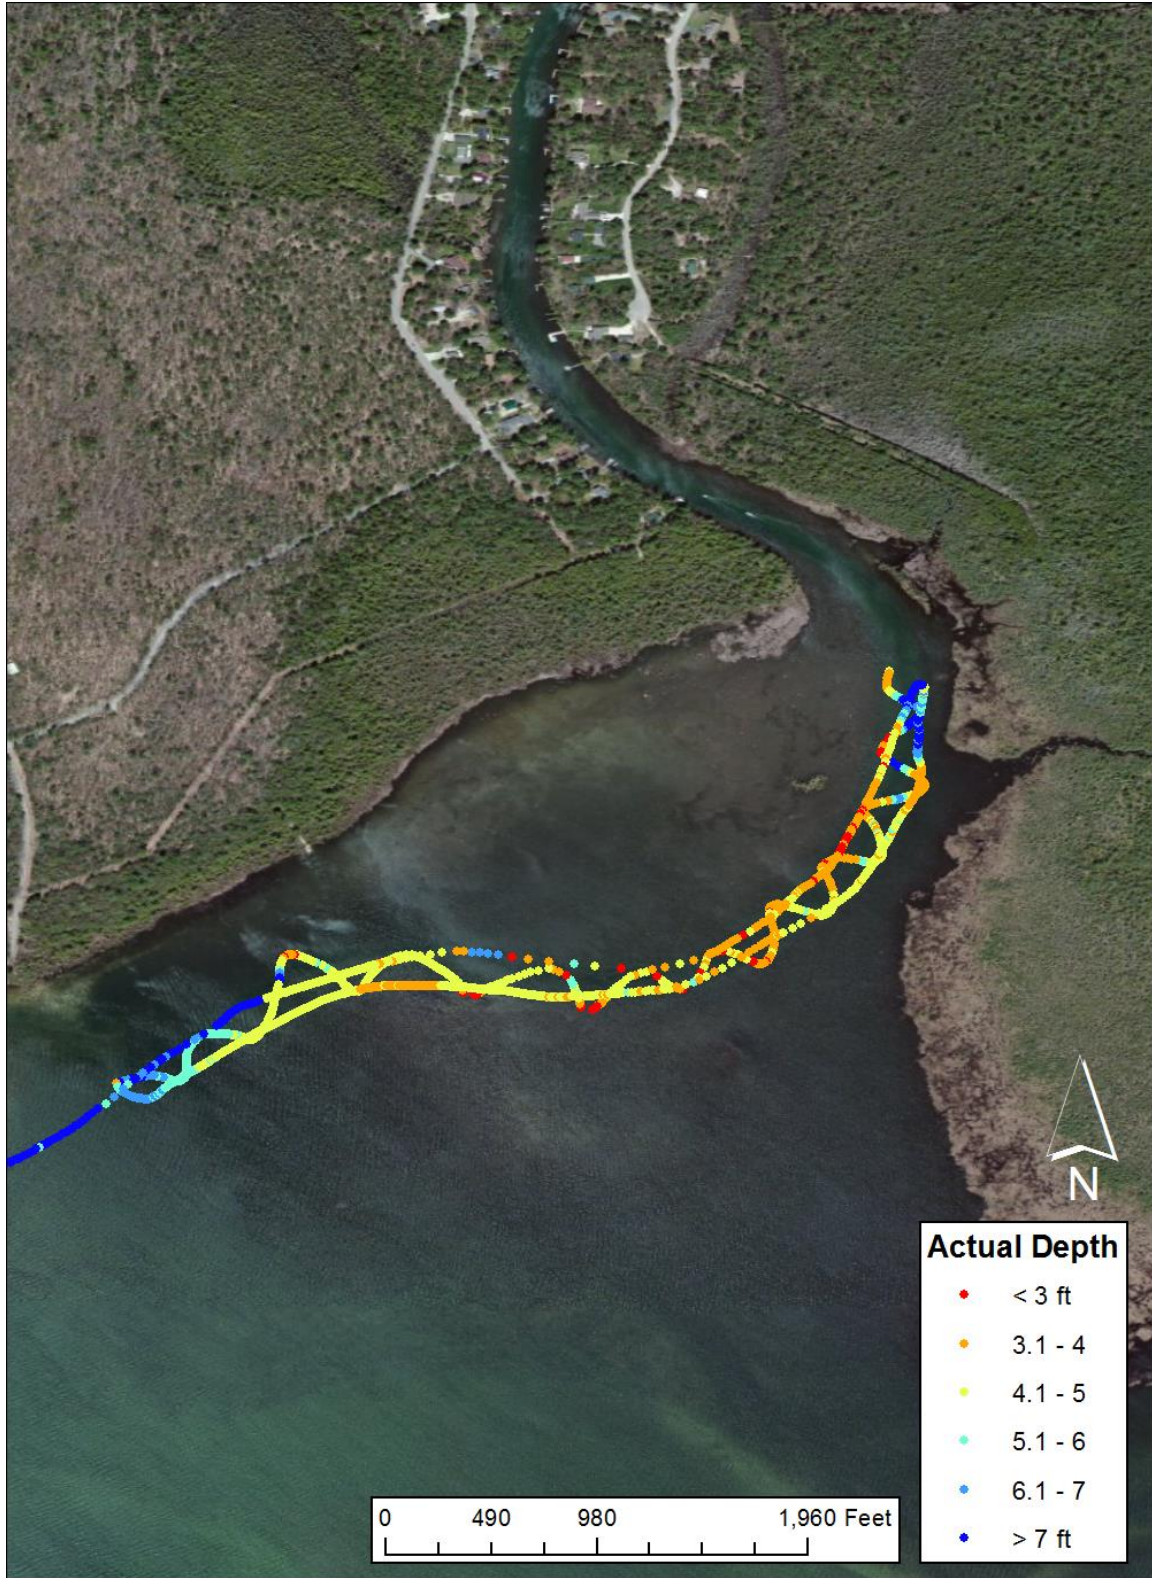
Figure 27. Map of detailed channel depths at the Torch River outlet into Skegemog Lake.

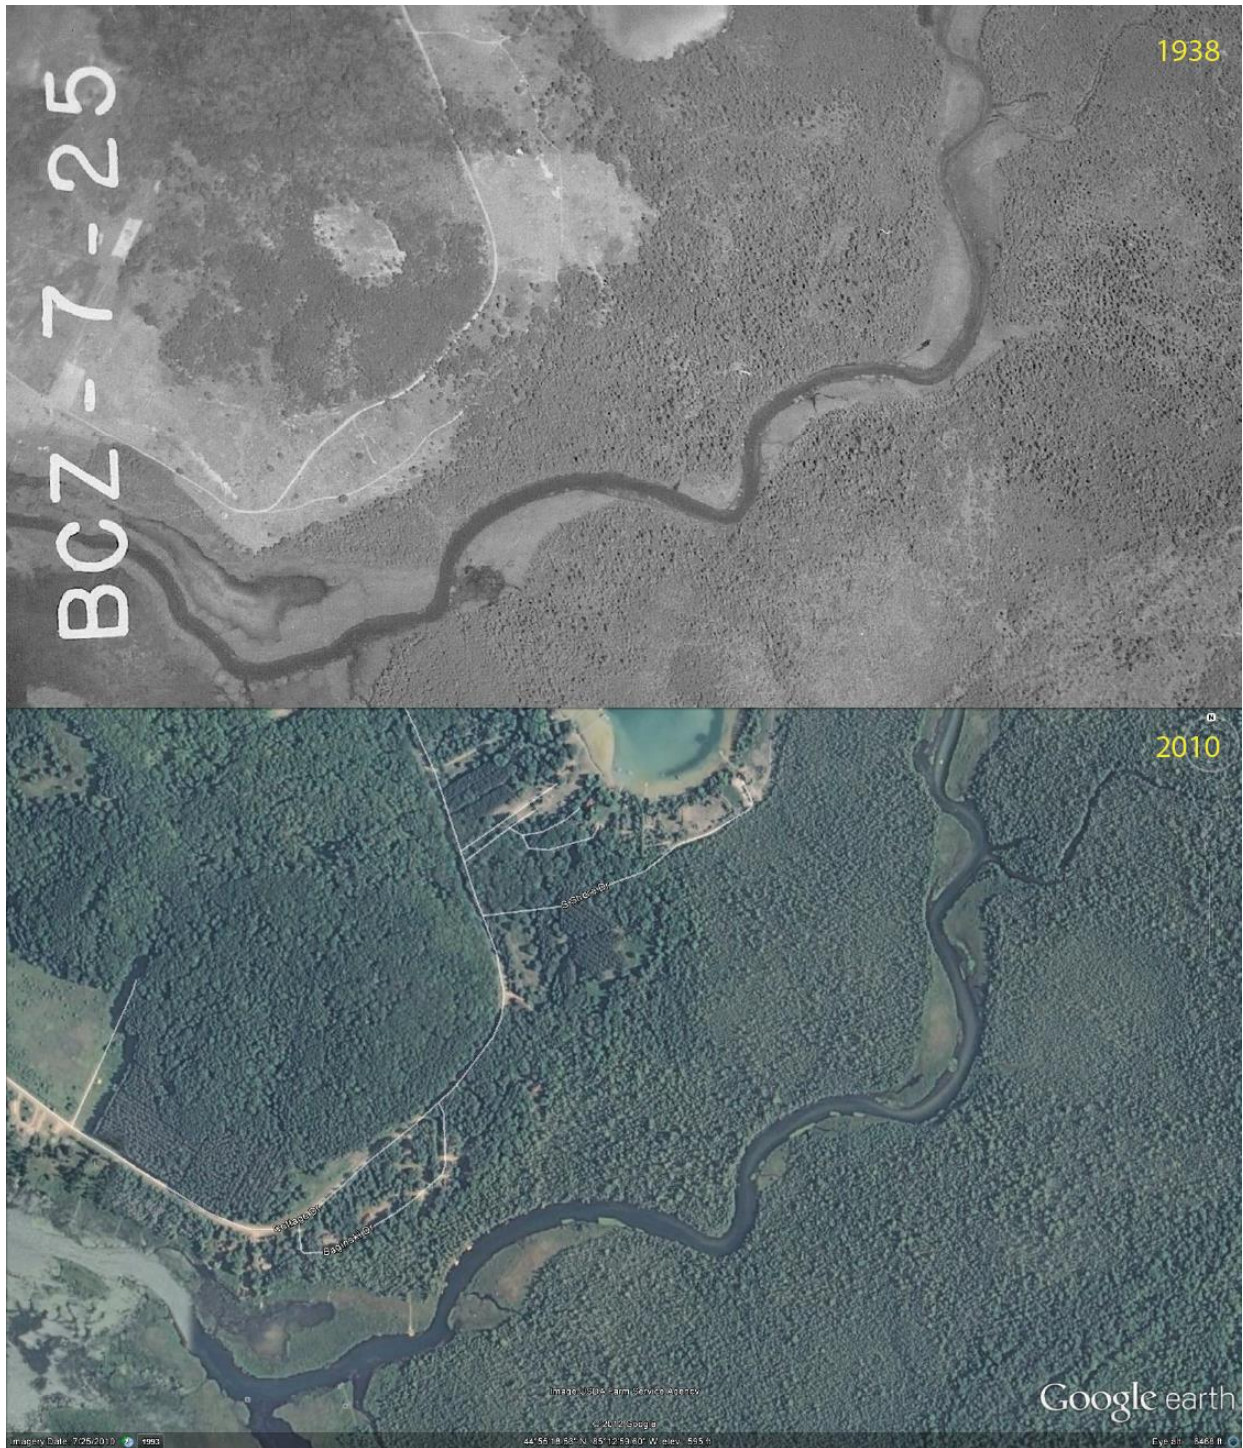
Figure 28. Comparison of the same frame (Grass River at the mouth into Clam Lake) between 1938 and 2010. The 2010 channel is significantly wider, and new mid-channel sediment features have developed downstream of Cold Creek.

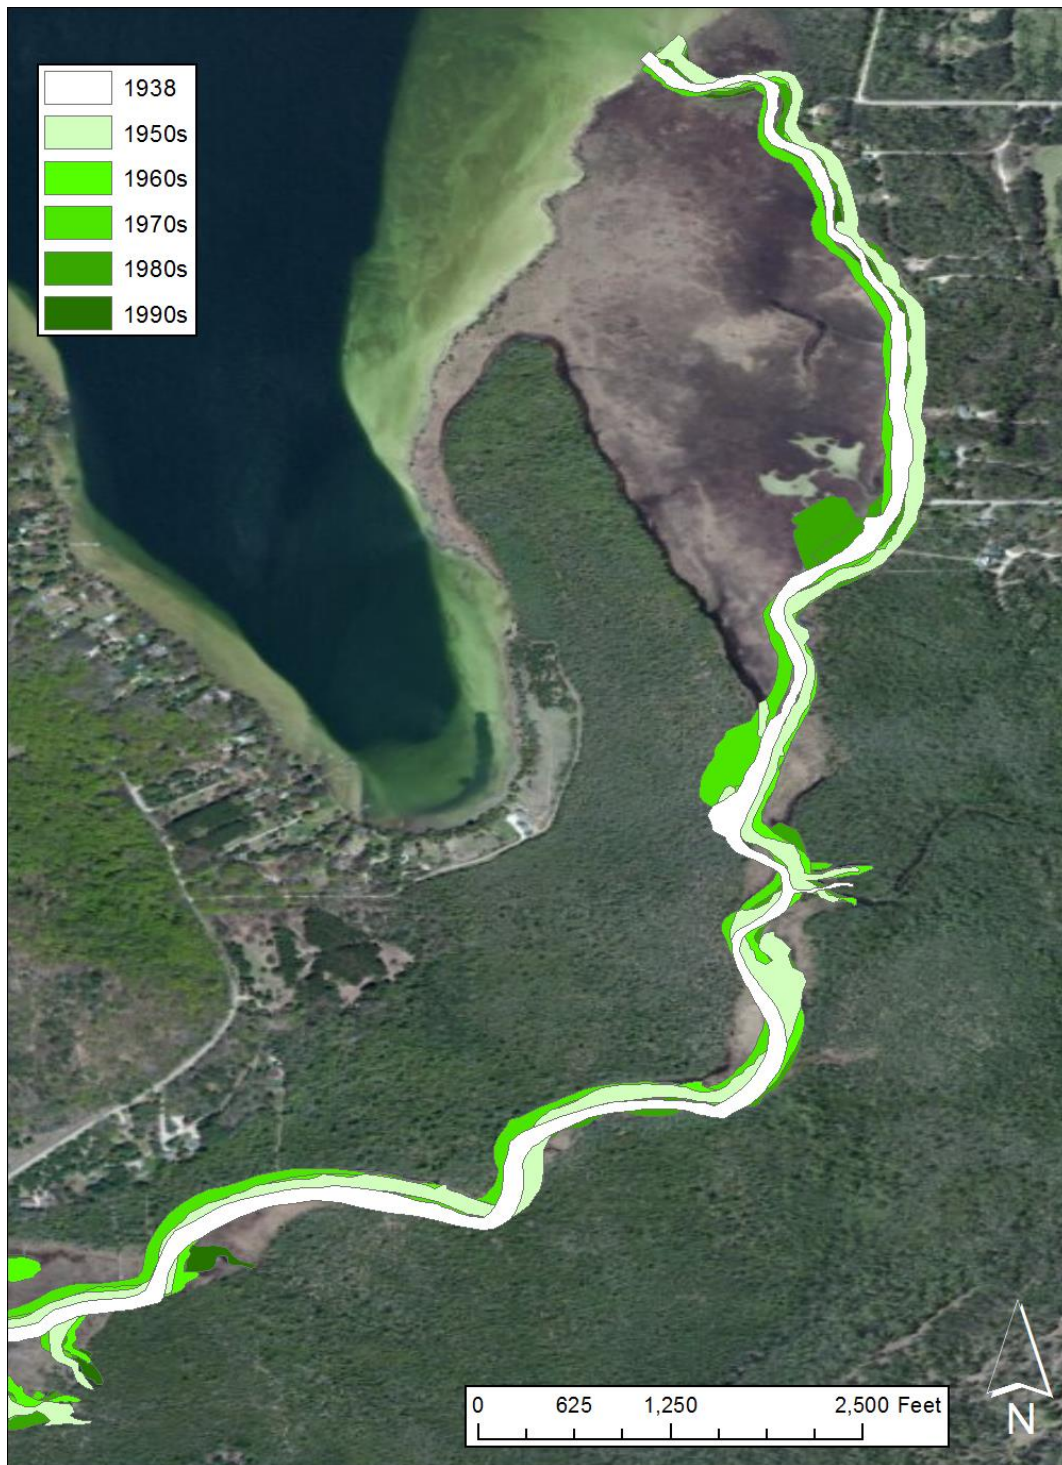
Figure 29. Map of the Grass River through time as digitized from historical aerial imagery. Note that the positions of the streams are not as accurate as the geometry. Thus the shifts in the channel should not be interpreted as genuine, but the shape of the channel and its dimensions are accurate.

Figure 30. Same stream channel maps as in Figure 29, overlain with cross sections approximately every 200 meters. Those cross sections were intersected with the stream channel edges in order to determine change in stream width over time.

Figure 31. Map of Torch and lower Rapid Rivers showing channel changes through time as mapped with aerial imagery. Caveats about channel position discussed in Figure 29 apply here as well.
