GRASS RIVER LARGE WOODY DEBRIS (LWD) PROJECT

2012 GRASS RIVER SEDIMENTATION STUDY

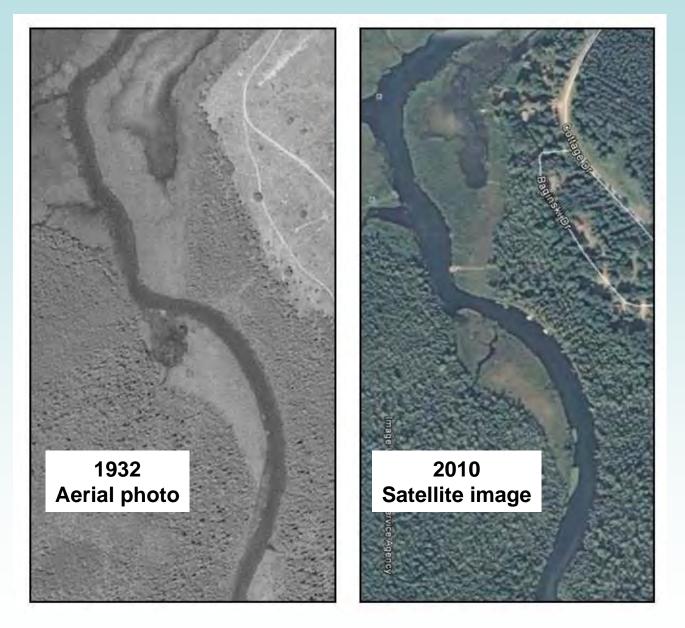
Grass River is becoming shallower & wider over time

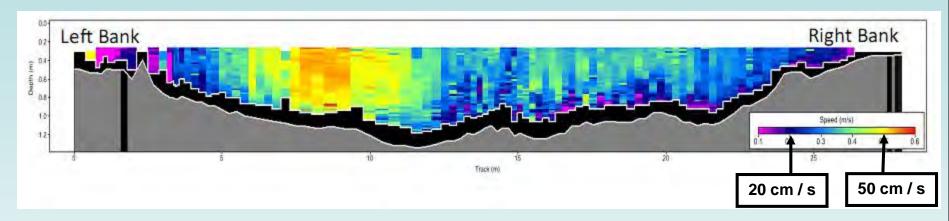
Flow velocity in stream channel cross section

- Flow volume is not evenly distributed across channel section
- Main channel flow is relatively slow allowing some sediment accumulation
- Areas with greater flow experience less accumulation
- Tree structures help focus flow toward main channel

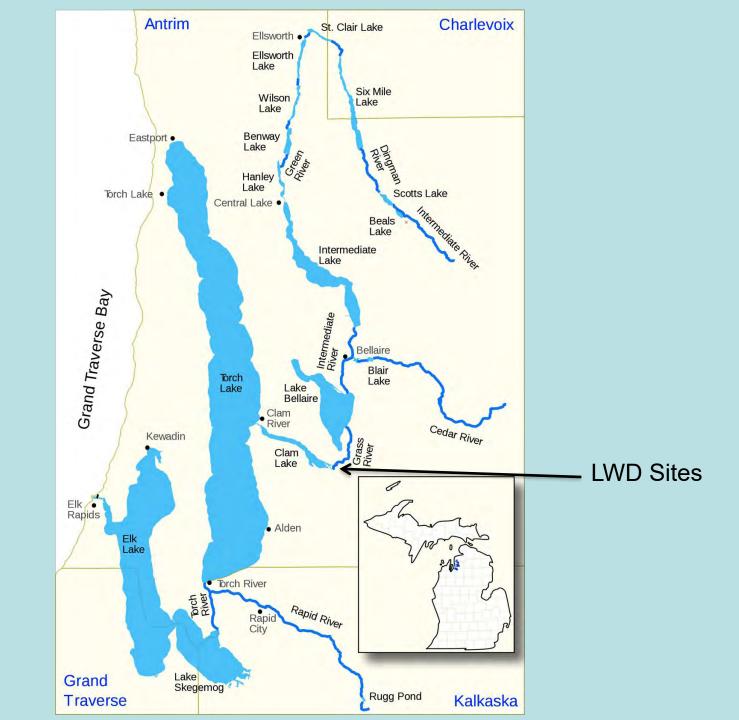
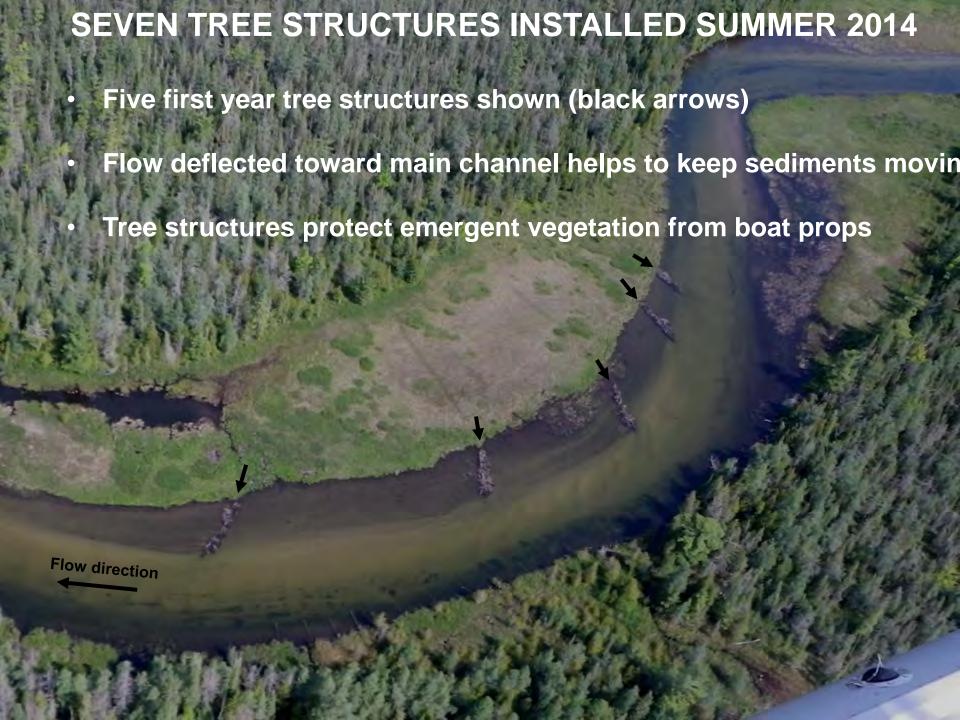
JOINT EFFORT

- •Technical guidance and installation expertise was provided by stream restoration specialist, Ken Reed.
- •Ken Reed and his assistant strategically positioned and secured trees to the river bank while a dozen volunteers from Grass River Natural Area, the County Board of Commissioners, area lake associations, Short's Brewery, and the Antrim Conservation District harvested and transported whole trees to the pre-designated sites.
- •Every tree was evaluated by representatives from GRNA with help from Antrim County Forester, Mike Meriweather.
- •Trees were selected away from the riverbank so removal would not have a visual impact from the water.
- •The entire project was completed in under four days with around 150 hours of labor.

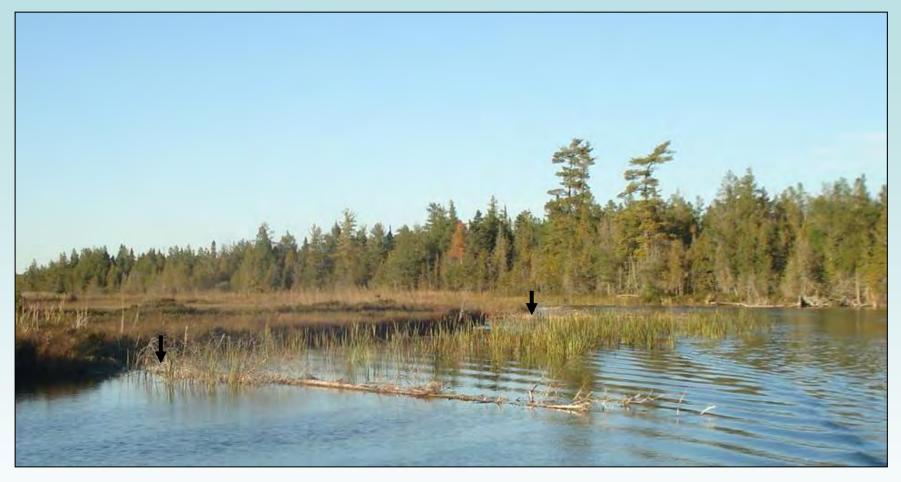
- Emergent vegetation grows between tree bundles
- Width of river may be restored over time
- Where river is narrower, current increases and channel becomes deeper

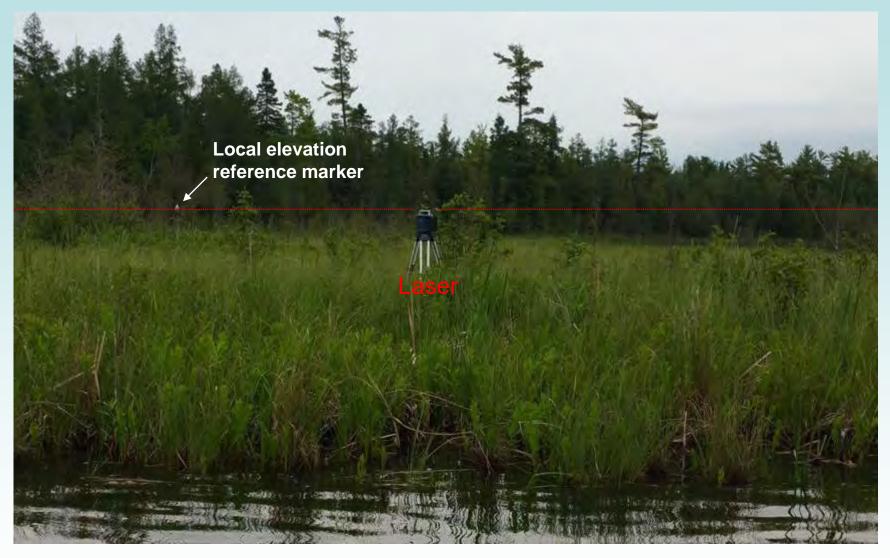
- Tree and white metal square used as a local elevation reference
- Laser is used to measure vertical distance to this elevation reference

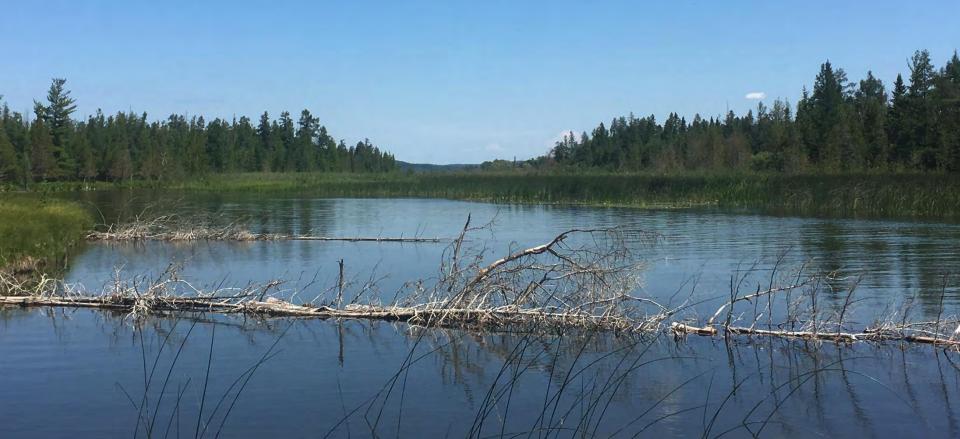
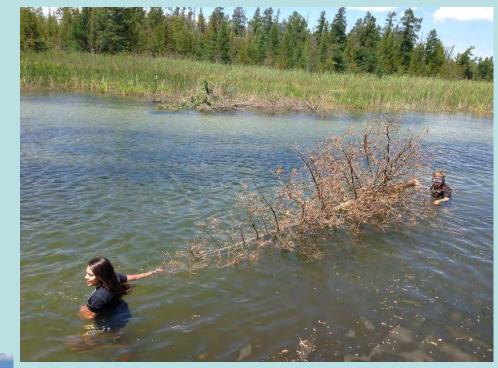
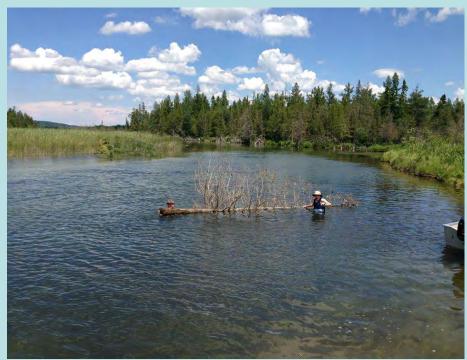
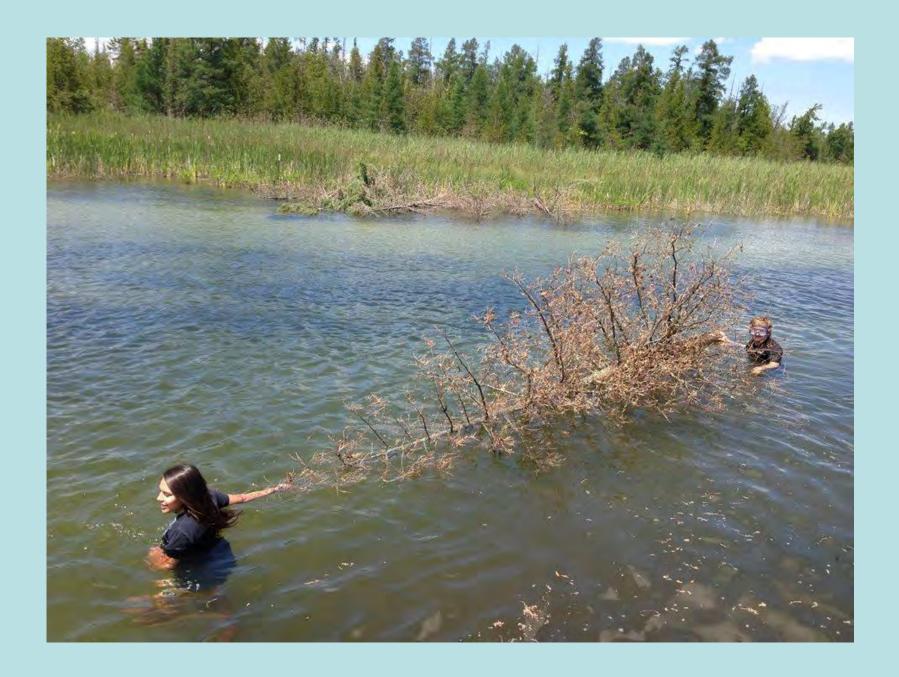
LWD STRUCTURES 2016

- Mark Stone applied for a second permit to install 10 LWD structures beginning in 2016.
- Five structures were installed with the the help of Mark Stone, TLA interns, volunteers, and TLA Board members.

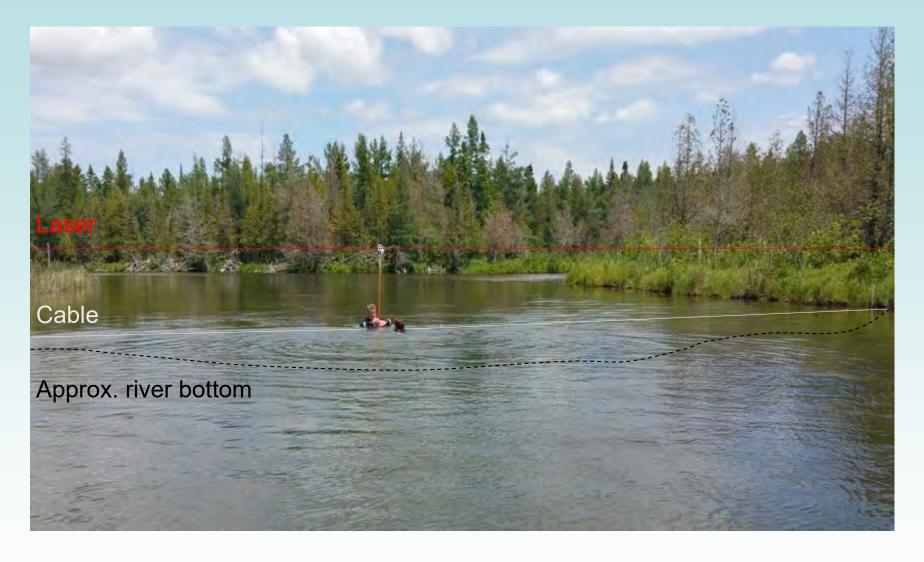
Vertical distance from elevation reference marker to the river bottom being measured along a chosen cross section before installing LWD
