GRASS RIVER & TRIBUTARIES RESTORATION ASSESSMENT: 2011 FINDINGS

Three Lakes Association PO Box 689 Bellaire, MI 49615 www.3lakes.com by

August 31, 2011

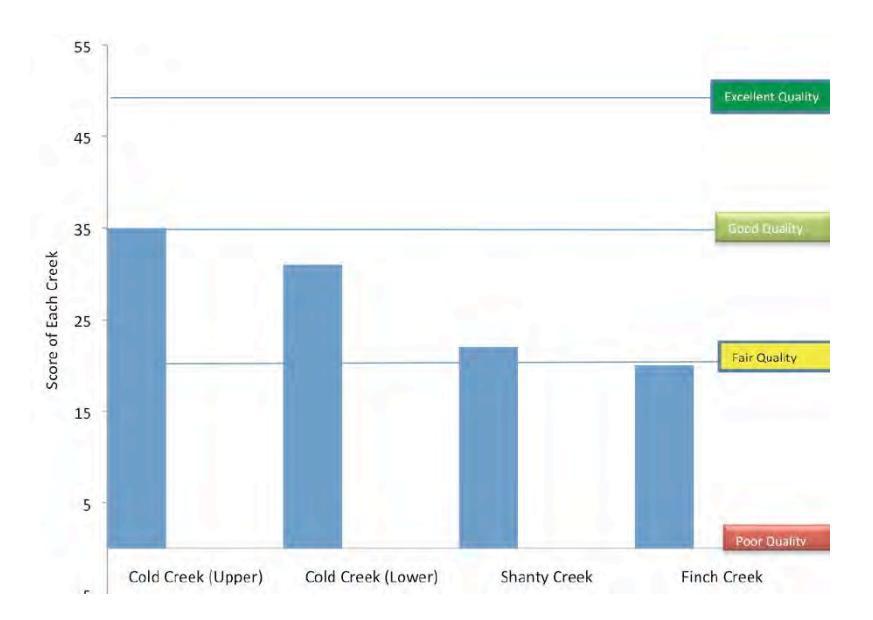
Macroinvertebrate scores

This graph shows the scores for the streams sampled during this project.

Streams that score less than 19 are considered poor quality, those from 19 to 33 are considered fair quality, those from 34 to 48 are considered good

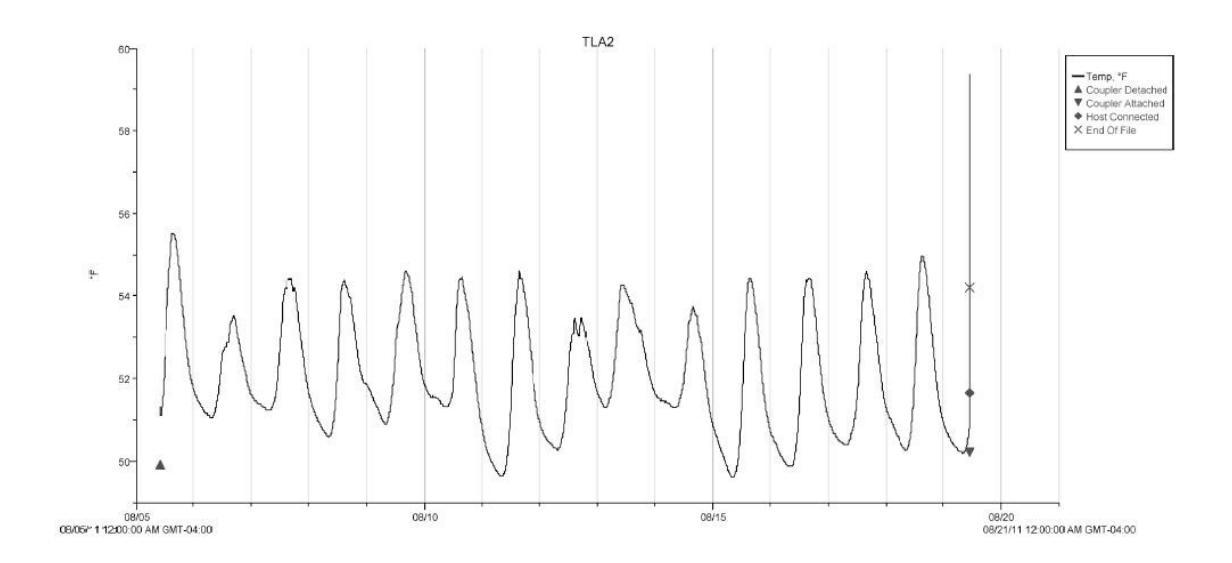
Example of time-temperature profile data, Shanty Creek

(Railroad culvert at Grass River Natural Area)
